## Failure Analysis and Failure Investigation of UZ/ACPT1 SS SIDUM Ejector Condenser

Department of Facility Integrity, Abu Dhabi National Oil Company, Abu Dhabi, United Arab Emirates

### Abstract

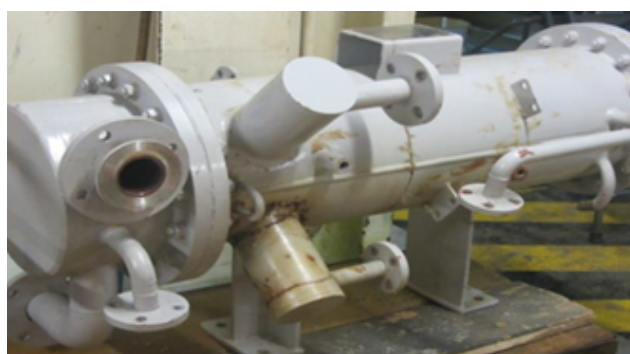
**Figure 2:** ACPT SIDEM Ejector Condenser.

ejector condenser consists of two stages. The downstream ejector removes non-condensables to the first stage of the ejector condenser. The exhaust steam is condensed in the second stage ejector condenser and the non-condensable are vented to atmosphere. Refer to Appendix 1 and 2 which shows the mechanical as built drawing of the ejector condenser (Figure 2).

Frequent failure are taken place for the SS ejector condenser, upon visual examination, Crack like damages are commonly taken place on the 3" 2<sup>nd</sup> stage Nossel, and near weld areas of the condenser associated nozzles. The Table 3 shows the Inspection history findings and recommendations. Inspection history shows that almost all the ejector condensers in SIDUM desalination Plant in ACPT has failed, by frequent leak reported, and claimed that chloride SCC is the damage mechanism of shell as detailed below.

1. Changing the material to more cracking risistant alloy such as Duplex Stainless steels S32760 (Zeron 100) S31254 (254 SMO), or N06625 (625 Alloy). Alloys Chemical Composition is shown in Table 9. Referring to approximate relative pipe cost assuming that it is applicable

to exchangers also, it is noticed that Alloy 625 has much higher relative cost (22.8) compared with 254SMO alloy (9.2) and Ziron 100 (6.8). Alloy 254SMO has better pitting resistance than Ziron 100, and thus it is recommended to use Alloy 254SMO as a condenser material.

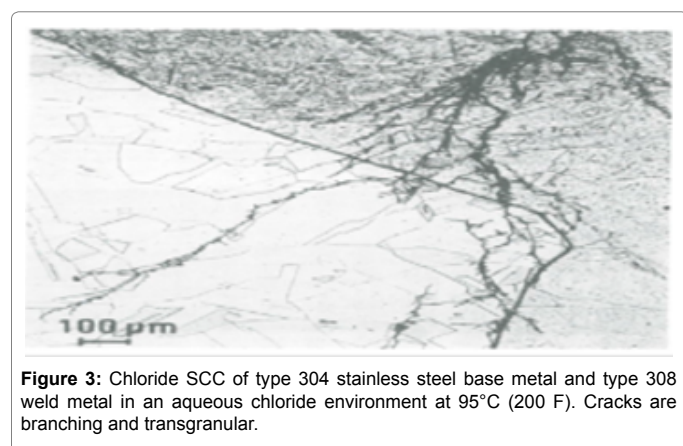
Welds in the 300-series austenitic stainless steels, contain a small amount of  $\beta$ -ferrite to prevent hot cracking during weld solidification. In hot, aqueous chloride environment (the same environment as for ejector condenser), these duplex weldments generally shows a marked resistance to cracking, while their counterparts crack readily. The generally accepted explanations for this behavior is that the ferrite phase is resistant to chloride SCC and impedes crack propagation through the austenite phase. Electrochemical effects may also play a part however, under sufficient tensile stress, temperature and chloride concentration, these duplex weldment will readily crack (Figure 3).
