Analysis of Catastrophically Failed Industrial Bolt

Abstract

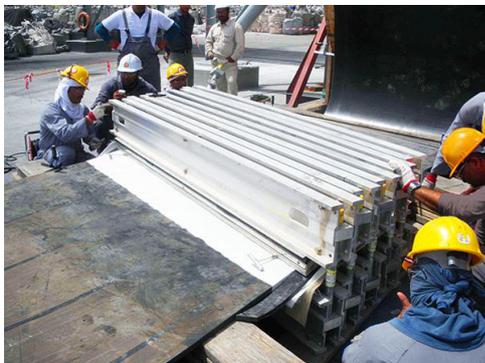
Figure 1: Vulcaniser shown being used at site for splicing conveyor belt [1].

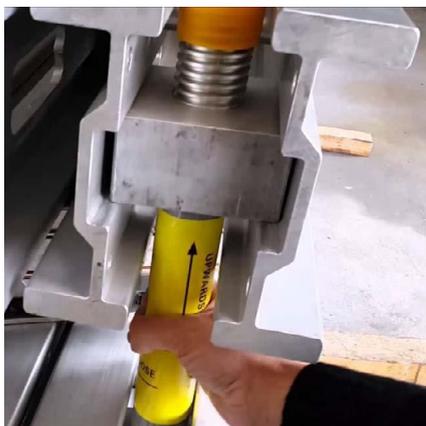
Figure 2: Vulcaniser bolt shown assembled in top beam.

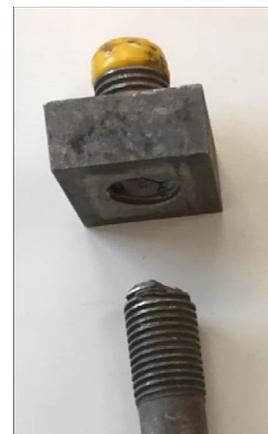
The bolt under consideration failed during use. It has been assumed that the bolt was used as per manufacturer guidelines. As can be seen in Figure 3, the bolt broke near to the end of threads in the nut.

Figure 3: Broken vulcaniser bolt shown with nut.

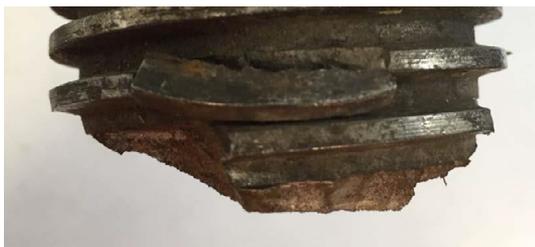
The side of the fracture surface shows the surface to be quite undulating as opposed to a flat surface which is associated with fatigue failure. The predominant mode of failure for the bolt was therefore catastrophic failure (Figure 4).

Figure 4: Side-view of fracture surface (low magnification).

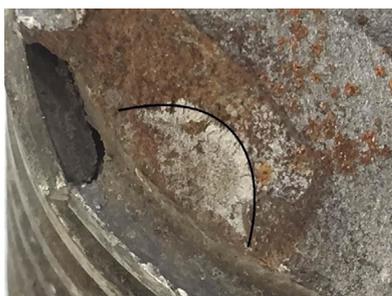
A higher magnification (of the black box area shown above) shows a smaller area that is flat i.e. perpendicular to the tensile loading that the bolt was experiencing during use. The flat area is a typical thumbnail

shape that is often associated with fatigue crack growth. The crack front is shown outlined with a black line for ease of visualisation. The crack would have initiated along the inner diameter edge of the bolt thread (Figure 6).

Figure 6: Fracture surface with fatigue zone outlined enclosed within curved black line and ID of thread (high magnification).

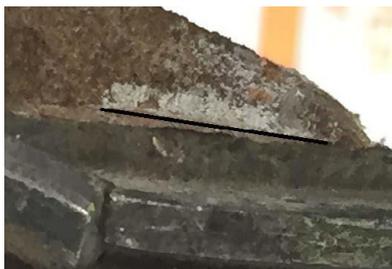
Figure 7 shows a higher magnification view of the side of the bolt. The ID thread edge of the thumbnail crack is shown below also with a black line for ease of visualisation. As can be seen, the flat thumbnail crack is nearly parallel to the ID of the bolt thread. The black lines shown in Figure 7 measures approximately 8 mm in length.

Figure 7: Side-view of fracture surface (high magnification) showing flat fatigue surface (black line) parallel to ID of thread trough.

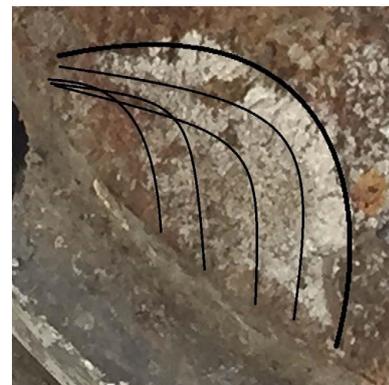
Figure 8: Fracture surface outlining possible striation fronts.

Based on the author's experience and knowledge, a number of possible striation fronts are identifiable and outlined in Figure 8. As can be seen, fatigue crack growth approaching catastrophic failure indicates that fatigue crack growth was relatively rapid over the last 5 uses of the bolt. It is likely that the fatigue crack initiated at least an equal number of uses prior to this more rapid crack growth as catastrophic failure approached. Based on these observations, it is anticipated that the fatigue crack would have been present for at least 10-15 uses prior to catastrophic failure. However, detection of the fatigue crack would be limited by the NDT technician and the instrument or method of NDT.
