Surface Defect in Telescopic Front Fork: A Metallurgical Analysis

Abstract

Keywords: Telescopic front fork; Induction welding; Internal oxidation; Hook crack

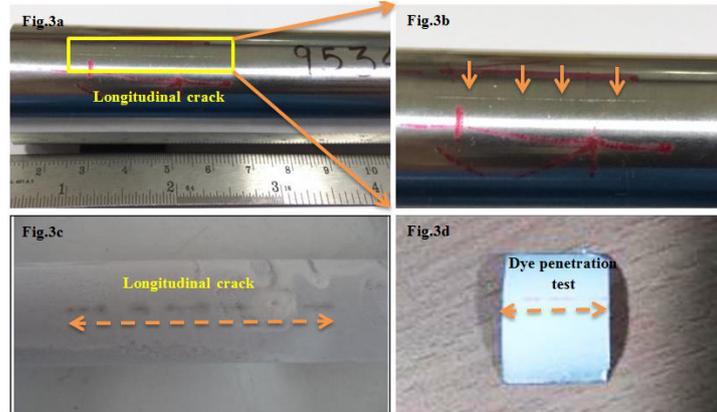
In case of Sample #1, visual observation of the tube sample showed that longitudinal surface crack along the length of the tube at the

circumference close to the weld (Figure 3a and 3b). The crack was around 4 cm in length and very thin and difficult to detect easily. As the split was exceptionally shallow inside and out and hard to distinguish so it was recognized by color infiltration test (Figure 3c and 3d).

Figure 3: a and b) Longitudinal surface crack on the tube; c and d) shows longitudinal crack was detected through dye penetration test.

If there should be an occurrence of Sample #1, visual perception of the tube test demonstrated that longitudinal surface split along the length of the tube at the outline near the weld. The break was around 4 cm long and thin and hard to recognize effectively. The un-etched microstructure revealed a crack, which looks like 'J' type and depth of around 0.5 mm, characteristic to hook cracking. MnS inclusions were observed in the along the crack locations. The overall MnS inclusion was high as shown in Table 3. Microstructural analysis further revealed that the hook of the crack was turning toward upward surface. The

Failure of the fork tube can lead to the serious consequences. Careful inspection by sound magnetic flux leakage methods is required to assure that the defects are not present. Extra care should be taken

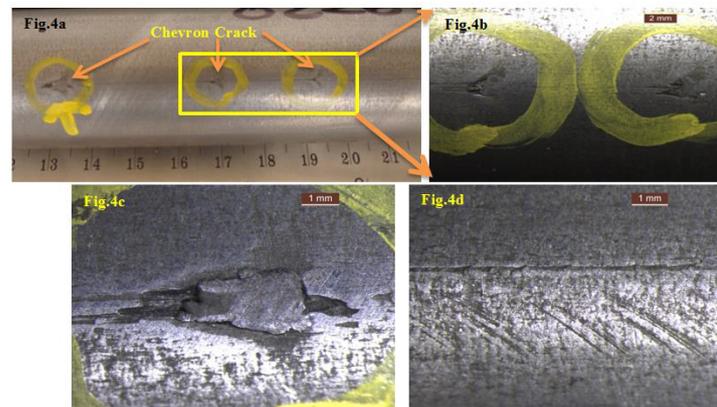
In case of Sample #2, general view of the tube sample with defect is shown in Figure 4a. Multiple chevron marks were observed on the outer surface of the tube. These chevron marks were found to form a single line (Figure 4b and 4c). Similar marks with less severity and a line mark running through centre of these defects were observed at 180 degree location (Figure 4d).

Figure 4: a-c) Chevron cracks on the surface of the tube; d) shows less severity defects were observed at 180 degree location of the chevron crack.

In case of Sample #2, repeating chevron marks were observed to

form a single line at certain interval on the tube surface. Similar marks with less severity and a line mark running through centre of these defects were observed at 180 degree location. Closer observation of the chevron marks in stereo microscope shows accumulation of material at centre of the chevron. Optical microscopy shows grain deformation at the defect contour indicating cold stage deformation. Based on the repetitive nature of the defect, it appears to be originating from the drawing stage itself and that too at exactly diametrically opposite locations of the tube. Decarburised grains along with internal oxidation associated with dark brown entrapment were observed along the cracks. Presence of mould power entrapment inside the crack indicates the defect originated from slab stage. The morphology and location on the tube suggests that the steel defect got aggravated during drawing forming the chevron mark. Mold powder entrapment occurs mainly in "transient casting" periods, e.g. the time of casting start, casting end, mold width change, ladle exchange, SEN change, etc. During the unsteady casting periods, usually, the casting speed is largely varied, which disturbs the flow of the liquid steel in the mold and results in severe fluctuation. Subsequently, shape powders are anything but difficult to be conveyed into the fluid steel and some are captured by the cemented shell and exist as non-metallic incorporations in sections. If the interfacial velocity of steel melt exceeds tear off velocity results in associated shear stress to become greater than the cohesion forces of the slag. Due to which slag gets torn off and carried over in the form of droplets in the liquid metal. While a part of these droplets immediately floats back towards the meniscus, another part is transported by the metal flow and scattered in the liquid pool [7]. In case of sample #2 it has been observed that higher severity index in this coil is explained due to unstable stopper position shown in the caster (Figure 8). As seen

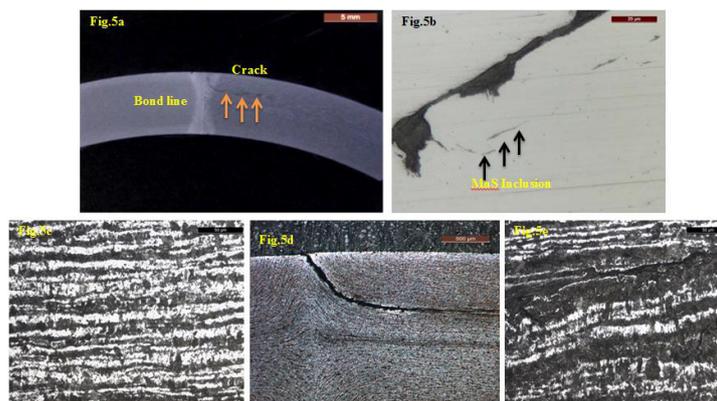
If there should arise an occurrence of first example, the un-m inside and out scratched microstructure demonstrated a break, 'J' type fit as a fiddle and of 0.5 m (Figure 5a), normal to snare breaking [1]. Facilitate the break was observed to be related with some non-metallic manganese sulfide (MnS) incorporations (Figure 5b) which were further, acclimated through EDS investigation. The full scale double zoom photo of the miniaturized scale test uncovered white bond line related with the break (Figure 5a). The 3% Nital carved microstructure demonstrated that the split was marginally balanced from the security line of the Cold drawn Electric obstruction Welding (CEW) crease (Figure 5a), however, following the weld stream lines and opened up at the periphery. The snare of the break moved in the direction of upward, as appeared in Figure 5d. The weld flow line of the tubes were good to the chilly drawn structure (Figure 5d) and the lattice uncovered grouped ferrite pearlite structure (Figure 5c and 5e) normal to such high manganese auxiliary steel grades [2].

Figure 5: a) Dual image of defect locations; b) un-etched micro image of the defect location; c-e) etched micro image of the defect location at different magnifications.

originator of hook crack is non-metallic inclusion primarily MnS stringers. These flattened non-metallic inclusions are formed during hot rolling of plate. They reduce the ductile toughness of the steel even in their normal position but do not affect the mechanical strength of the steel [3]. Thus the tensile properties of the tube under investigation were also satisfactory. Close bond line these non-metallic incorporations reorient themselves such that they move toward becoming subjected to tractable loop pressure when the pipe is pressurized [4] and bringing about start of break. The slight bombshell of the metal at the weld acted to turn the finishes of this generally little subsurface break toward the surprise. Since the metal stream amid the surprise is toward the two surfaces. The hook of the hook crack may turn toward either the outside or inside surface, depending on which the delamination takes place in that direction where, the greatest amount of upset occurs. Generally the upset is greater toward the outer surface this causes the hook to turn towards outer surface [5]. In current examination additionally the break moved in the direction of the external surface because of more prominent miracle toward the external surface. Since snare splits are seen in the plate thickness thusly surface oxidation amid hot rolling and warmth treatment can't be in charge of snare break [6]. The chemical composition revealed higher high manganese and sulfur ratio and in this case favored the formation of MnS inclusion resulted in higher inclusion rating. These MnS inclusions caused deficiency at the edge of the strip which deviated towards the outside diameter of tube surface causing in hook crack creation during upsetting at the time of welding process. Thus the hook crack was originated during tube manufacturing which surfaced out when the tube was put in field service.

In Sample #1: Analysis of the results suggests that the presence of MnS inclusion at the edge of the caused the origin of the hook crack, this exposed during process, resulting in cracking of tubes.

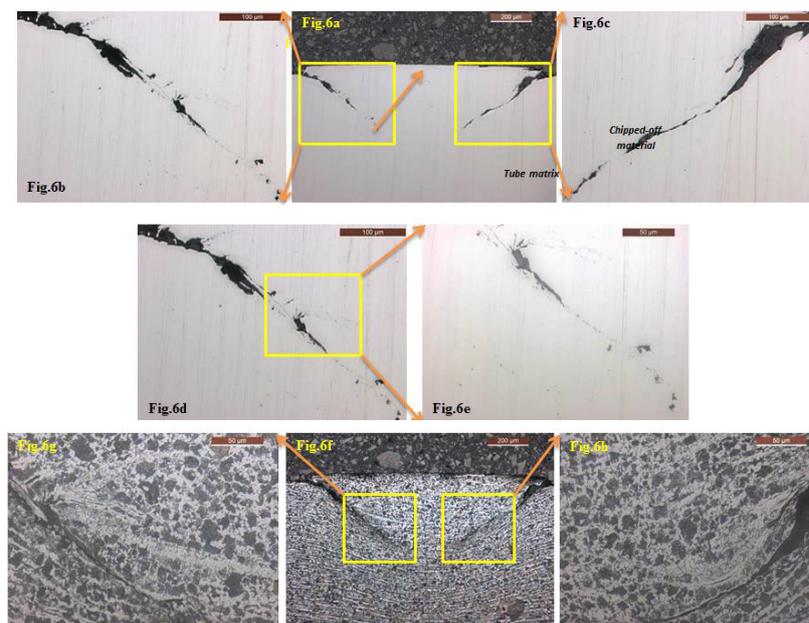
In case of Sample #2, un-etched micro image of the samples from defect area revealed bowl shaped defect. This was formed by chipped-off material as shown in Figure 6a. Figures 6b and 6c show closer view of the cracks on both edges of the defect. It revealed that the cracks contain some non-metallic entrappings in it. At higher magnification, as shown in Figure 6e, suspected internal oxidation was observed in chipped-off material.

The etched microstructure at the defect location is shown in Figure 7a. Banded ferrite - pearlite structure was observed which followed the contours of the defect/chipped-off material. At higher magnification, decarburised grains were observed along the suspected internal oxidation. The chipped-off material does not show any banding or deformation. However due to accumulation of this material, grains in the matrix below it got deformed which is cold condition effect (Figure 6a-6h).

Figure 6: a-d) Un-etched micro image of the defect location at different magnifications; e) presences of dark brown entrapment along with internal oxidation. f-h) etched micro image of the defect location at different magnifications.

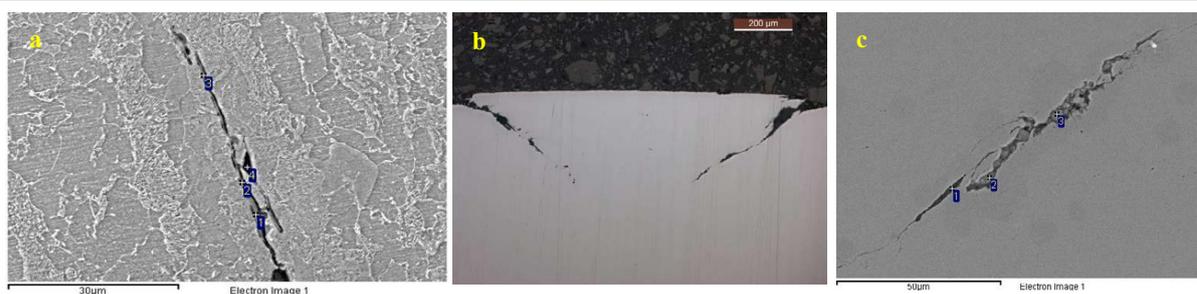
In case of Sample #1, EDS analysis was carried out on non-metallic inclusion by Field Emission Gun Scanning Electron Microscope. EDS analysis conformed the inclusions as MnS (Figure 7a and Table 2). Inclusion rating was carried out by worst field method as ASTM E 45 to check complete cleanliness of the steel. The inclusion rating, as shown in Table 3, revealed higher level MnS inclusions in steel (Tables 2-3).

Sample #2: EDS analysis of the dark brown entrapment revealed prominent peaks of Ca, Si, Al, Na, F and O which proves that crack has generated due to mould powder entrapment (Table 4).

Figure 7: a) EDS analysis of the sample#1 at cracked location; b and c) EDS analysis of the sample#2 at defect location.

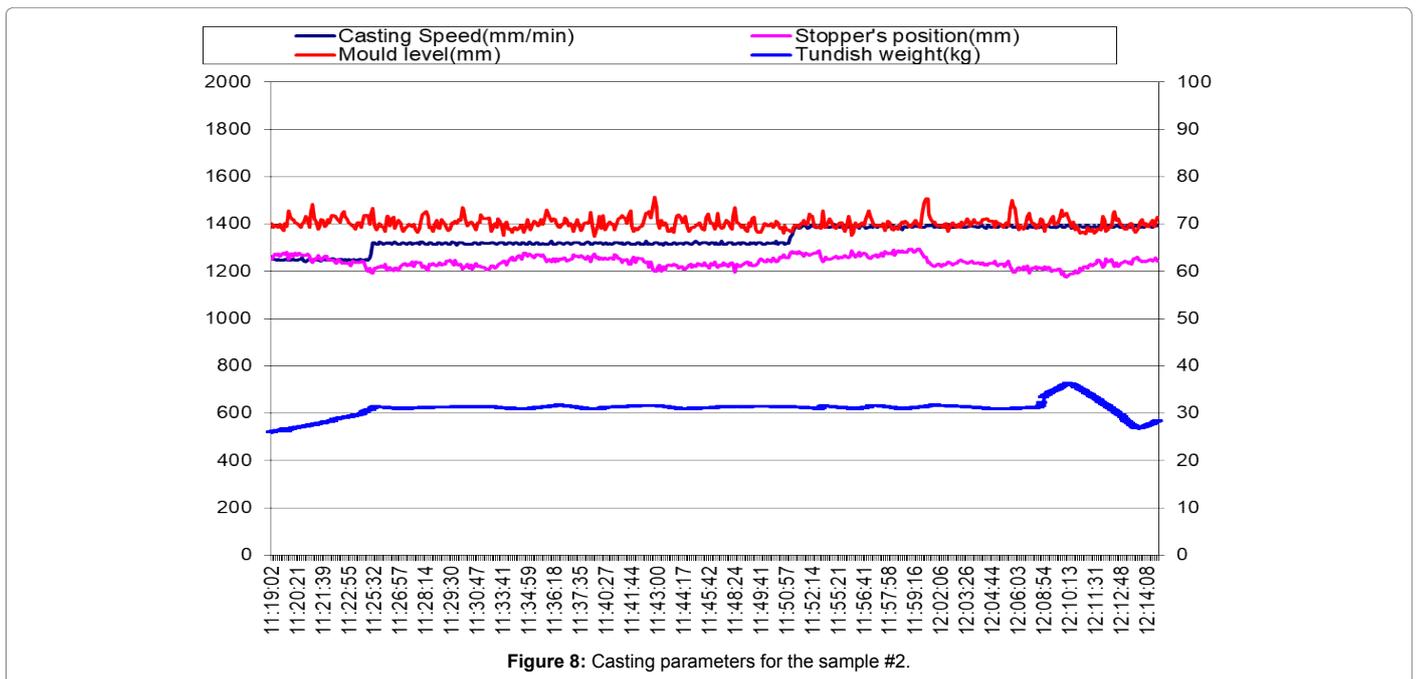
Figure 8: Casting parameters for the sample #2.

from the chart given for this slab, there are large fluctuations in casting speed along with large mold level fluctuations. Whereas casting speed is steady. Hence changing stopper position causes unstable molten steel flow and so entrapment of mold powder (Figure 8).

In Sample #2: The slag entrapments of the mold fluxes in sub-surface of the strands are the main origin of the surface defect in telescopic fork tube. The morphology and location on the tube suggests that the steel defect got aggravated during drawing forming the chevron mark.

to maintain the stopper position and casting speed regarding casting of surface critical grades to avoid non-metallic inclusions in the steel.
