Unusual Puncture Marks on Poly Vinyl Tubing

The case study involves the examination of puncture marks on a polyvinyl (PV) tubing of an industry pipelining wherein sabotage had occurred. The study carried out to individualize the characteristic and sub-class characteristic marks formed by the tool implemented and their unusual features formed are attempted. The paper also brings out differences in the characteristics of puncture marks on PV tubing resulting from the three knives/tools submitted by the investigating officer and the linking of one of the knives to the questioned tool marks on the tubing.

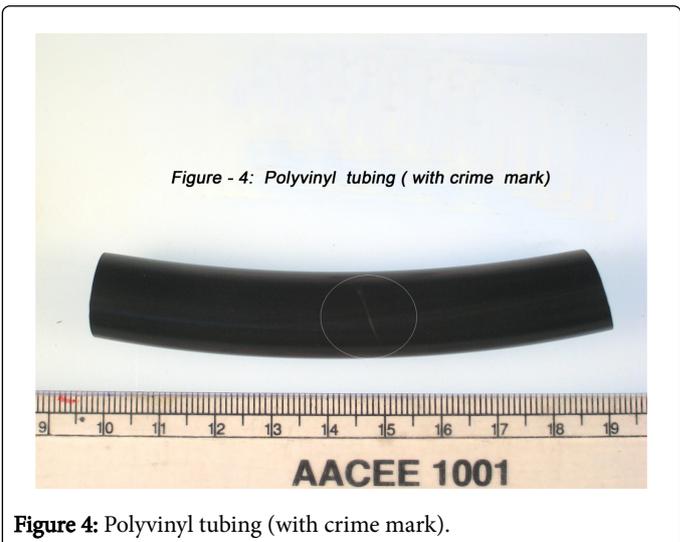
The Figure 4 is the photograph showing the black colour, 1.7 mm thickness and 12 mm diameter cylindrical polyvinyl tubing having the suspected puncture marks/damaged.

Figure 4: Polyvinyl tubing (with crime mark).

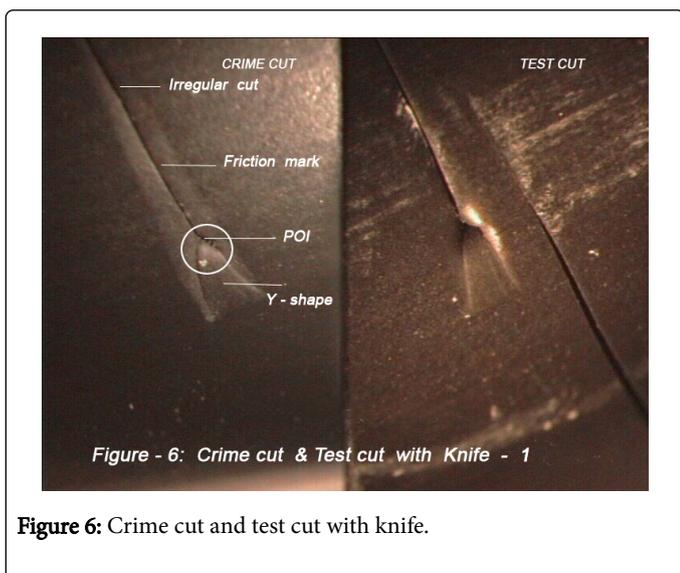
The test cut marks made on the P.V. tubing was compared with the suspected cut mark using the Leica comparison microscope. The external view of the puncture made by the knife (Figure 1) depicts several characteristic features as shown in the Figure 6. In this Figure the most obvious characteristic is the friction mark left by the knife blade [1-3].

This friction mark will reflect the general shape and size of the knife's blade portion. This is usually caused by the P.V. material gripping the surface of the knife blade as it enters the tubing. This is the evidence worth looking for in a puncture. It can provide certain clues to link the type of knife used to make the puncture. From the Figure 6 the Point of Insertion (POI) can be identified as the characteristic unusual feature of puncture mark.

Figure 6: Crime cut and test cut with knife.

The tear mark in POI is the characteristic of a single edge blade knife with blade thickness of approximately 1-3 mm. It has characteristic shape of "snake's tongue or Y". This is caused by the back of the knife tearing the P.V. tube apart as the knife is inserted [1]. This

The comparison made between the puncture marks made by the above said three knives, whose close-up blade edge view is given in Figure 9, on the P.V. tubing showed the difference in puncture made by each knife. The comparison made showed that the knife in the Figure 1 had caused the puncture mark on the tubing shown in the Figure 4 and its comparison shown in the Figure 6.

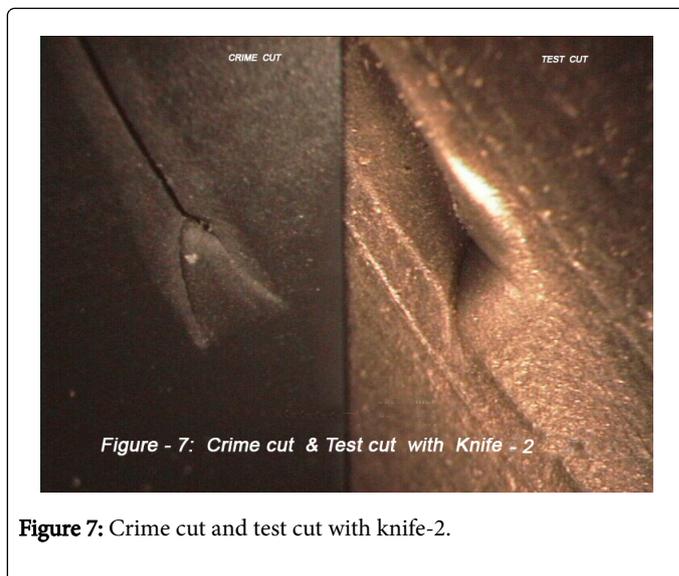
Figure 7: Crime cut and test cut with knife-2.

The Figure 7 shows photomicrography of the puncture marks formed by a relatively thin blade of the broken knife (Figure 2) with serrated single edge blade. The cutting edge is serrated the full length of the blade to the choil. The external view of the cut shown in the Figure 7 gives the friction mark present and POI. Even though this is a single edge blade knife the "snake's tongue-Y" is having a characteristics difference from that of the "Y" in the Figure 6.

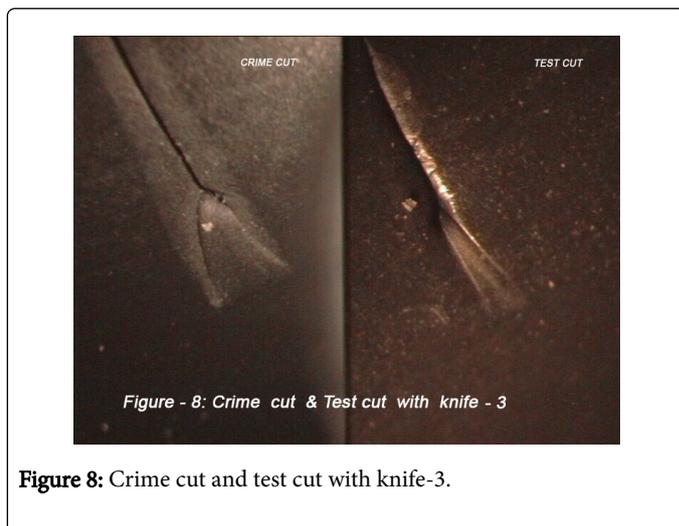
Figure 8: Crime cut and test cut with knife-3.

The Figure 8 shows the comparison microscope observation of the external view of the cut made by very thin sharp surgical knife (Figure 3). The individual characteristics as shown in the Figure 8 have a relatively little detail. The cut is very thin and barely visible. This is because of the small amount of the friction mark present [5,6]. The 'Y' shape is very irregular and the POI seen is also the exclusive characteristic mark made by the surgical knife.
