Electronic Health Record Artifact Caused by Surgical Diathermy

Here we present an example of such unexpected artifact in anesthesia charting software that appeared during maintenance of general anesthesia in a child.

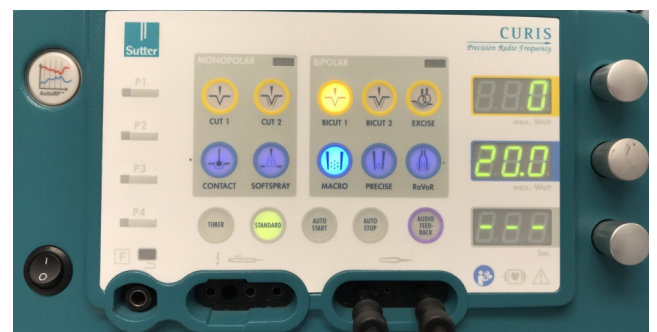
When the surgeon started to use diathermy (Figure 1), we noticed an ECG changes (Figure 2), in addition to strange changes including opening new, or closing existing Microsoft windows, adding new drugs not given or ordered to the child’s anesthesia chart, and some actions were deleted from electronic anesthesia record (Figure 3).

Figure 1: Diathermy (Curis Sutter Medizintechnik tullastraBe 87-79108 Freiburg/ Germany).

The computer use was scanned to detect any virus; worm or software problem but we did not find any offender. We have noticed that this problem happens whenever we have a new diathermy machine added to the operating theatre. Therefore, we sought to change the diathermy machine and no further artifact was noticed.

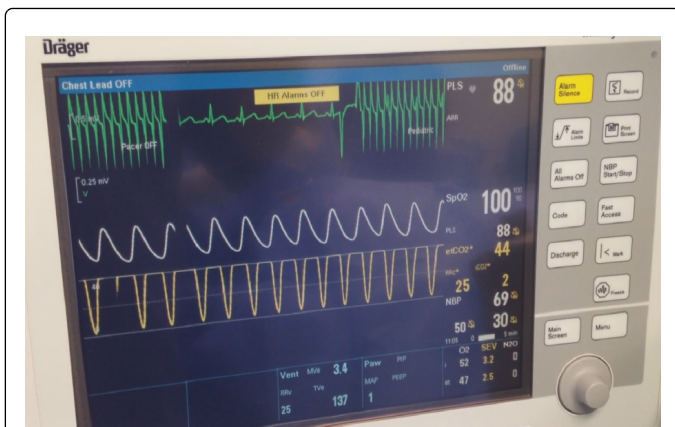
Figure 2: ECG changes with diathermy.

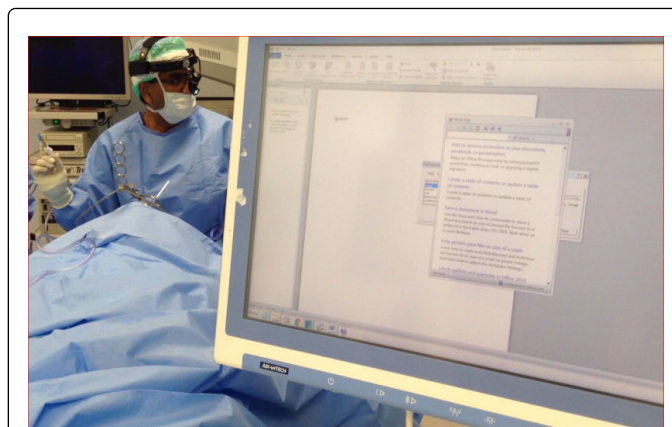
Figure 4: Opened Microsoft word document artifacts with diathermy.

We tried to open the word file document and to analyze the artifacts and track its sources. At this time, we found that alphabetical letters were typed randomly on one of the spontaneously opened Microsoft Word file as artifacts during using surgical diathermy. The spontaneous typing was related to surgical diathermy and has stopped whenever the surgeon stopped using it (Figure 4).

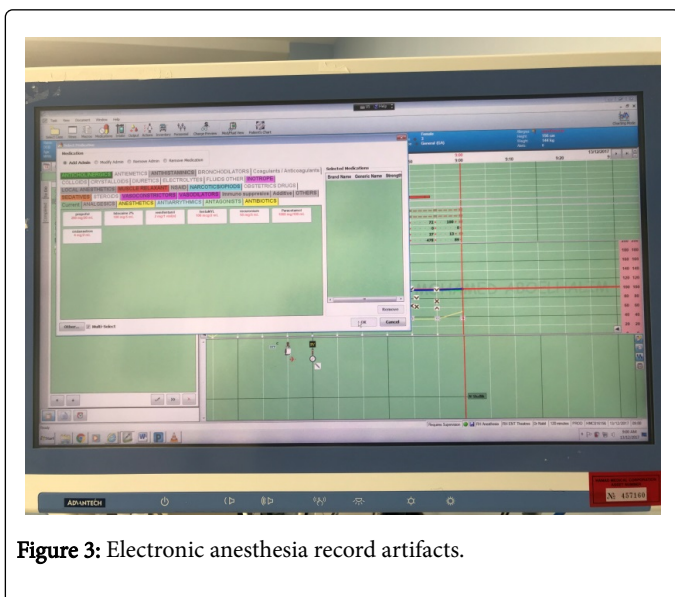
Figure 3: Electronic anesthesia record artifacts.
