Landslides in Rawalakot-Arja Valley: A Review

Landslides in Rawalakot-Arja Valley

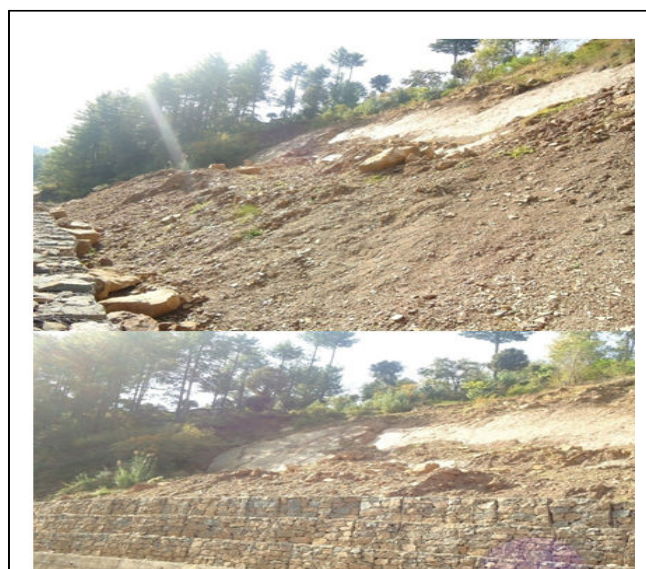
Figure 1: View of Mujahidabad landslide and retaining wall.

This slide has been studied at Mujahidabad, occurred in 2001. It has a length of about 35 meter from top to bottom, and a width of almost 50 meter, with a slope angle of 65 degrees. Along with the steep slope, weak lithological formation and sparse vegetation, one of the main causes is the quarrying activities in the area since 2001 that made the slope unstable. The bedrock is composed of the alternating beds of sandstone and siltstone. Heavy rainfall during summer and snowfall in winter caused mass movement and damaged the infrastructure in the area [2].

According to the local people the area was covered with thick vegetation in 1980, but at the time of field survey in October, 2010 there was sparse vegetation cover on the slopes. The slide has damaged about one kilometer of road section. The road section has been reconstructed and retaining wall has also been constructed to control the fall of loose material on the road. Houses at the top of the sliding area are also at risk as shown in Figures 1 to 3.

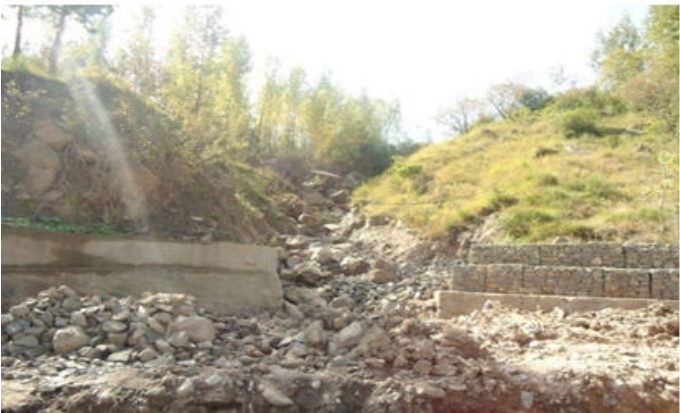
Figure 3: View of broken retaining wall due to landslide at Sanadi area.

A huge mudflow has been examined at Sanadi on, GR 33°53'59"N parallel, and 73°41'52" E meridian, occurred on 24th of February 2007, 15km away from Rawalakot in Sanadi Area locally known as Sanadi Rakh. This seems to be a huge mudflow, having its origin on the top of the mountain range 3500 meter high with thick forest. Sanadi, a perennial stream (nala) has carved a wide and deep channel on the slope of the mountain range, from top to the bottom, with a width that varies from ten meters at the top to about seventy meters at the base in the main valley. The slope of range is steep, ranging 65° to 80°. Sanadi nala is flooded during the monsoon period. In July, 2007 huge boulder hit a vane in which seventeen people were died [3]. The forest has partially been cut by the people to clear the land for agriculture as well as for the construction of houses. Occasional mass wasting phenomenon, particularly, landsliding and mudflow are common in the area. The material of the flow was composed of huge boulder, gravels and clay. The reconstruction of the road was still in progress, during the field work in October, 2010 as shown in Figures 4 to 8.

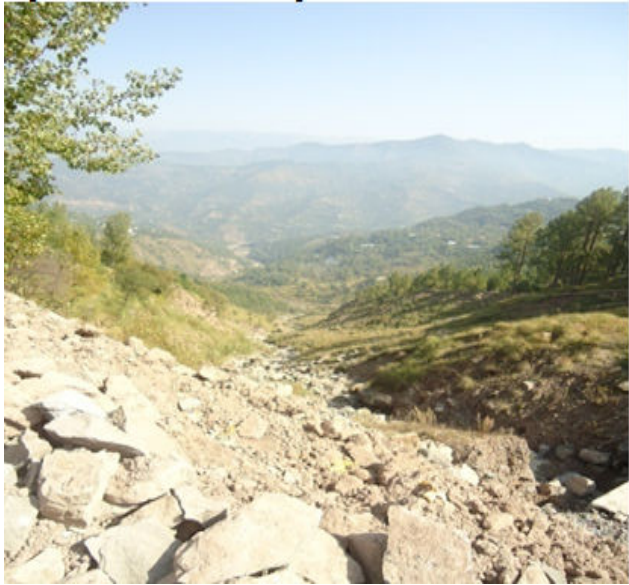
Figure 4: View of eroded material due to landslide at Sanadi area.

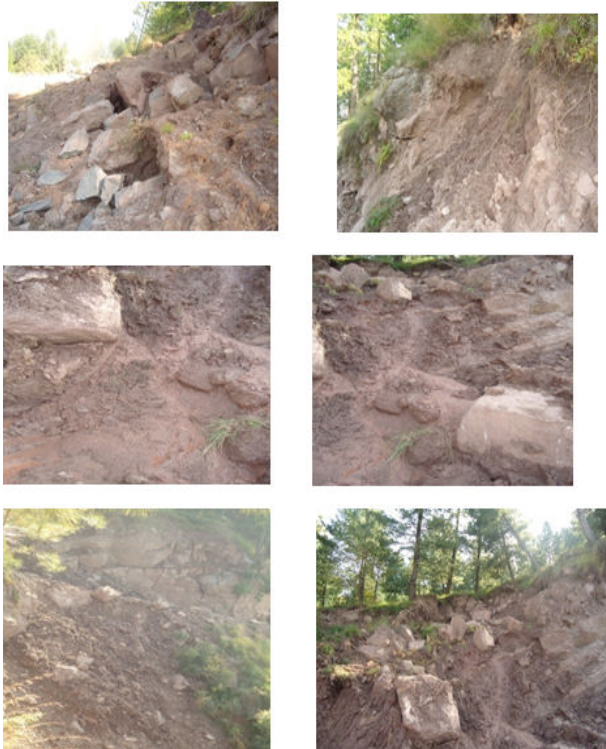
Figure 5: Different views of mudflow at Sanadi.

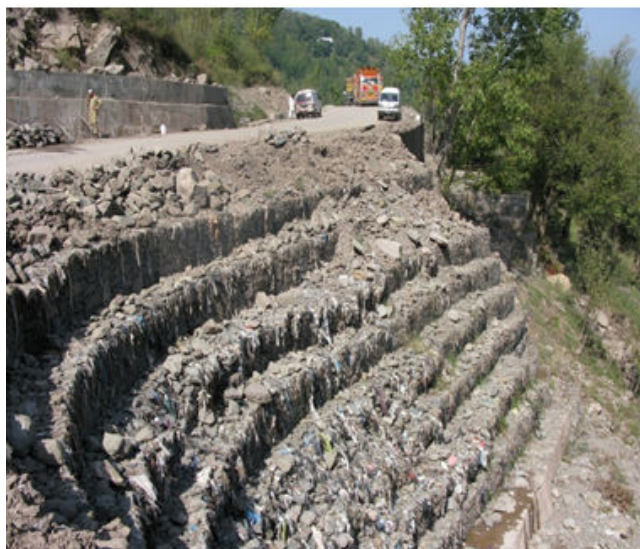
Figure 6: View of newly constructed retaining wall in Sanadi area.

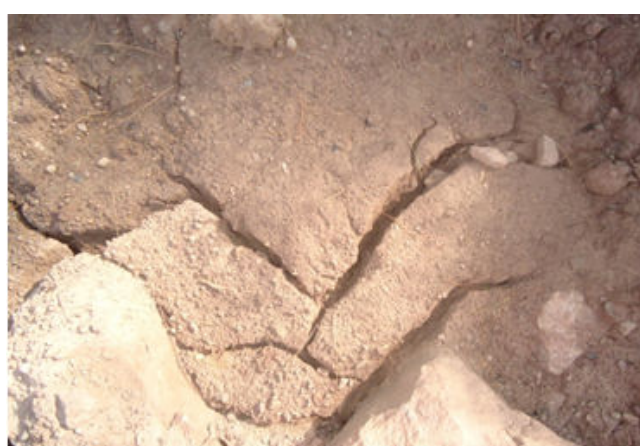
Figure 7: View of cracks in Sanadi area formed during earthquake.

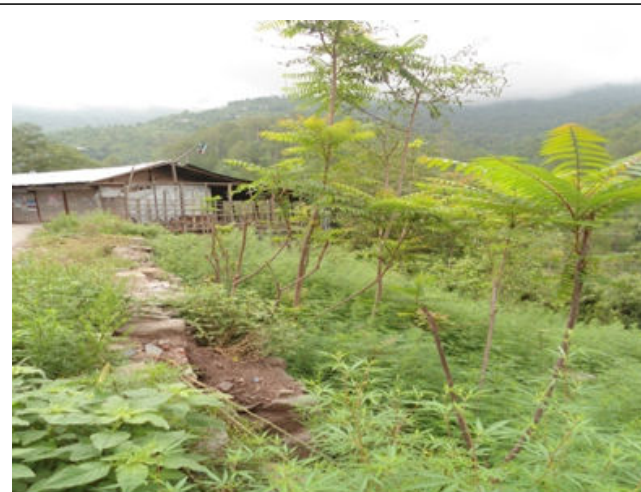
Figure 8: A view of damaged market in Khadd Bazar.

Khadd Bazar is located on the old Rawalakot-Thorar-Mang Road, about 15 kilometers from Rawalakot. It is mountainous area with high mountain ranges and very steep gradients, between 70 degrees to 80 degrees. Geologically, the rocks are weak sandstone of enormous thickness, and severely deformed by tectonic movements. The forests cover the slopes of the mountains, but they are not due to the steep slopes and cutting for the construction purpose [4]. The mountains have been severely eroded by streams with narrow and steep gorges and valleys. In the earthquake 2005, a huge slide occurred, a part of the mountain slid downslope that destroyed the Khadd Bazar, with a large number of shops, houses, agriculture land and almost one kilometer of the Rawalakot-Thorar road. A fresh almost vertical scar can still be examined very high on the mountain slope, from where the boulder of the rock detached and slipped downward. Currently a large part of destroyed market is covered with bushes and gives a destroyed look. Each year, during the monsoon period, material saturated with

water slid downslope and due to this situation new construction is not possible as shown in Figures 9 and 10.

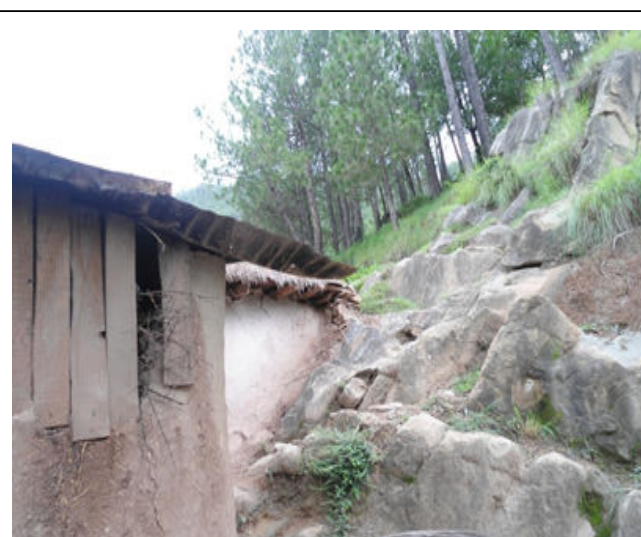
Figure 9: A view of damaged house near Khadd Bazar.

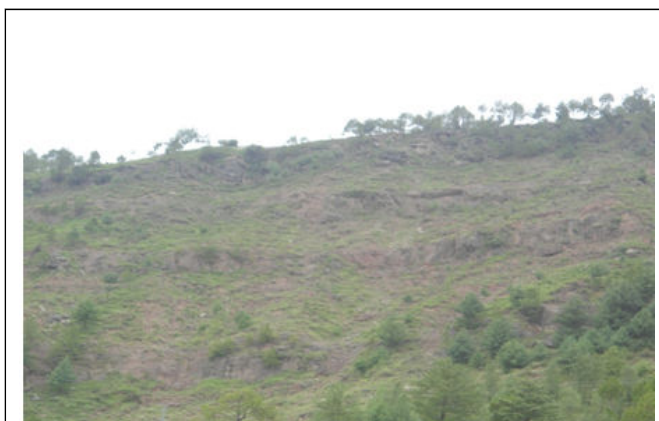
Figure 10: A view of Landslide in village Bosa Gala.

The area is locally called Sarinagala, lying about three kilometers to the north of Thorar and falls in the UC Tain, sub division Thorar, District Poonch. In 1992, due to seventeen days continuous rainfall, a huge landslide occurred in the area. A high sandstone mountain slid downward with million tons of rock, because of the rainfall, weak sandstone rock formation steep slope of about 85°, and lack of natural vegetation. Due to dispersed houses, only eight houses washed away in the village and a large number of agriculture fields were destroyed [5,6]. Thousands of chir and pine trees were uprooted and destroyed. According to the respondents every year in monsoon period, sudden fall of loose material is a common phenomenon in the area as shown in Figures 11 and 12.

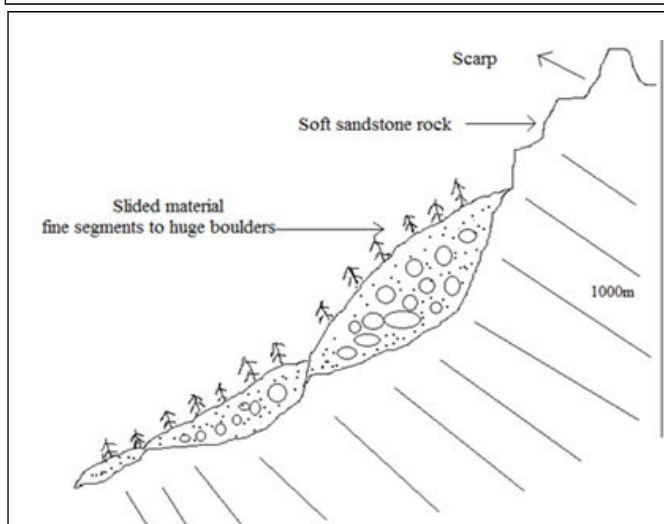
Figure 11: Sketch diagram of Bosa Gala slide.

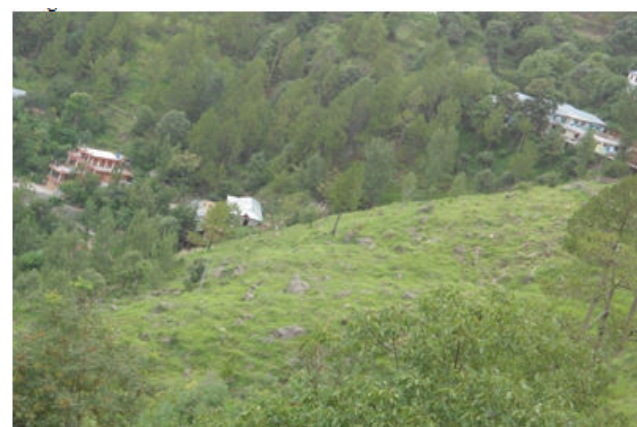
Figure 12: A view of Narh-Gran slide.

Narh-Gran is a well known village on the mountain slope in Tain area, main Jhelum valley about 10 kilometers from Thorar. It is comparatively large nucleated village of the area, with about three hundred houses, the land is fertile, due to the availability of water from the springs there are orchards with large number of fruit trees in the village, while people also practice agriculture on terraced fields. In this area ground moves downslope by one meter per year during rainy season for the past 50 years to 60 years. Due to this problem, the people of the area have started to migrate to safer places [7]. According to the local respondents, people of the area have started plantation to overcome the problem. After plantation the problem has been solved to some extent. The people have again reconstructed their houses in the area and have also practise agricultural activities. According to the respondents there were a large number of natural springs in the area in the past and it may be due to these water bodies that the material became saturated and slid down. A large number of springs have dried up with the passage of time, may be due to climatic change (Figure 13).

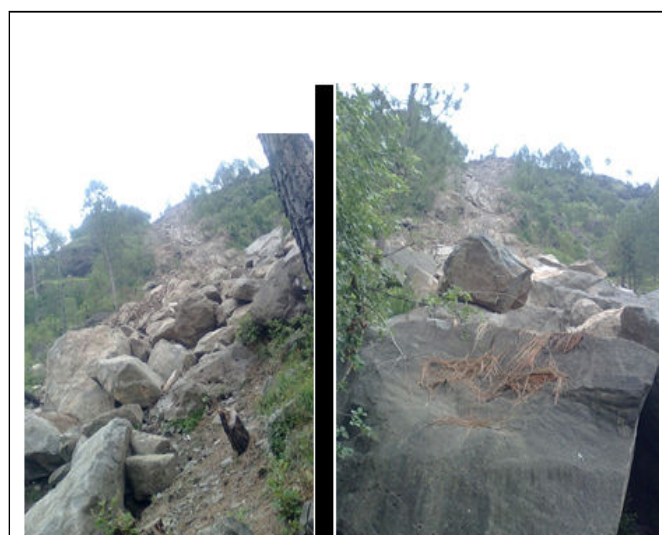
Figure 13: Debris of Sokkini-na-par slide comprising of huge sandstone boulders.

Another very important and huge landslide has been examined in Tain area known locally as Sokkini-na par slide, in main Jhelum valley. A huge block of bedrock, about 300 meter, (1000ft) has detached from almost vertical cliff in 2005 earthquake and moved downslope for hundred of meters. The bedrock i.e. Sandstone badly shattered and many large pine and chir trees were uprooted. Huge boulders and rock fragments have spread over a large area [8,9]. This slide has started after the earthquake, 2005 and is still active. As this slide is away from the residential area, no damage to houses and livestock has been observed but a large section of Thorar-Tain-Dhalkot road was destroyed, while a large number of agriculture fields were also destroyed and washed away with sliding material [10]. The slides mentioned are the important ones out of the hundred of the slides that have occurred in the past as shown in Figures 14 and 15.

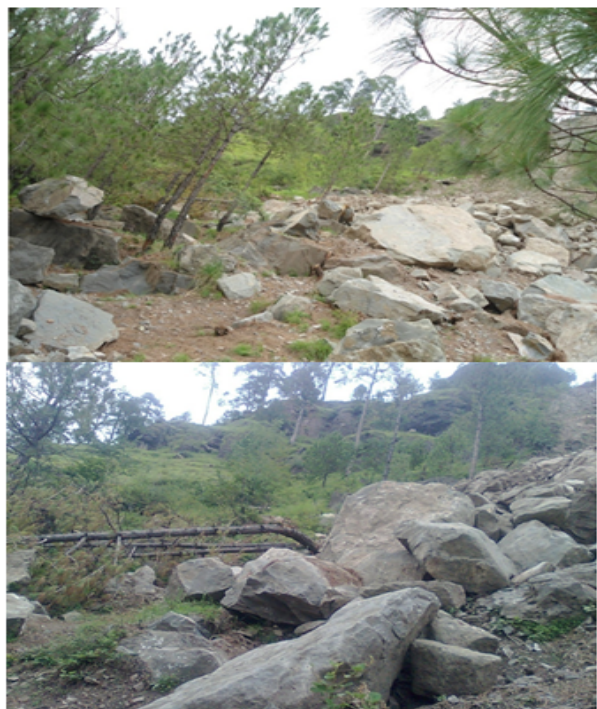
Figure 14: Different views of landslide in the area of Sokkini-na-par.

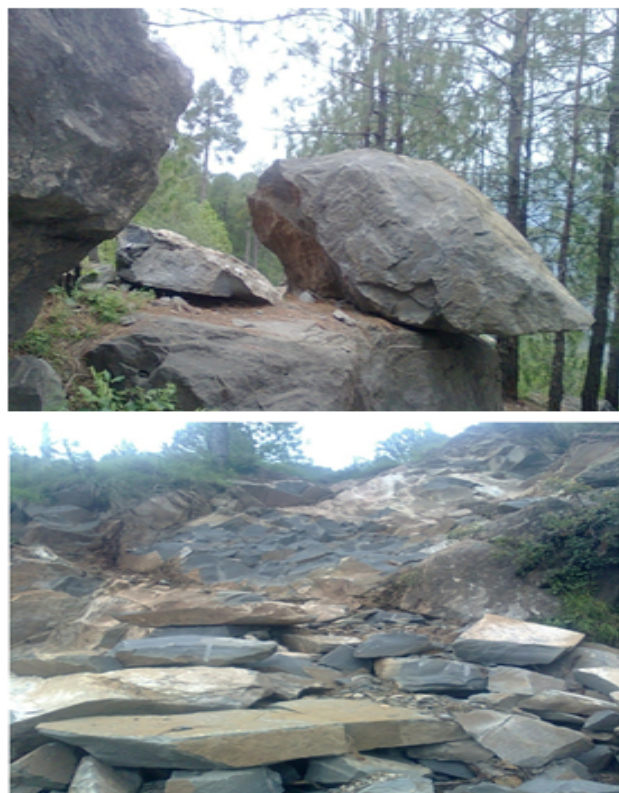
Figure 15: Huge rock fragments in the area of Sokkini-na-par.
