Spatial and Temporal Distribution of Landslides

Abstract

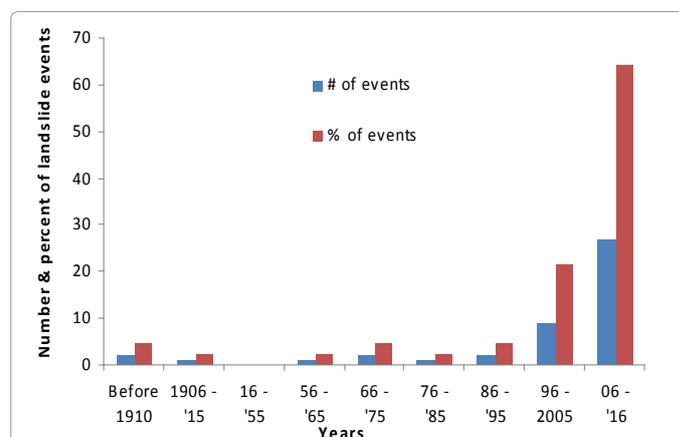
Figure 1: Histogram plot of landslide events in Tanzania (<1910 to 2016). Note that this histogram was constructed based on the information from archived sources and field exploratory study. Thus, there may be other landslide events that went unreported or whose details are unavailable.

A total of 45 landslides were identified and mapped over a span of 106 years in Tanzania. Of these, 5 were mapped based on field exploratory study while the remaining 40 were based on Google Earth search and image interpretation, aided by reviewed information from archived sources. The 45 landslides and their details are presented in the specific sections of this inventory as mentioned in Table 2. Based on this inventory, the earliest recorded landslides in Tanzania date back to about 100000 years ago and involved collapses of Kibo crater rim at Mt. Kilimanjaro [26-29]. The reviewed sources provide no record of damage to property, fatalities or other impacts from these collapses. The most recent reported landslide event in Tanzania occurred on May 4, 2016 in Lwangwa and Lupata wards, Rungwe district, Mbeya region and involved rotational slumps (Table 2). Generally, the period 1996-2016 reported more landslides than any other period covered by this inventory (Figure 1). Low but fluctuating number of landslide events is noted before year 1910 and the period between 1910 and 1995. The period between 1916 and 1955 presents an unusual case, where no landslide event was reported. Of all landslide events, mudslide/flows, rock falls, rotational slumps and mine collapses seem to have relatively higher frequency of occurrence than other types (Figure 2).

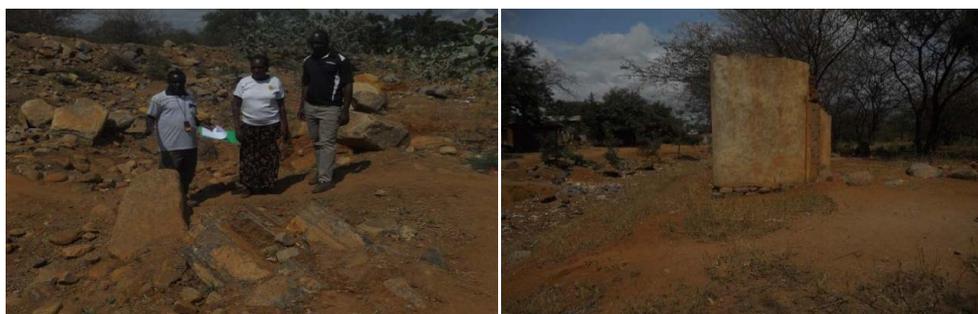
Figure 9: Lower section of Mtowashi natural channel (left); Remnants of dilapidated buildings (right).

the upper section of Mtowashi natural channel filled in by debris The event was preceded by 2-3 consecutive days of rainfall averaging to 90 mm per day [31] and earthquake whose magnitude was not established due to absence of seismometers in the village. On the onset of the event, loud cracking sound was heard and flash lights seen, probably from crushing rocks in the middle portion of the mountains. In the uphill, debris flows were confined in the mountain valleys. Upon reaching the foot slopes the debris over flew the 2 known natural channels- Mtowashi and Shingo (Figure 9) and flooded the low-lying areas of this village. The channels had been in place for many years and were used to pass water through during rainy seasons. It was reported that similar event occurred in the same area about 50 years ago. Human-induced de-vegetation on the SPMs was perceptually reported to underlie these landslides.

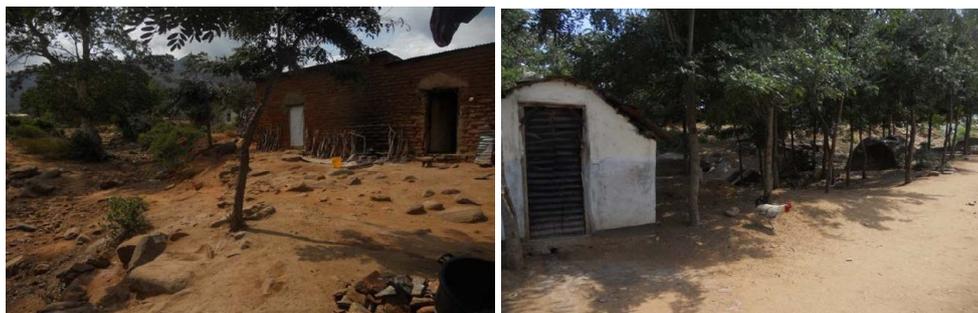
Figure 10: Some of the residential houses constructed after debris flow in Makuyuni village. Part of the Mtowashi natural channel in front of the 2 houses can be noticed.

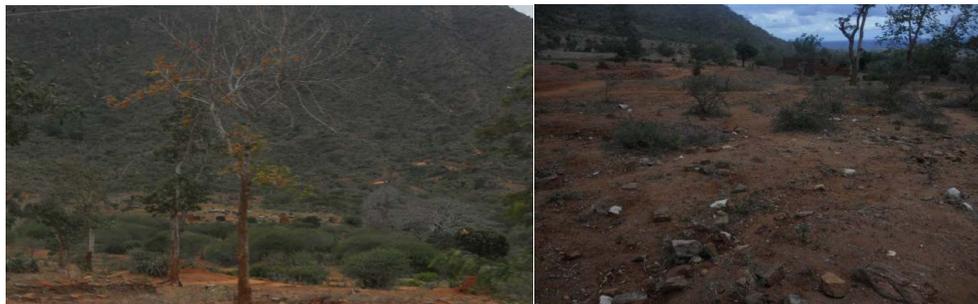
Figure 11: Location of the former Kijomu village (left); Rock fragments deposited during movement of debris (right).

Kilimanjaro region at the foot slopes of the SPMs (Figure 11). The visited landslide is situated at latitudes 0383763 and longitudes 9500046, and an altitude of 816 m a.s.l (Figure 7). The nature of landslide in this village was similar to that of Makuyuni village. An interview with Hassan Omari aged 71 years revealed that the last landslide events occurred in 1930s, 1958 and 1968. According to him, these events were minor and had no significant damage. He pointed out that agricultural activity, which contributed to loss of forests atop the mountains, were and are yet the major underlying factors for landslide events in the village.

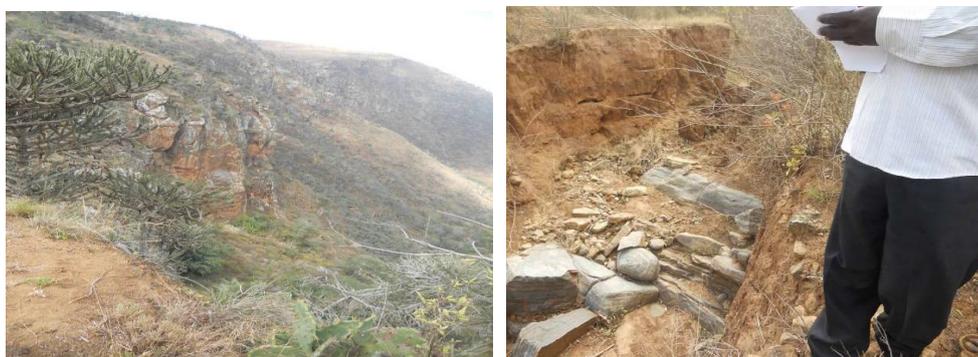
Figure 12: One of the higher elevations in Gorjaza village (left) and Gully erosion (right).

The only notable landslides occurred in 1998 and 2013, and were perceptually triggered by rainfall. An eyewitness reported materials constituting mud and rocks of different sizes moving from highlands to lowlands through natural channels. The incident caused neither casualties nor loss of property as it occurred in uninhabited area. The serious and emerging threat to this village is gully erosion (Figure 12).

Unstable slopes and deeply weathered soil with little or no vegetation to hold soil together underlie gully initiation and development in this village. Villagers reported development of new gullies due to human-induced loss of vegetation on mountains.

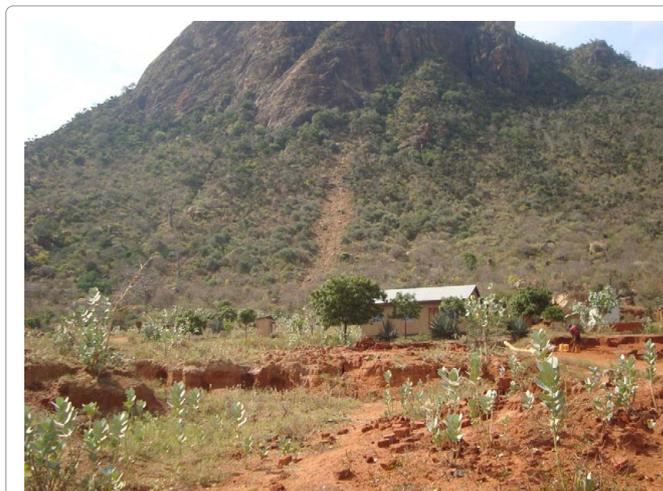
Figure 13: A landslide scar in Kifaru village. The poor vegetation recovery on the fresh geological surfaces created by the scooping action of moving mass created.

Kifaru village: Kifaru village is located in Kileo Ward, Mwanza District in Kilimanjaro region. The village is located on the North Pare Mountains close to Tanzania-Kenya border (Figure 7). The visited landslide scar is situated at latitudes 341474 and longitudes 9610734 and an elevation of 755 m a.s.l. The scar looks like a strip of scratched surface on the ground (Figures 13 and 14). It is about 15 m wide and runs from the base of the rocky hill to about 300 m down-slope. As reported by villagers, the landslide event occurred in 1998 and was preceded by 3 consecutive days of rainfall averaging to 120 mm per day [31]. It was also reported that 2 to 3 years before the event villagers felt earthquakes in the area whose magnitude was not established due to absence of Seismometer for the area. According to eyewitnesses and as seen in Figure 13, a crack of about 100 m in length is visible on the upper part of the rocky hill in which water collects and concentrates when it rains. During the event, a mixture of weathered rocky debris and water from the rocky cliff moved down-slope, scratching the ground and leaving almost bare ground along its path. To date, the scratched surface has developed into a gully (Figure 14). At the time of this field exploration the gully was about 1 m wide and 30-45 cm deep. According to the eyewitnesses, this gully keeps on increasing in its width and depth. Apart from the 5 visited landslides, 6 other landslides (Hans Meyer, Shighatini, Mto wa Mbuu, Moshono, Usambara and Usangi) were identified and mapped in the NEZ using Google Earth visualization and interpretation and review of archive sources (Figure 7 and Table 2).

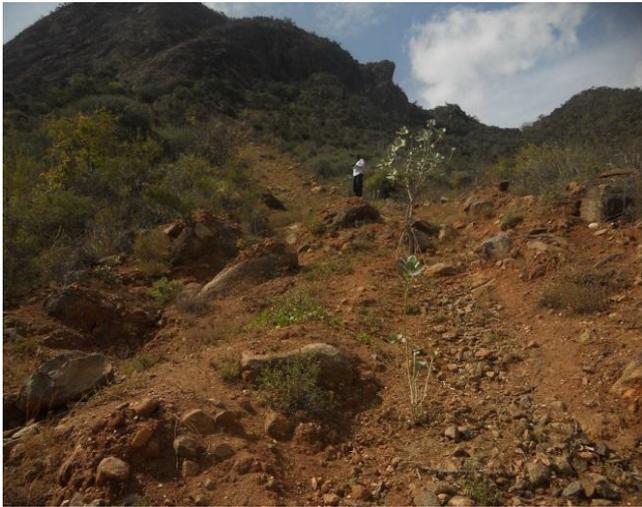
Figure 14: A gully created on the scratched surface.

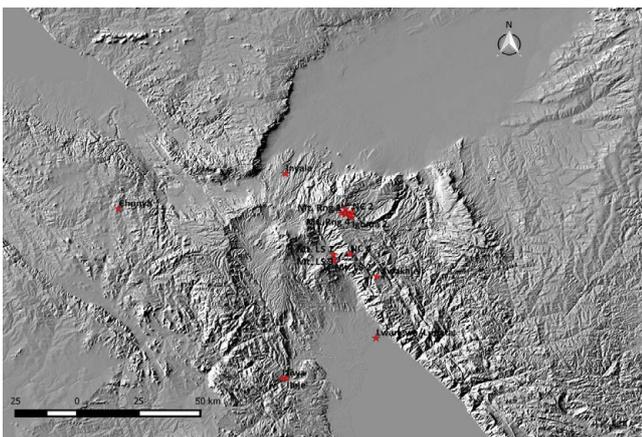
Figure 15: Landslides around Mt. Rungwe (Rng) and Livingstone (Mt. LS) and Ngozi Crater (NC) (the name is generally labeled as the nearest known place to the landslide).

mapped and described in the SHZ (Figures 15-17). Of these, 15 were identified in six areas (labelled on map as Inyala, Iziwa, NC, Igoma, Mt. LS, and Mt. Rng) using Google Earth visualization and analysis. These occurred in areas around the 3 large volcanoes (Rungwe, Ngozi, Kyejo) and around Mt. Livingstone. These landslides were triggered by tectonic and seismic activities, resulting into Rungwe sector collapse and avalanches in the Holocene. Additionally, the most recent earthquake activity in December 2009 in the northern Malawi might have triggered small landslides along the steep inner slopes of the Ngozi Caldera as seen in Figure 16 [15,32]. The remaining 4 landslides (labelled on map as Chunya, Ileje, Lwangwa/Lupata and Mwakaleli)

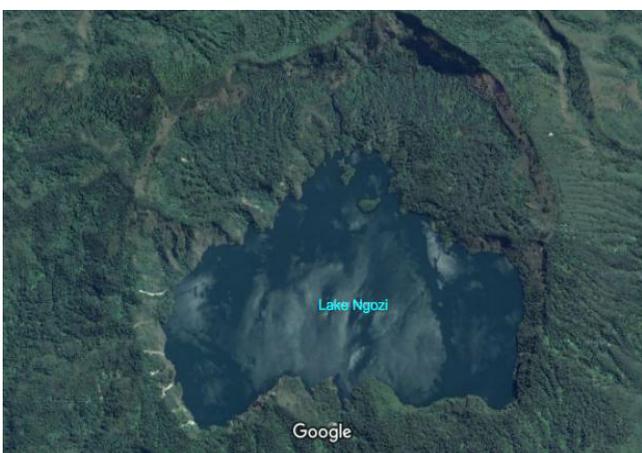
Figure 16: Ngozi Crater (the light-coloured strips on the SW and NW parts of the Crater. These strips are possibly landslide scars [14] (image source: Google Earth in year 2014).

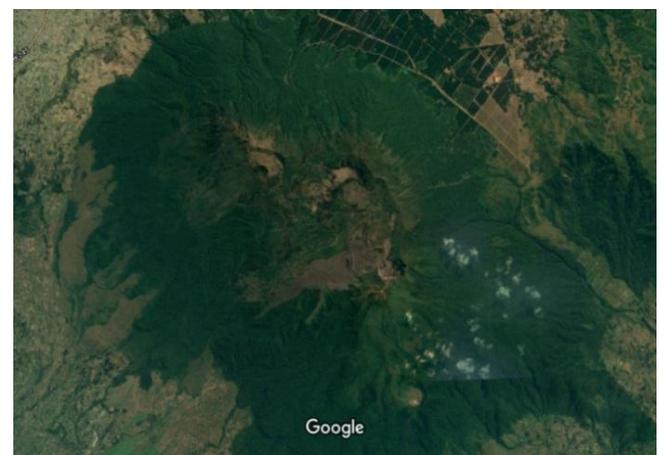
Figure 17: Flank/sector collapse on Rungwe volcano (9.114552°S, 33.635360°E) in Holocene generated debris avalanche.

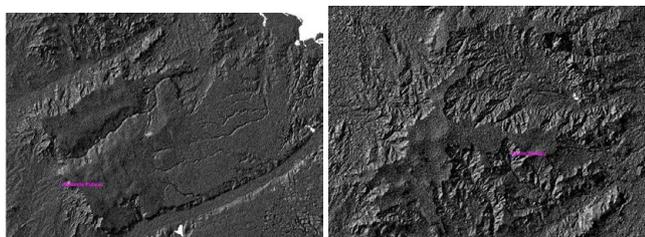
Figure 19: The Rondo Plateau (left) and Makonde Plateau (right). They are locally deeply dissected and have steep scarps of about 300-400 m high.

Southeastern zone: The Rondo (10°04'S, 39°15'E, 465-885 m a.s.l) and Makonde (10°44 S, 39°36 E) Plateaux are high and extensive massifs in Lindi and Mtwara regions in the southeastern Tanzania, respectively (Figures 18 and 19). Landslides and severe erosion are common on the forest boundaries where trees had been cleared. Based on Google visualization and interpretation, landslides are confined to the escarpments of these plateaux (over 700 m a.s.l) and date back to 1980s and were largely triggered by rainfall. Based on secondary sources 4 landslide events were reported in this zone. In 1980 mudflows on Makonde Plateau affected 300,000 people in different ways, rendered about 50,000 people homeless, and left 30,000 others severely

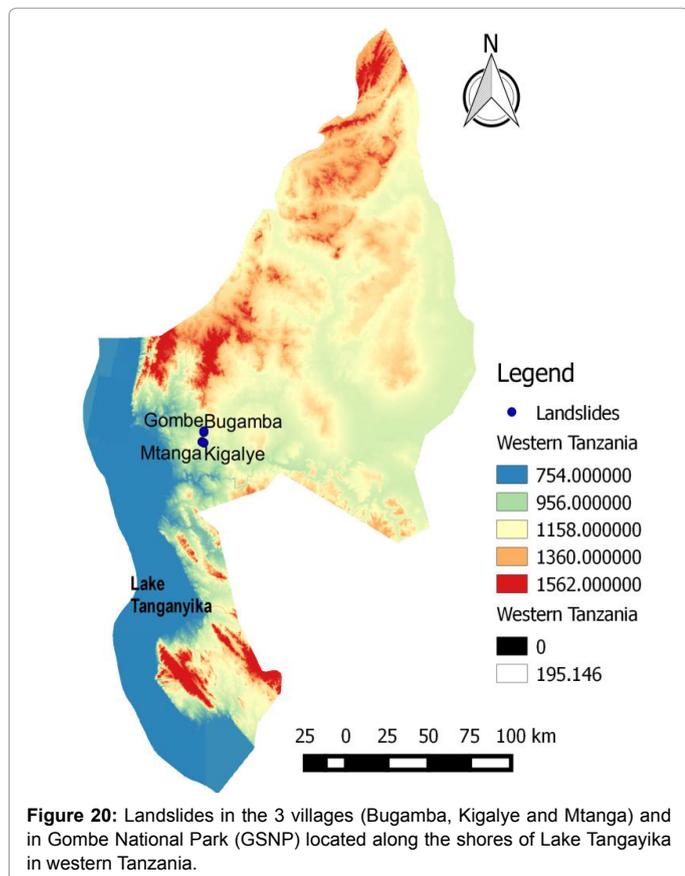
Figure 20: Landslides in the 3 villages (Bugamba, Kigalye and Mtanga) and in Gombe National Park (GNSP) located along the shores of Lake Tanganyika in western Tanzania.

floods and debris flows loomed Mtanga village (Figure 20) [19]. Before the event, villagers reported to hear sounds of drums in the distance. Soon, they saw a torrent of mud-laden water coming down the river valley towards the lakeshore, eroding riverbanks and sweeping structures and other properties along its path. Sparks and smoke were also seen in the middle of the turmoil. The landslide claimed 13 people's lives, leaving 30 residential houses, 1 refugee centre and 1 church building buried under debris.

Bugamba village (4.561558°S, 29.647667°E): In May 1999 at mid night a similar landslide event struck some farming areas of Bugamba village (Figure 20) about 2 km inland from the lake shores [19]. Although no person lost life, the landslide swept a large amount of buried water pipes and devastated unspecified size of farmland.

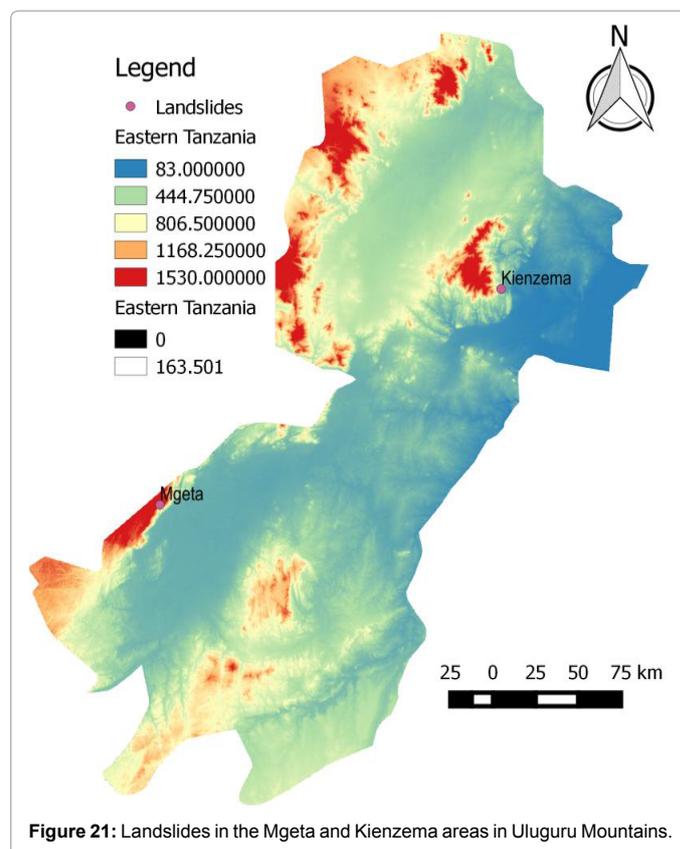
Figure 21: Landslides in the Mgeta and Kienzema areas in Uluguru Mountains.

Eastern zone: Based on existing literature, landslides (largely in form of debris and mudslide and flows) in the EZ have been reported [10,11,33], in Mgeta (8.222729°S, 36.095336°E) and Kienzema (7.122381°S, 37.580716°E) on Uluguru Mountains (Figure 21). For example, on February 23, 1970 heavy rainfall triggered more than 1000 landslides in the Mgeta Valley. Of these landslides, 47% were observed to originate in cultivated fields, 46% in grassland and <1% in areas covered by forest. Although no person was killed, the landslides damaged 1600 residential houses, displaced 270000 m³ of debris and caused economic damage amounting to 90000 USD [10]. The landslides in Kienzema occurred in 1969, and the referred sources provide no detailed information about the event.

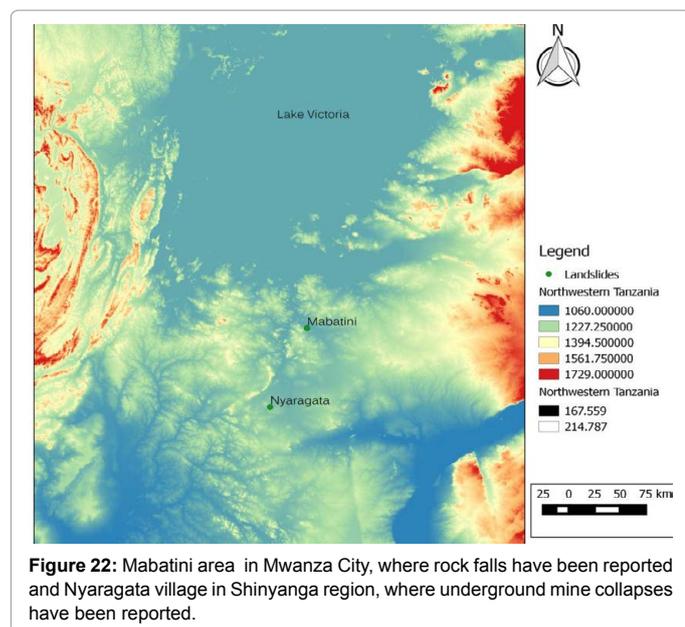
Figure 22: Mabatini area in Mwanza City, where rock falls have been reported and Nyaragata village in Shinyanga region, where underground mine collapses have been reported.

Northwestern zone: Contrary to other zones of Tanzania, reported landslides in the NWZ are largely associated with underground mine collapses (Figure 22) as most of the mining activities are located in this zone. There are also events of rock falls in areas close to Lake Victoria
