Behaviour and Strength of Ferrocement Rectangular Beams in Shear- A Experimental Study

Abstract

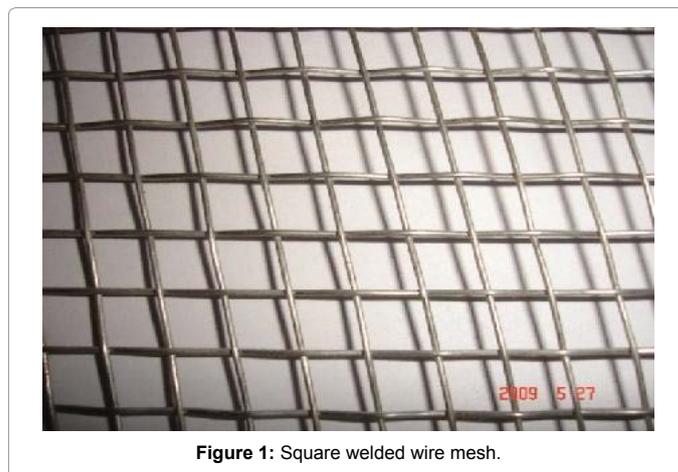
Figure 1: Square welded wire mesh.

Welded wire mesh: Wire mesh is one of the important constituent of Ferrocement. This generally consists of thin wires. The Mechanical Properties of ferrocement depends upon the type quantity and strength properties of mesh reinforcement. The wire mesh used in this dissertation is of square pattern with an opening of 12.5 mm x 12.5 mm and having a diameter of 1.2 mm. The yield strength in tension for the wire mesh was 410 N/mm². The different types of wire meshes are square woven or welded meshes, chicken (Hexagonal/aviary) wire mesh, expanded metal mesh lath etc. Except for expanded metal mesh, generally all the meshes used are galvanized. The properties of wire mesh are tabulated in Tables 1 and 2. Figure 1 depicts the typical steel wire meshes used in ferrocement.

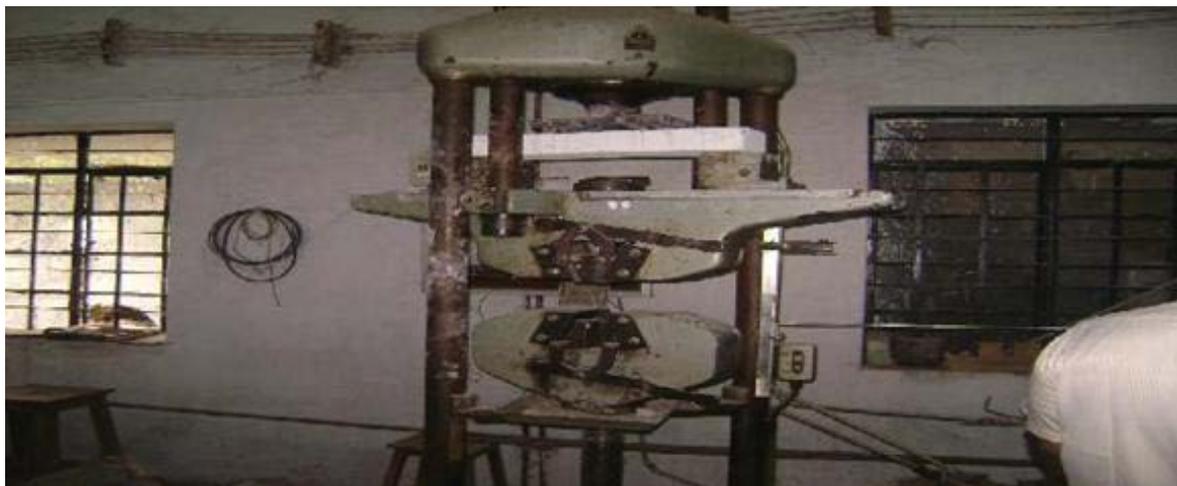
Figure 2: Test Setup.

All beams were simply supported on the two edges. The beams were white washed to assist in crack detection. All specimens were tested under two symmetrical point loads in universal testing machine. The deflection under the load point was measured and a search was made for the appearance of cracks. Powerful lenses were also used in detecting the appearance of cracks. The early cracks progress and position was marked by using pencil and sketched by using permanent marker. The load at initial crack for each test specimen is noted. After the Failure the ultimate load, mode of failure and cracking pattern were recorded (Figure 2).

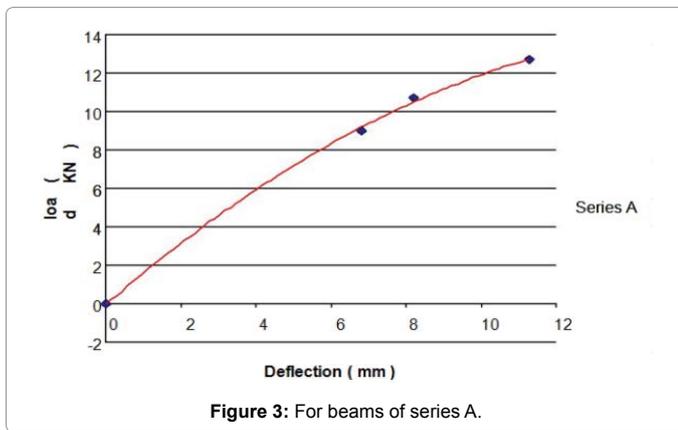
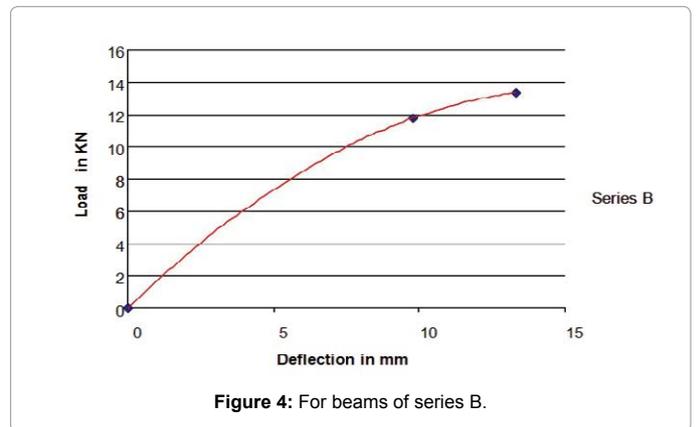
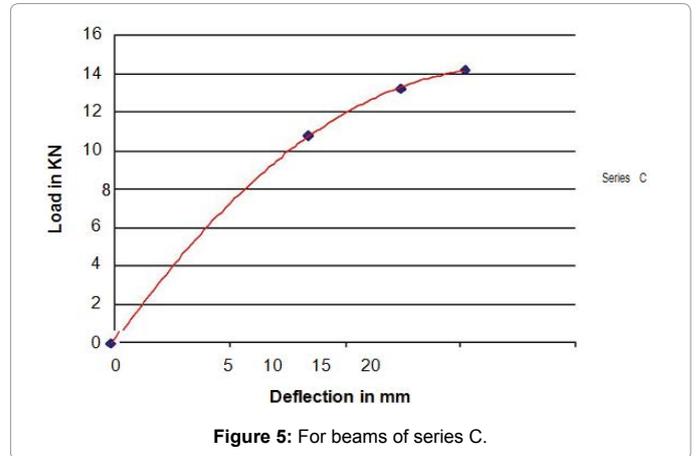
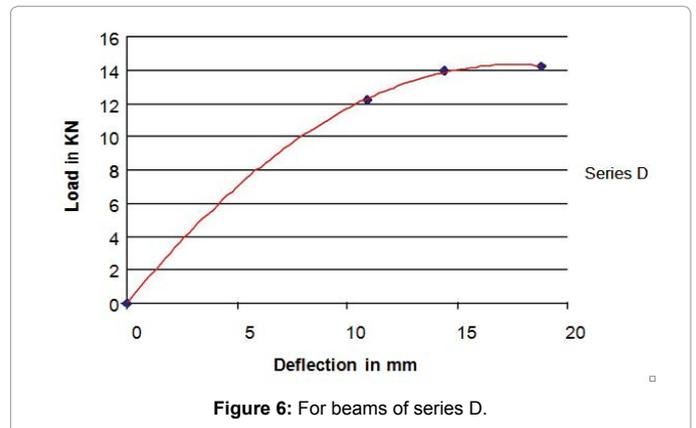
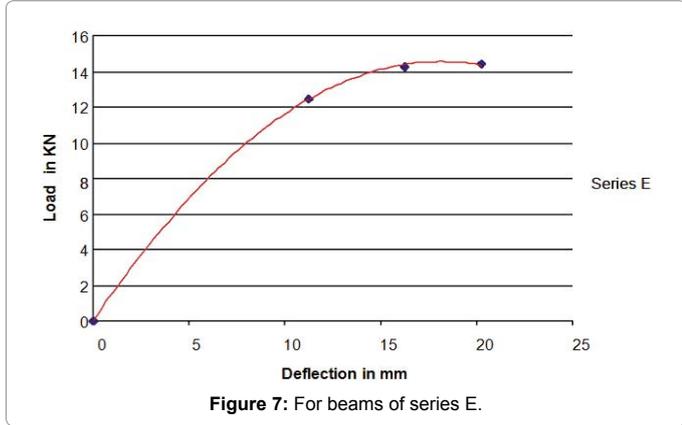
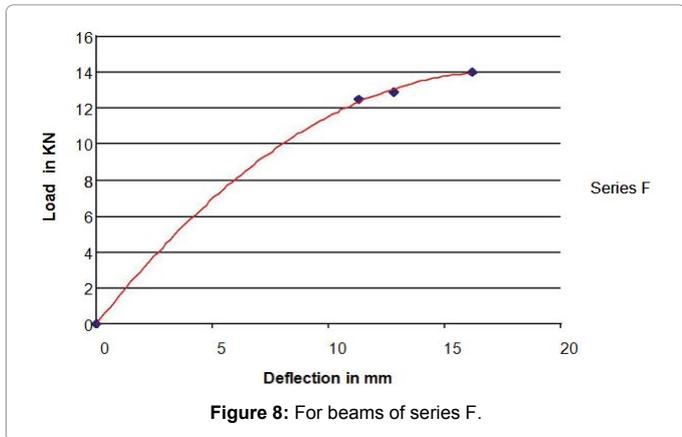
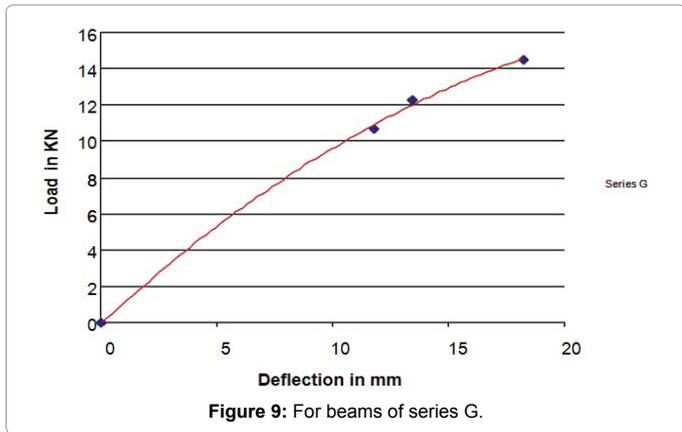
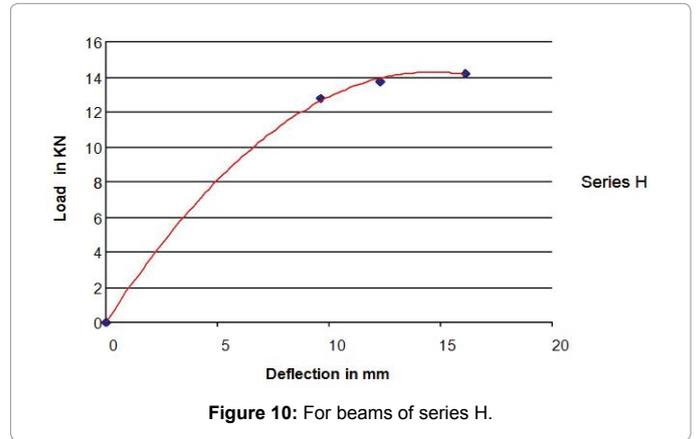
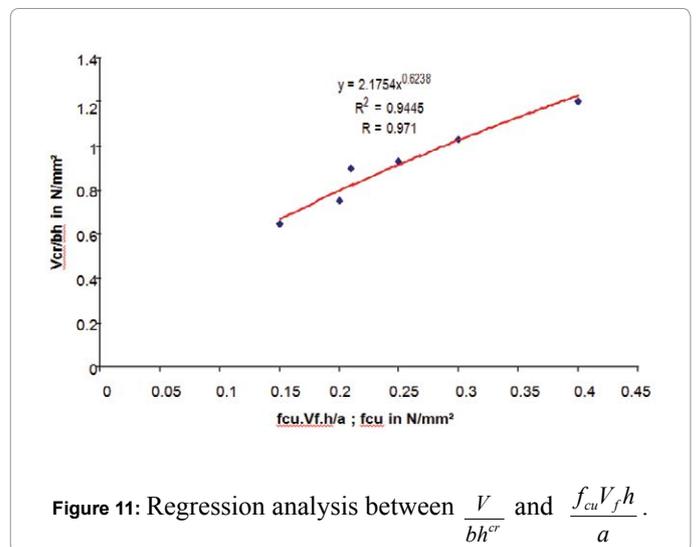
The load – deflection curves are drawn in Figures 3-8.

Load deflection relationship: The load-deflection curves for the tested beams are shown in Figures 3-11. Stage - I: The load-deflection

relationship is linear (Steepest Slope) before the cracking of the mortar. Stage - II: The end of the linearity of the curve marked the beginning of cracking as indicated by the deviation from the load-deflection relationship corresponding to the load increment. This shows a little flatter slope. Stage - III: Finally in this stage, as the ultimate load is reached the cracks gets widened and the curve became almost parallel the deflection axis. At this stage the failure of specimen is clearly visible. The end of stage-I occurred at a load of 0.70 Vu to 0.90 Vu. The first crack was observed soon after reaching the load corresponding to the deviation from linearity of the slope at stage-I.
