Cleanliness of Drinking Water Faucets in Public Facilities

Abstract

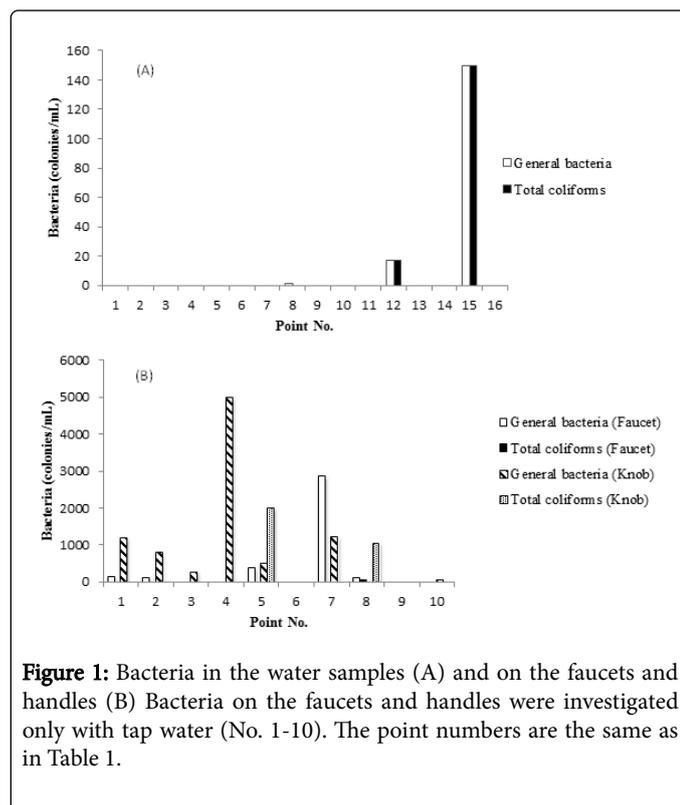
Figure 1: Bacteria in the water samples (A) and on the faucets and handles (B) Bacteria on the faucets and handles were investigated only with tap water (No. 1-10). The point numbers are the same as in Table 1.

The results appear in Figure 1. The results of the bacterial tests are presented as number per milliliter for the water samples and the total number (present in 10 mL sterile water) from the faucet handle and intake port samples. We detected general bacteria in the hot-spring water and some of the water samples; we found coliforms only in the hot-spring bathing water. However, we detected general bacteria in most of the park samples and coliforms in about half of the park samples in the deposits around the faucet. This result points to the risk of contamination to the tap water. In the tap water, we did not find levels of general bacteria and *Escherichia coli* in excess of the standards defined by of the Water Supply Act (100 cells/mL and not detected in 100 mL, respectively). However, the hot-spring water samples did not meet these criteria. This may have been because of the reduced amount of chlorine in the hot-spring water owing to degradation of components by residual chlorine or because of the unpleasant smell of chlorine when bathing [7]. The high temperatures of the water in hot-spring bathing are suitable for bacterial propagation, and bacterial proliferation may have been promoted by human bathing and human waste contamination [8]. However, we did not detect bacteria in the drinking fountain water.
