Management of Peristomal Skin Complications with Negative Pressure Wound Therapy: A Case Study

Aim: Estimate the effectiveness of the Negative Pressure Wound Therapy (NPWT) into managing a complex peristomal skin complication in a patient with a urostomy. The goal was to improve the conditions of the skin in order to concede stoma management with the appropriate ostomy device. The clinical condition of the patient was exasperated by her overall status: advanced neoplasia, skin deterioration and diabetes.

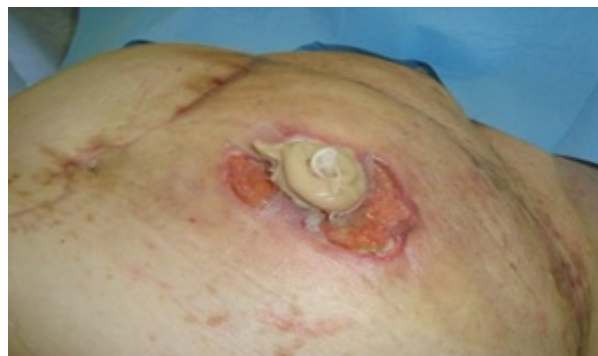
Step 2: Then we applied the Stomahesive Paste to flatten and protect peristomal skin from urine leakages (Figure 3).

Figure 3: Application of the Stomahesive Paste in order to protect the lesion from the urine.

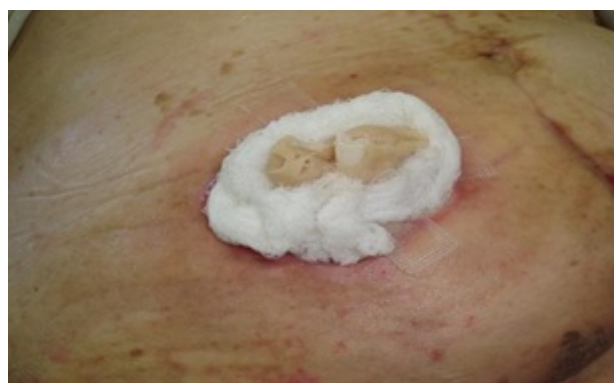
Step 3: As we experienced some challenges in adapting the Polyurethane Foam to the peristomal area, we decided to protect the skin with sterile gauze (Figure 4).

Figure 4: Application of the antimicrobial gauze.

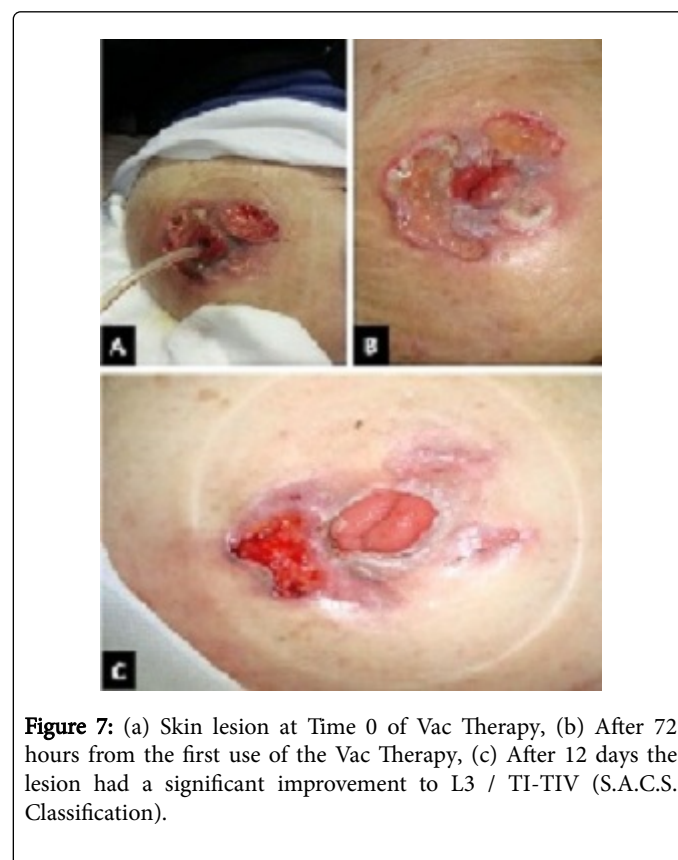
In each follow-up visit, we assessed a constantly improving condition of peristomal skin. The patient was treated with NPWT for 12 days. After this time we could already observe a significant improvement of the lesion. The skin condition, initially rated L4, improved to L3; the extension of the skin lesion also reduced from TV to TI-TIV (Figure 7).
