Mechanical and Thermochemical Studies Using the Experimental Fracture Mechanics Single Contoured-Cantilever Beam Specimen

David Boyajian* and Tadeh Zirakian

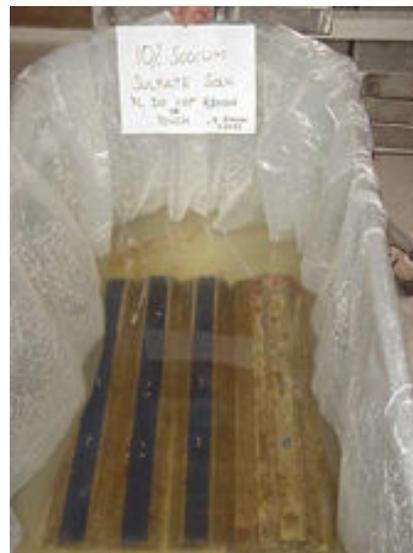
Figure 4: Wetting-drying.

Two separate environments of wetting were used in this study: one, in a bath of 10% sodium sulfate at a pH range of 6.2-6.5, and another in a bath of sodium hydroxide at a pH of 12 (Figure 4). A single wetting-drying cycle constituted 3 days of wetting and 4 days of drying in an environmental chamber maintained at 40°C and 50% relative humidity. The percentage reduction in fracture values of specimens at 10, 20, and 30 cycles was as follows: 86, 83, and 68%, respectively, for the sodium sulfate specimens, and 90, 71, and 59%, respectively, for the sodium hydroxide specimens [1].

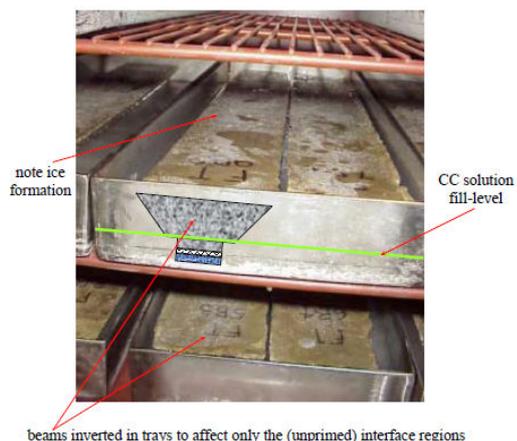
Figure 3: Freezing-thawing.

A single freezing-thawing cycle was designed to take the FRP-concrete interface as subjected to a calcium chloride environment (Figure 3) from room temperature (20°C) down to -20°C in a two hour time frame, sustain that freezing-level for two hours, then ramp back up to room temperature in two hours. The percentage reduction in fracture values of specimens at 50, 100, 150, 200, and 300 cycles was as follows: 94, 86, 82, 71, and 61%, respectively [3].

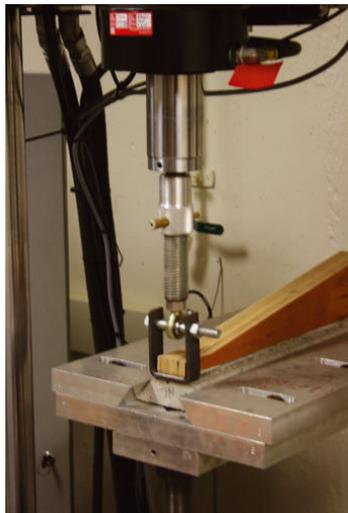
Figure 5: Cyclic fatigue.

Cyclic fatigue tests (Figure 5) were performed on FRP-concrete specimens in which the following two parameters were considered: load ratios (R), i.e., the ratio between the minimum and maximum load, of $R = 0.25$ and $R = 0.50$; also frequencies (f) of: $f = 3$ Hz and $f = 5$ Hz. Crack propagation rates (da/dN) were found to range between $da/dN \approx 4 \times 10^{-6}$ in/cycle to $da/dN \approx 200 \times 10^{-6}$ in/cycle, depending in particular to the degree of surface preparation of the underlying concrete substrates, as explained in greater detail in the following subsection. Interestingly, it was found that sand-blasting the surface resulted in longevity of the interface bond exceeding 20 million cycles for the dry specimens, indicating imperviousness due to the phenomenon of cyclic fatigue at such R and f values [4-5].
