## Mechanical and Thermochemical Studies Using the Experimental Fracture Mechanics Single Contoured-Cantilever Beam Specimen

### Abstract

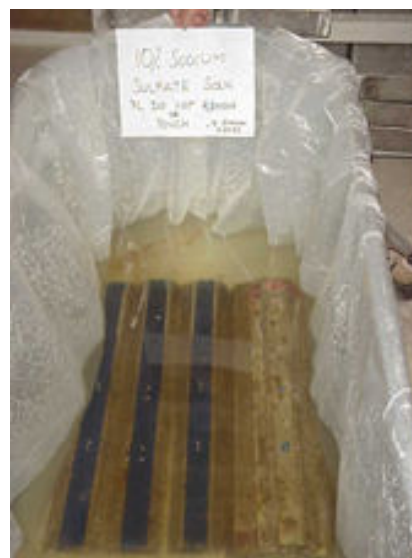
**Figure 4:** Wetting-drying.

Two separate environments of wetting were used in this study: one, in a bath of 10% sodium sulfate at a pH range of 6.2-6.5, and another in a bath of sodium hydroxide at a pH of 12 (Figure 4). A single wetting-drying cycle constituted 3 days of wetting and 4 days of drying in an environmental chamber maintained at 40°C and 50% relative humidity. The percentage reduction in fracture values of specimens at 10, 20, and 30 cycles was as follows: 86, 83, and 68%, respectively, for the sodium sulfate specimens, and 90, 71, and 59%, respectively, for the sodium hydroxide specimens [1].

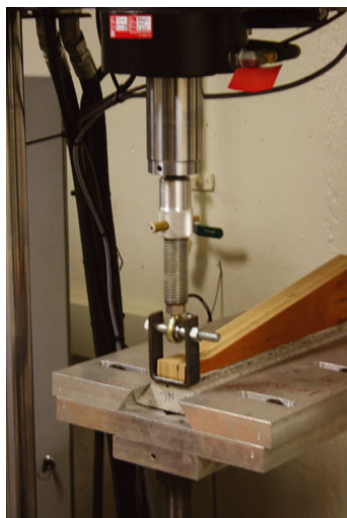
**Figure 5:** Cyclic fatigue.

Cyclic fatigue tests (Figure 5) were performed on FRP-concrete specimens in which the following two parameters were considered: load ratios (R), i.e., the ratio between the minimum and maximum load, of  $R = 0.25$  and  $R = 0.50$ ; also frequencies (f) of:  $f = 3$  Hz and  $f = 5$  Hz. Crack propagation rates (da/dN) were found to range between  $da/dN \approx 4 \times 10^{-6}$  in/cycle to  $da/dN \approx 200 \times 10^{-6}$  in/cycle, depending in particular to the degree of surface preparation of the underlying concrete substrates, as explained in greater detail in the following subsection. Interestingly, it was found that sand-blasting the surface resulted in longevity of the interface bond exceeding 20 million cycles for the dry specimens, indicating imperviousness due to the phenomenon of cyclic fatigue at such R and f values [4-5].
