# Retrospective on Treating Periimplantitis

Edward R Kusek\*

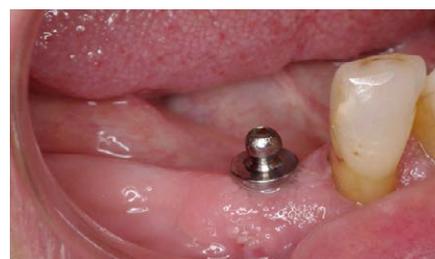
Figure 1: Case-1, Fistula present.

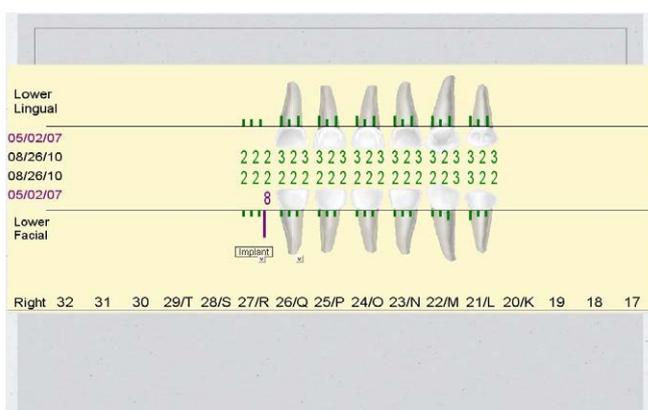
Figure 4: Case-1, Probing after 3 years.

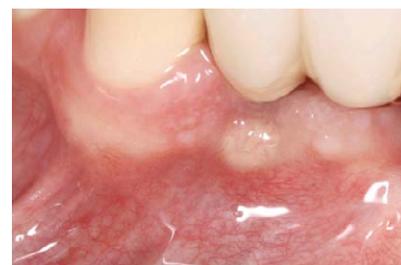
Figure 5: Case-2, Facial fistula.

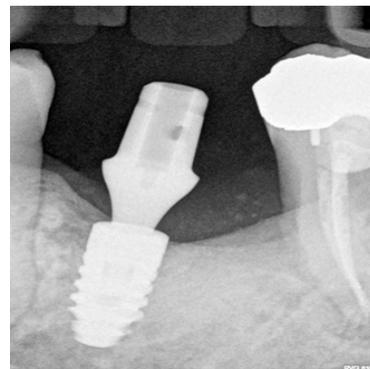
Figure 10: Case-3, 3 months after implant placement.

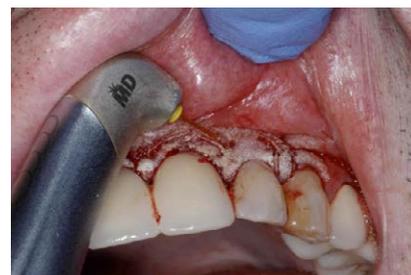
Figure 16: Case-4, Deepithelialization.
