Total Hip Arthroplasty in Severe Osteoporosis - Technical Tips to Avert Complications Prophylactic Locked Plating Along With Total Hip Arthroplasty for Severe Osteoporosis with Intramedullary Nail *In Situ*

Rajesh Malhotra and Deepak Gautam*

Department of Orthopedics, All India Institute of Medical Sciences (AIIMS), New Delhi, India

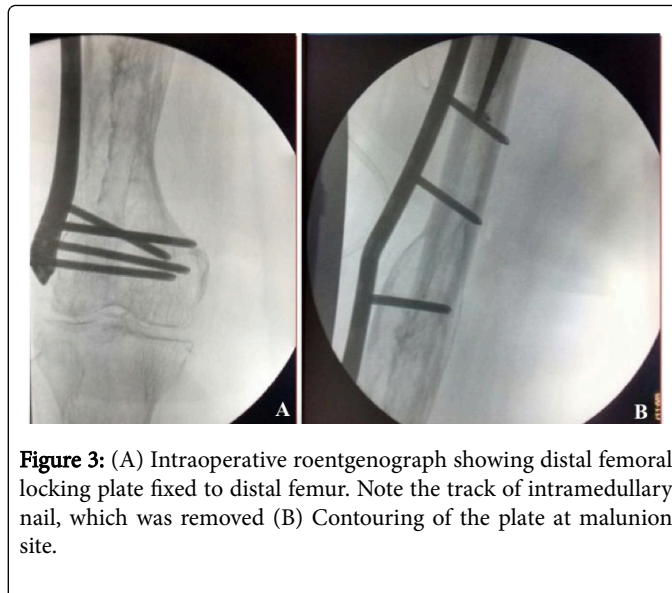
Figure 3: (A) Intraoperative roentgenograph showing distal femoral locking plate fixed to distal femur. Note the track of intramedullary nail, which was removed (B) Contouring of the plate at malunion site.

- The periosteal surface of the bone was exposed by directly incising the Tensor Fascia Lata and the Vastus lateralis.
- A 16 hole anatomical locking plate was inserted and slid through the insertion site submuscularly passing over the malunion site. The length of the plate was checked under the image so that the upper end of the plate wouldn't hinder the femoral stem during THA. The plate was contoured so that it could fit over the lateral surface at the bulky malunion site.

- The plate was then fixed with locking screws under the image guidance (Figure 3). A hole was drilled for the use of a unicortical

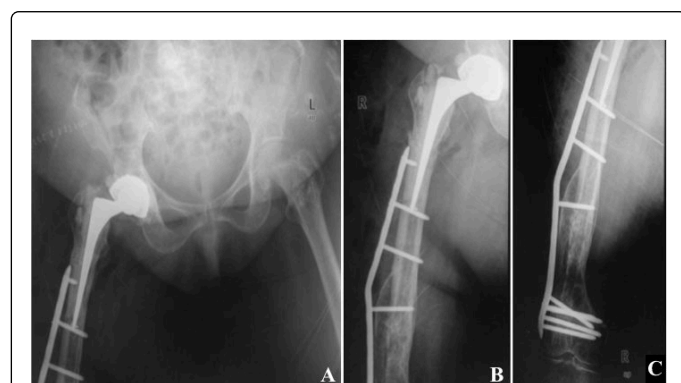
Figure 4: Immediate post-operative roentgenograph showing (A) Cemented total hip arthroplasty in right hip (B & C) Distal femoral locking plate applied prophylactically.

Postoperatively, the patient was made to sit by the side of the bed with legs dangling down on the evening of the surgery. She was mobilized and made to walk with the help of walker on the next day of surgery under the supervision of a physiotherapist. At the latest follow up of two years, the patient is walking well without any support, which she left after 6 weeks of surgery. The implants are well positioned *in situ* with no signs of migration or failure (Figure 4 and 5). However, she is continuing her anti-osteoporotic therapy.

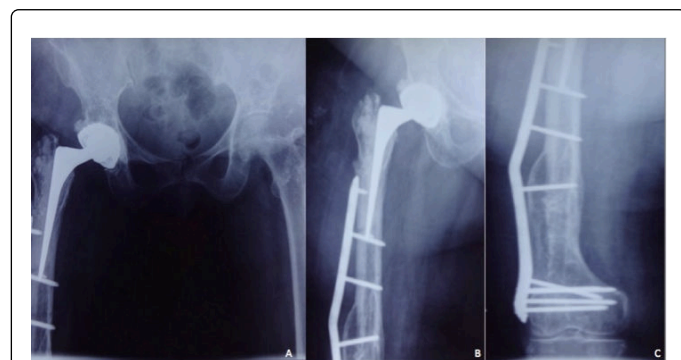
Figure 5: Roentgenograph at two years follow up (A) Antero-posterior view of both hips with pelvis (B) Antero-posterior view of right hip with upper thigh. (C) Antero-posterior view of right knee with lower end of thigh showing the plate protecting the malunited site.
