Seismic Behavior of Historic Masonry Monasteries in Sikkim in the 2011 M 6.9 Sikkim Earthquake: Case Study of Hee Gyathang Monastery, North Sikkim, India

Abstract

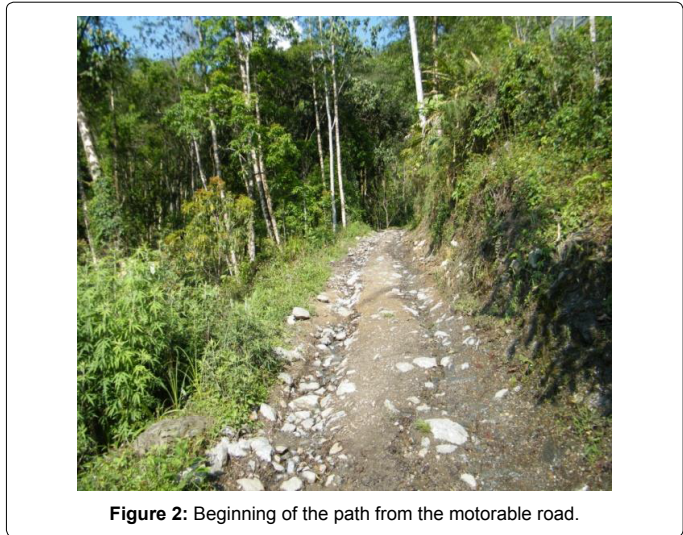
Figure 2: Beginning of the path from the motorable road.

on the road from MangantoGor via Sankalan. The monastery is located 2.5 kms from the village and can be accessed only on foot through an arduous one hour hike through a steep pathway through dense forests, without any human habitation along the way (Figure 2). The monastery is built on a small patch of flat ground about 1600 sqm area on a hill top at an altitude of 1669 meter (Figure 3). The geographical coordinates are simultaneously 27.4750 N and 088.5010 E.

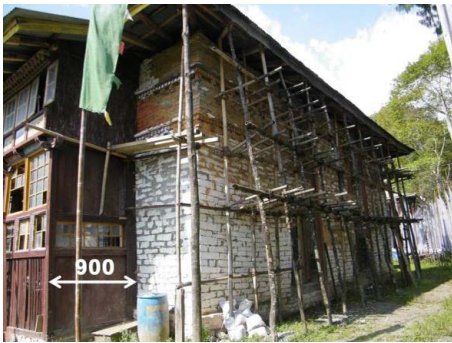
Figure 7: Projected Covered Wooden Verandah.

the monastery has a wooden verandah of 900 mm width (Figure 7). The fenestration pattern on the rear side is not the same on both the floors. While the first floor has two window openings, the ground floor has none (Figure 8). It is noticed that the old windows have been replaced by new ones (Figure 9).

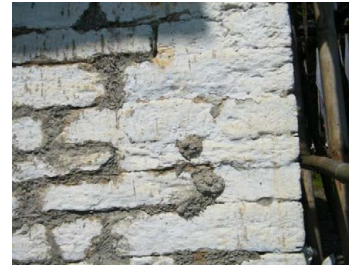
Figure 10: Rubble masonry.

The old monastery is made with Random Rubble stone masonry structure (Figure 10) with a thickness of 600 mm. Four timber posts are located at the centre of the assembly hall, only two horizontal beams are observed above the wooden posts spanning only in the “X” direction (Figure 11). The wooden posts are decorated at the top (Figure 12). Two decorated wooden posts are located at the entrance of the front verandah (Figure 13). No bands are present in the monastery. Floors

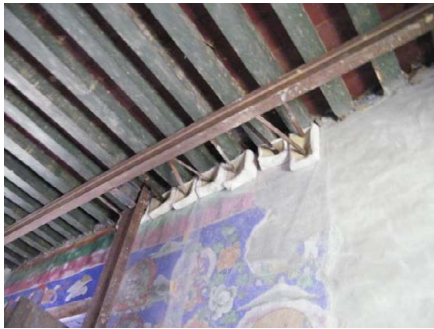
Figure 14: Wooden Rafter and Planks.

are made with timber planks. Wooden rafters hold the timber plank in the first floor (Figure 14). Roof is covered with G.I sheets (Figure 15).

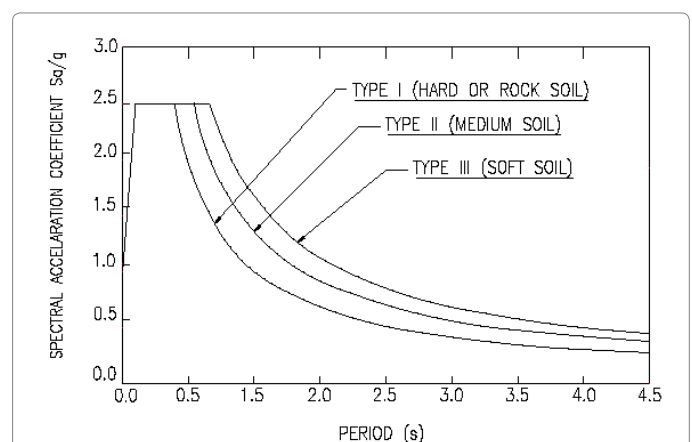
Figure 16: Response Spectra for Rock & Soil Sites For 5% Damping [9]. Ah: Design Horizontal Spectrum Value; W: Seismic wt of all floors of the building (Dead load and part of the imposed load - IS 1893-2002). VB: Seismic Base Shear is the total design lateral force on the building at the base of the structure. It is directly proportionate to the weight of the building.

NOTE: This design horizontal seismic coefficient A_n is determined by the following expression provided that for any structure with T ≤ 0.1 Sec the value of A_n will not be taken less than Z/2 whatever the value of I/R.
 Sa/g=Spectral Acceleration Co – efficient depends on i) Fundamental Natural Period 'T' and ii) the type of soil at the site. Soil type of Sikkim is Hard Rock. The Sa/g value can be derived from the graph (Figure 16) - Response Spectra for Rocky Soil Sites For 5% Damping.

The entire state of Sikkim lies in Zone IV with maximum expected intensities of VIII on the Modified Mercalli Intensity (MMI) scale. As per IS 1893:2002 (Part 1) the Zone Factor Z is 0.24 for seismic zone IV. The value of Importance Factor, I is chosen 1.2 for being religious building. For unreinforced load bearing masonry wall building has the Response Reduction Factor, R is 3 [4-6]. During earthquake shaking a building will oscillate to and fro in any mutually perpendicular directions. The Fundamental Natural Period (time taken to complete one back and forth motion in seconds), derived from the expression $T_a = 0.09h/\sqrt{d}$ (IS 1893:2002), where, h =Height of building, in metres, d =Base dimension of the building at the plinth level, in m, along the considered direction of the lateral force. (To get the lesser value of "T" the longer dimension of the base is considered.) S_a/g =Spectral Acceleration Co-efficient (As per the graph for Rocky and hard soil considering 5% damping the value of S_a/g is 2.5.) (Figure 16 and Tables 2-6) [7-9].

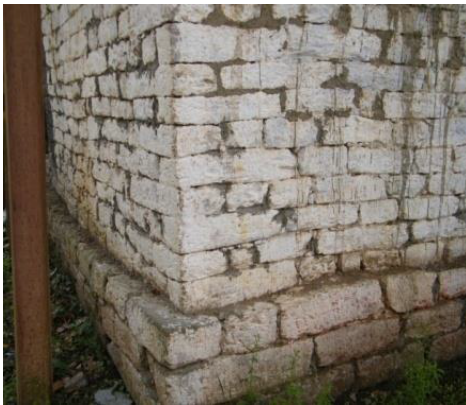
Figure 20: Shear cracks and bulging of wall in bending.

After the 2011 earthquake, it was observed that the old structure had suffered edirreparable damages. Visual inspection revealed the deteriorated condition of the monastery due to these damages (Figures 17-19). The random rubble masonry walls suffered bulging due to out of plane bending (Figure 20), diagonal and plaster cracks developed on the inside walls plaster (Figure 21) The timber posts also suffered bending (Figure 22). The damages sustained may be attributed to the inability of the walls to withstand the tensile stresses generated during earthquake induced shaking. Clearly, these cracks have weakened the structure and remedial measures need to be taken to prevent their further propagation. However, it is noteworthy that the structure has not collapsed despite suffering such widespread damage. The DCR values indicate that the structure should have sustained Grade

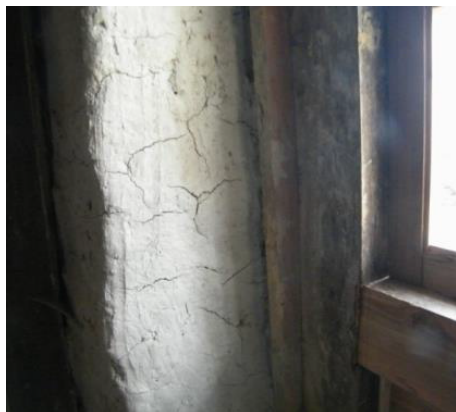
Figure 21: Plaster cracks.

1 damage as per IS 1893: 2002, that is, fine cracks in plaster. However, the structure experienced moderate and heavy damage including small, large and deep cracks in plaster, bulging of columns, gaps in
