Assessment of the Category of Technical Condition and Seismic Stability of Historic Structures Using the Method of Dynamic Geophysical Tests

Abstract

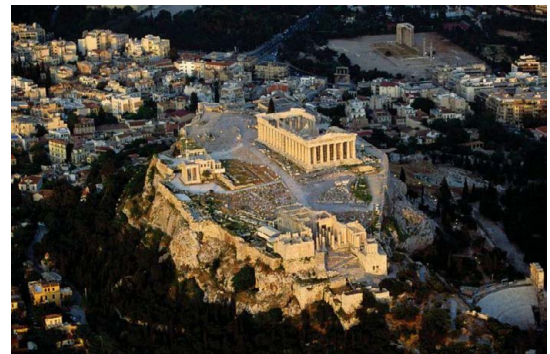
Figure 1: The Parthenon temple in Athens in the photograph clearly shows the proportional relationship between the size of the hill and the temple.

The ancient builders paid much attention to the geometric proportions of the structures [1] When designing structures, they took into account the proportions of the hills on which the construction was erected. In the case of the Parthenon, the size of the hill is proportional to the size of the temple. Since the dynamics of the structure depends not only on its dimensions but also on its design and strength. The value that takes into account the geometric and strength parameters of the structure is called rigidity (Figure 1) [2-6].

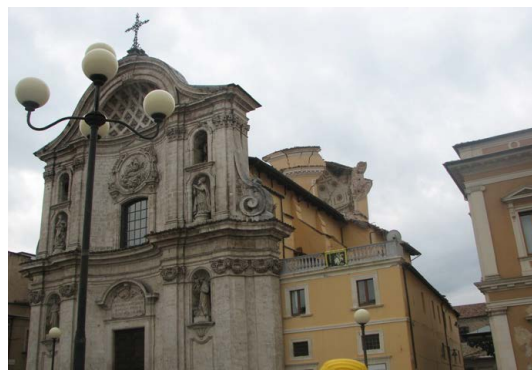
Figure 3: The Church of Santa Maria del Suffrajo in the town of Aquila, damaged after the seismic impact of the earthquake in 2009.

For the construction of the Church of Santa Maria del Suffrajo in the city of Aquila in the Republic of Italy, the relationship between the periods of construction and soil is 1-1.6, which is less than 2 and corresponds to the resonant state, which apparently contributed to the collapse of the dome. Structures under the influence of seismic waves, have direction of motion of the wave. Traces of seismic waves on the stone pavement near the church showed that the waves moved parallel to the facade of the temple. Just the largest damage the dome received in the direction of motion of the front of seismic waves.

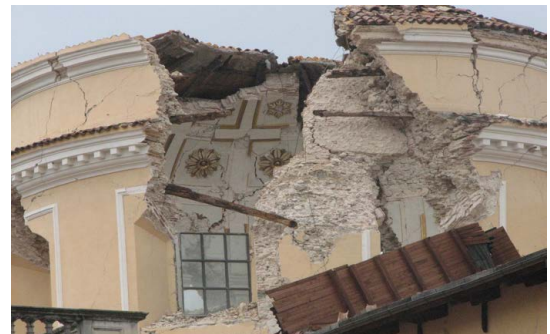
Figure 4: The destruction of the dome (the greatest destruction of the dome coincided with the direction of the seismic wave front) of the Catholic church in the town of Aquila in the province of Abruzzo in Italy, after the devastating earthquake in 2009.

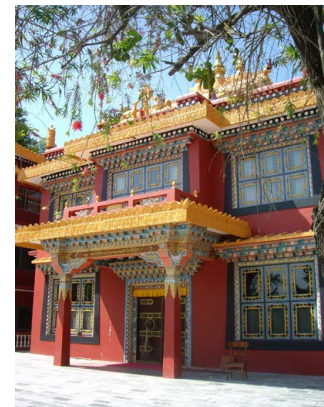
Figure 5: The Buddhist temple in the Republic of Nepal, erected on a rocky hill, was slightly damaged.

In contrast to the Italian temple, the Buddhist temple in Nepal, with strong seismic action, did not receive significant damage, its location on the rocky hill and the absence of resonance between the ground and the structure helped (Table 1 and Figures 3-7).

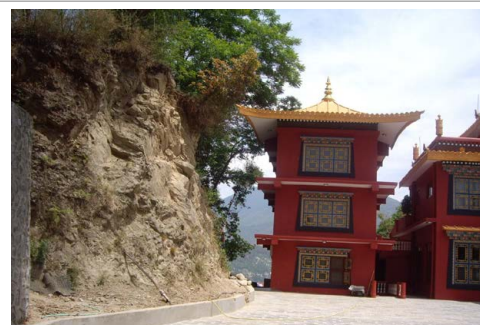
Figure 6: The rocks of the hill are visible, on which the Buddhist temple in Nepal is erected.

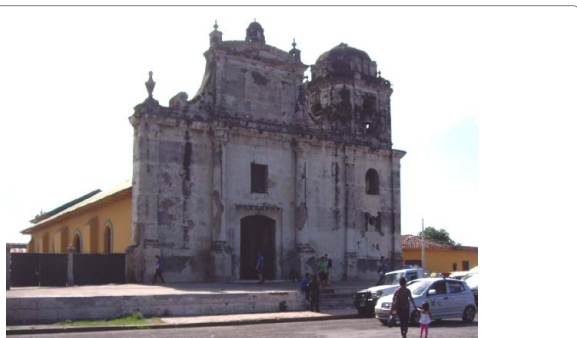
Figure 7: The Catholic Church of St. John in León, Republic of Nicaragua.

Let us consider an example of an assessment of the category of technical condition and seismic resistance of St. John's Catholic Church in Leon, Republic of Nicaragua (Figure 7) using dynamic-geophysical test data. The structure consists of a bell tower and a main block, there is a deformation seam between them. The foundation is ribbon, stone. The walls of the structure are made in the basement part of natural stone with the transition to brickwork. Lintels above the doors and windows are wooden. Columns inside the building with a height of 6,890 mm are wooden. Bearing beams on columns are also made of wood. To determine the dynamic parameters of the structure and soil and its seismic stability, the mobile diagnostic complex "Struna-3M-Strela" was used, including [2]:

A stiffness deficit along the X and Y axes was found, along the Z-axis there was no stiffness deficit.

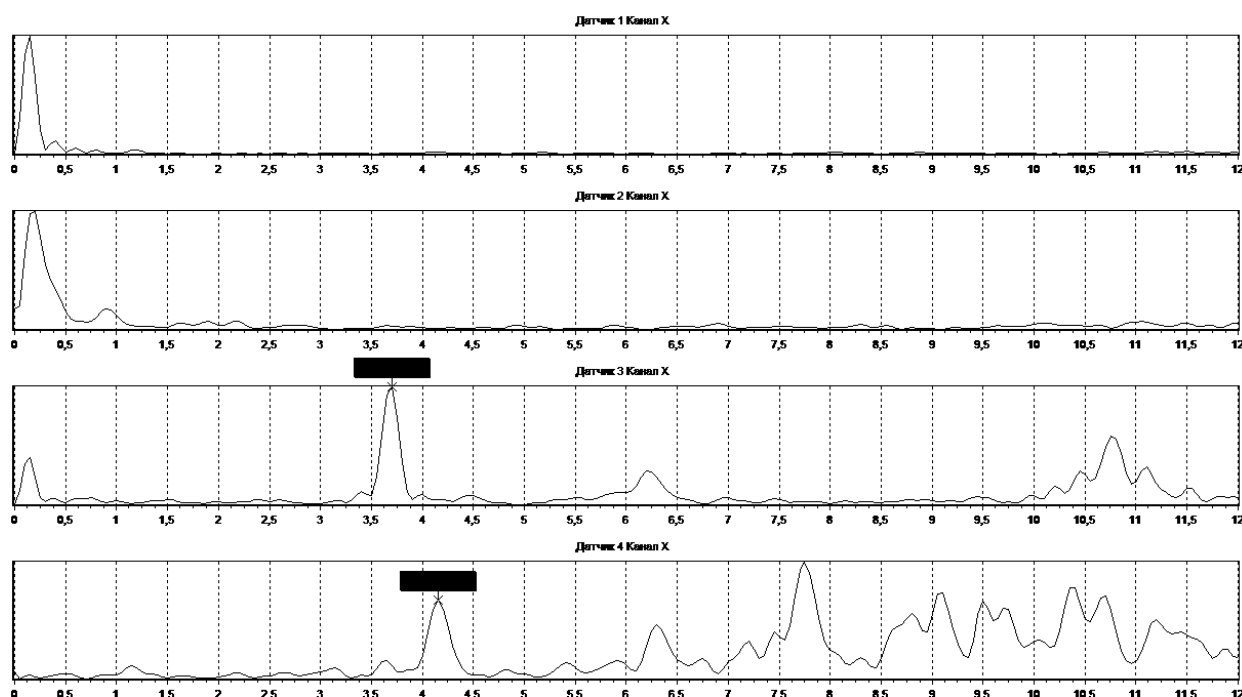
Figure 8: Spectrum of natural oscillations of the building of the Church of St. John (1 sensor - ground, 2 - zero level of the building, 3 - bell tower of the church, 4 - cornice of the opening in the altar part of the church) along the X axis.

- A computer with a software package for analyzing seismic vibration signals. During the dynamic tests of the soil-structure system, micro seismic effects of the soil on the structure were recorded. The first sensor was installed at the base of the structure, the rest sensors were installed on the different heights in the building itself. The results of dynamic geophysical tests are shown in Figures 8-10.

Spectral analysis of data obtained as a result of dynamic tests shows that the periods of natural oscillations of blocks in the first tone along the X, Y, Z axes have the following values:

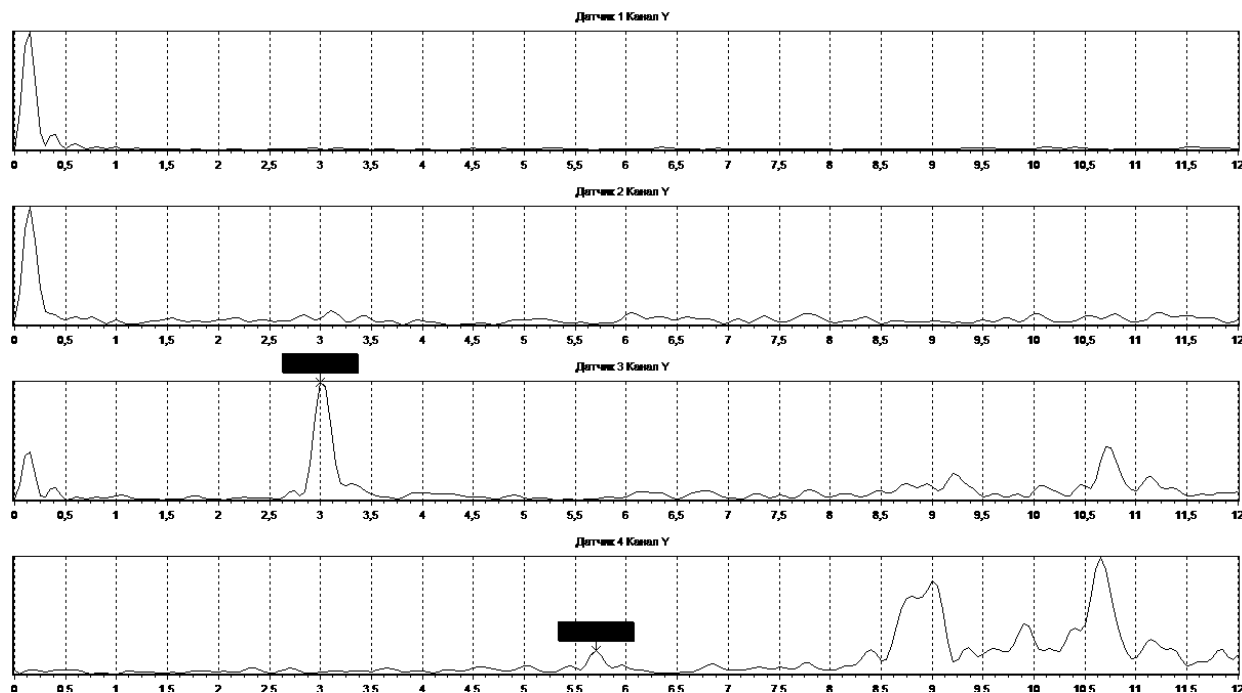
Figure 9: The range of natural oscillations of the building of the Church of St. John (1 sensor - ground, 2 - zero level of the building, 3 - bell tower of the church, 4 - cornice of the opening in the altar part of the church) along the Y axis.

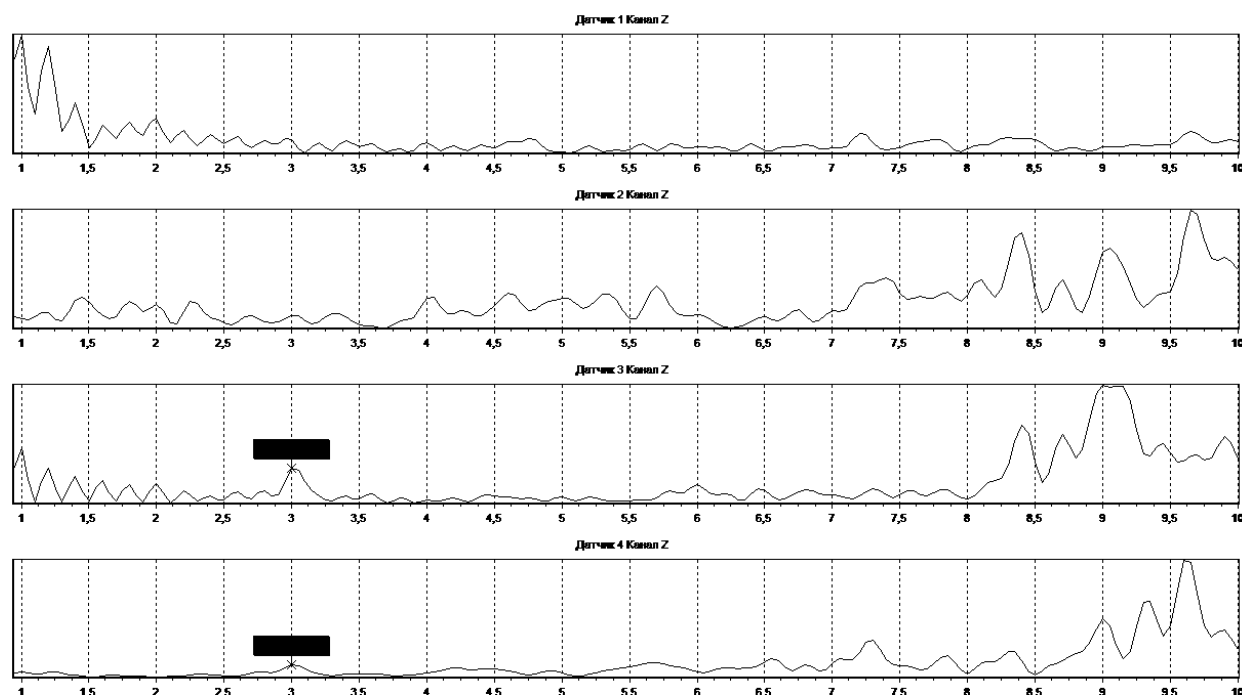
Figure 10: The spectrum of the natural oscillations of the building of the Church of St. John (1 sensor - the ground, 2 - the zero level of the building, 3 - the bell tower of the church, 4 - the cornice of the opening in the altar part of the church) along the Z axis.
