Locational Analysis of Hill Cutting Areas in Chittagong city, Bangladesh

Abstract

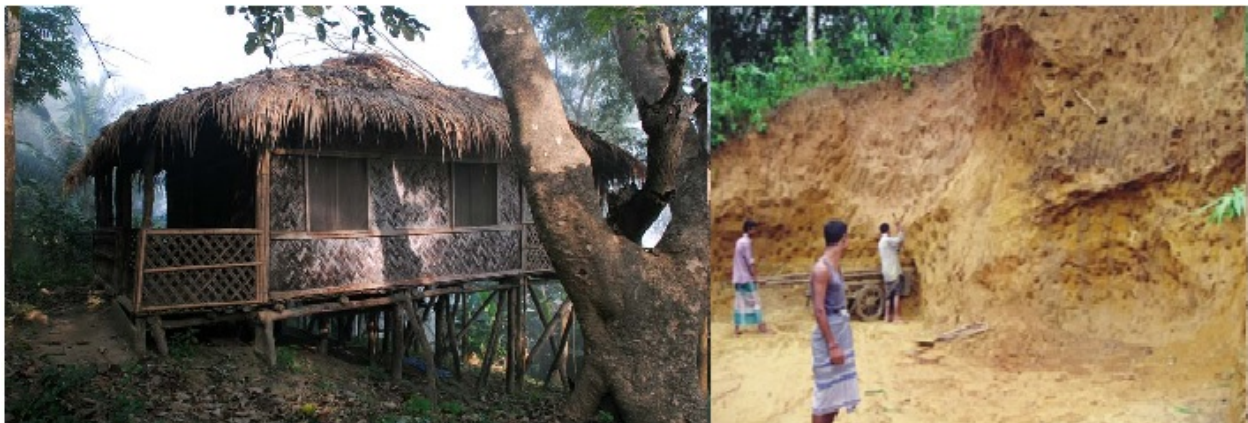
Figure 1: The location of a house on top of a hill.
