Restoration of a Non-restorable Lateral Incisor Using Forced Orthodontic Eruption, Fiber Post and Zirconia-Ceramic Restoration

Pinar Cevik^{1*} and Ozlem Akinci²

¹Department of Prosthodontics, Gazi University, Ankara, Turkey

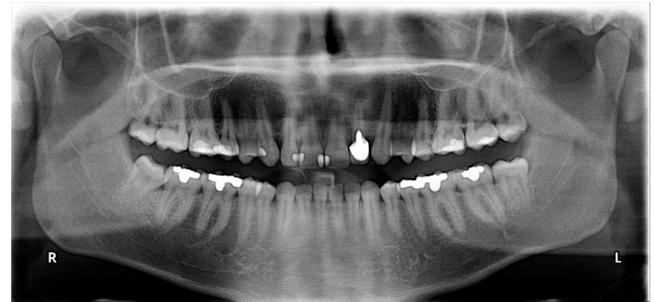
Figure 1: Initial radiograph.

A 20-year-old boy was referred to the Department of Prosthodontics at the Selcuk University Faculty of Dentistry with a crown fracture of traumatic no restorable maxillary left lateral incisor. The patient reported that he had a food related traumatic injury on left lateral incisor previously. Patient's history indicated that the related tooth had been restored with screw intracanal post and metal ceramic prosthetic restorationwith no root canal obturation. After radiographic examination, a periapical lesion was determined on the apical section of lateral incisor without any bone or root fracture (Figure 1). The periodontal space around the tooth was widened and there was no damage around the adjacent teeth. Vitality responses of adjacent teeth were checked. After getting positive response to pulp

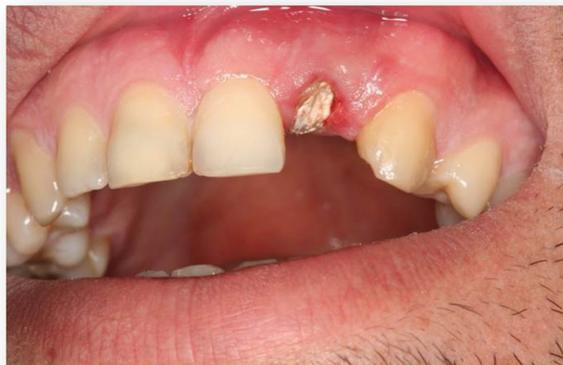
Figure 3: Intraoral view.

vitality tests from the adjacent teeth, conventional endodontic retreatment was performed of tooth 22. Obturation was radiographically followed and periapical radiolucency and gutta-percha overfilling was observed at the apical area (Figures 2 and 3).

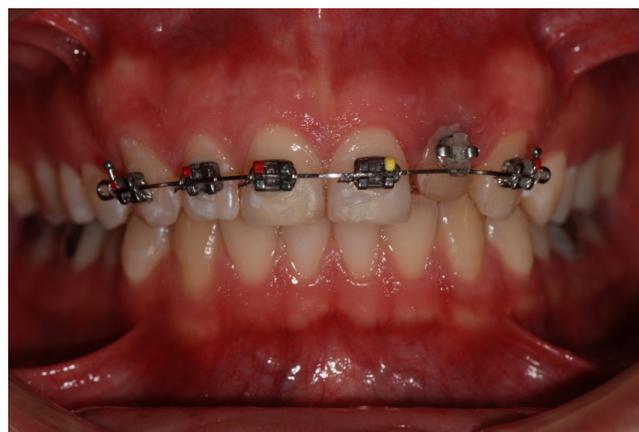
Figure 6: Orthodontic extrusion period.

Stainless steel standard edgewise brackets (790-010, Dentaaurum, Pforzheim, Germany) with an average base surface area of 10 mm², were bonded (Blugloo,Ormco Corp, Glendora, Calif) from maxillary right canine to left canine. The bracket on the left lateral incisor was poisoned approximately 1,5 mm more cervically to allow for the extrusion. Extrusion was initiated by ligation of an elastic archwire (Dentaaurum, Pforzheim, Germany). After 5 week extrusion period, the extruded root was stabilized for 13 weeks by same bonded brackets. While extrusion period, palatal side of the left lateral incisor was gradually reduced by a diamond burr in order to cut off the contact with the opposite teeth (Figures 6 and 7).

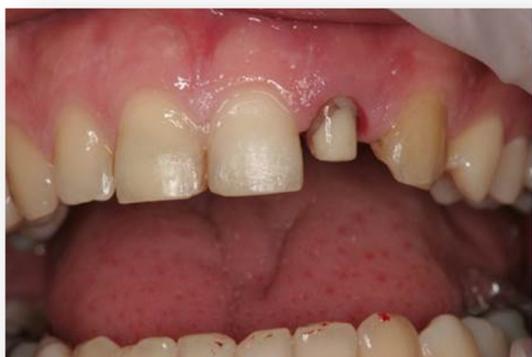
Figure 8: Crown preparation.

After atraumatic extrusion of the related root, a ferrule effect was obtained around the left lateral incisor for the final ceramic restoration

on the post core. Then the clinical procedure consisted of cleaning the crown structure acid etching using 37% phosphoric acid (Total Etch; Ivoclar-Vivadent, Liechtenstein) and application of adhesive, after which a transparent strip crown (Systemp Crown, IvoclarVivadent, Liencheinshten) was filled with composite and placed on the tooth prior to all ceramic complete crown restoration. All ceramic complete crown preparation was generated and a definitive impression of the prepared tooth was made using polyvinylsiloxane impression material (Virtual Putty and Lightbody, IvoclarVivadent Liechtenstein) after then (Figure 8). The interim prosthesis was fabricated and inserted into the relevant tooth. Zirconia framework (Vita Zirconzahn, GmbH & Co KG, Germany) for the left lateral incisor was fabricated and layered with feldspatic porcelain (Vita Zahnfabrik, GmbH & Co KG, Germany). The definitive all ceramic restoration was fabricated with canine guided occlusion. Finally, the crown was cemented with self-cure adhesive resin cement (RelyX[™] Unicem, 3M Espe, USA). The patient was given postoperative instructions for the prosthetic restoration and oral hygiene instructions were given. The patient was scheduled for follow-up appointments for every six months (Figure 9).
