An Investigation of Utilizing Ripraps as Substrate for Oyster Stocking within Delaware Coastal Bays

Keywords: Oyster reefs; Oyster restoration; Oyster stocking; Riprap; Rock crevices

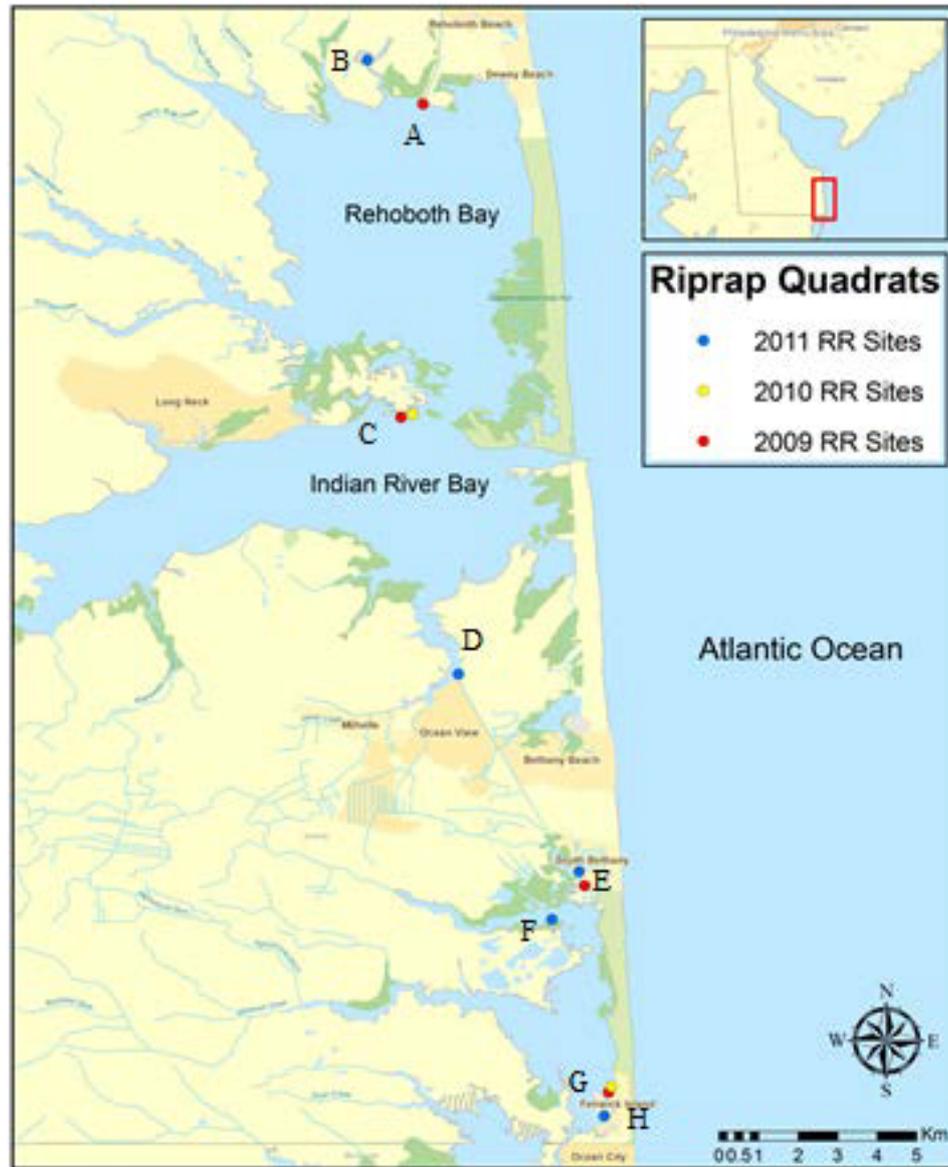
Figure 1: Locations of riprap study sites. Each site was comprised of three quadrats, each with 25 oysters, for a total of 75 oysters per site.

In August 2009, researchers at Delaware State University and The University of Delaware Sea Grant Program selected and established four sites (A, C, E, and G) as riprap testing locations (Figure 1). Each riprap site contained three experimental quadrats, where 25 living oysters of known shell heights were planted between rock crevices in each quadrat. Quadrats were outlined on rocks using PVC mainly to geographically mark which rock crevices the oysters were placed. Quadrat positions were marked with plastic stakes, and photographs were taken so

relocation of our exact planting site was achieved. An additional two sites were established in 2010 (sites C and G), and five in 2011 (B, D, E, F, and H) (Figure 1) with oysters produced from each year's oyster gardening crop. Most oysters produced in 2010 were utilized in another experiment. Oysters varied from single individual oysters to clusters containing up to five or six oysters. The oyster height, width, and thickness were recorded with digital calipers to the nearest 0.1 mm for all 25 oysters placed in each quadrat. Oysters were planted during low tides, and it took several days to set up this study. No containment gear (i.e. mesh bags) was employed, as we wanted to mimic our program's restoration procedure of placing oysters individually into rock crevices. We returned to each location roughly one year after establishing each quadrat. During low tide, we searched by hand all rock crevices within each quadrat (approximately 1 m² for the planted oysters. We combed each quadrat for 10 minutes, or until all 25 oysters were retrieved. Each oysters' fate (alive or dead), height, width, and thickness was recorded.
