Unusual Puncture Marks on Poly Vinyl Tubing

The case study involves the examination of puncture marks on a polyvinyl (PV) tubing of an industry pipelining wherein sabotage had occurred. The study carried out to individualize the characteristic and sub-class characteristic marks formed by the tool implemented and their unusual features formed are attempted. The paper also brings out differences in the characteristics of puncture marks on PV tubing resulting from the three knives/tools submitted by the investigating officer and the linking of one of the knives to the questioned tool marks on the tubing.

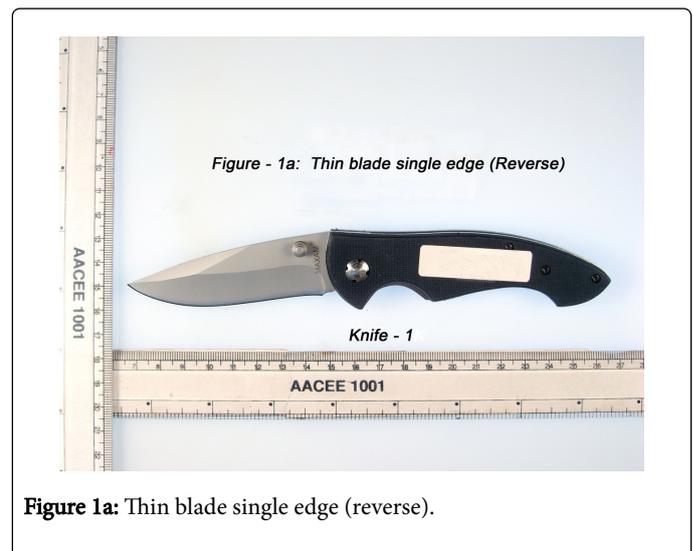
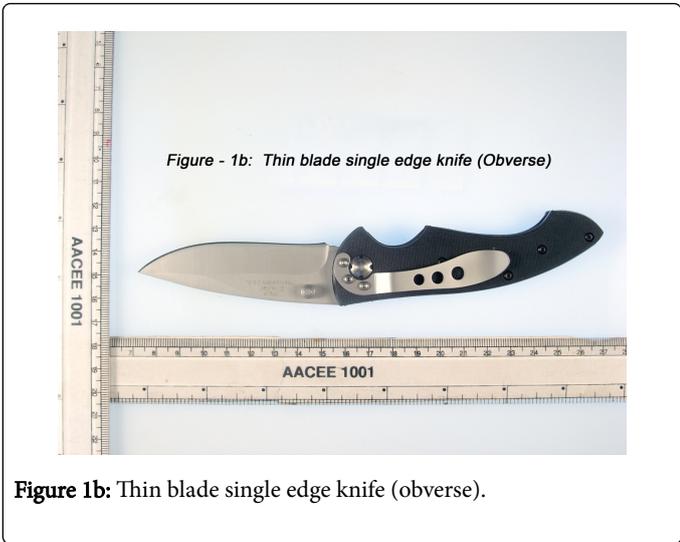
Three suspected knives marked as knife-1 to knife-3 (Figure 1-3) of which one knife is broken i.e., without handle and the other knife is supposed to be a surgical knife of no 24 was utilized for making test cut marks on P.V. tubing. The Figures 1a and 1b shows the relatively thin blade single edge knife with choil.

Figure 1a: Thin blade single edge (reverse).

Figure 1b: Thin blade single edge knife (obverse).

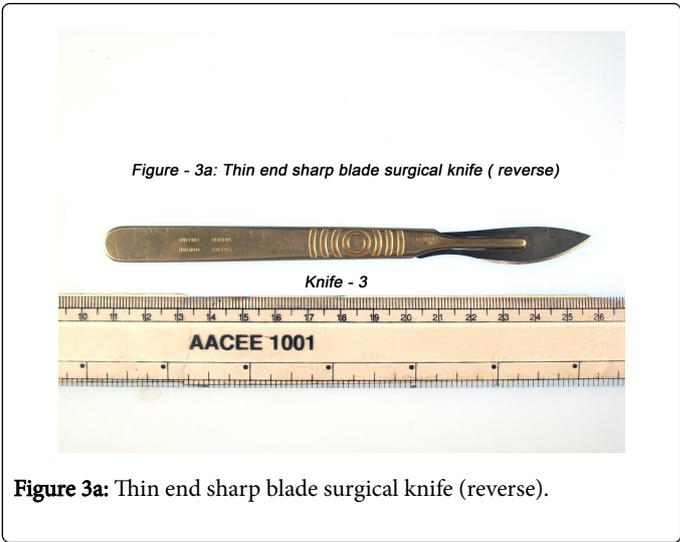
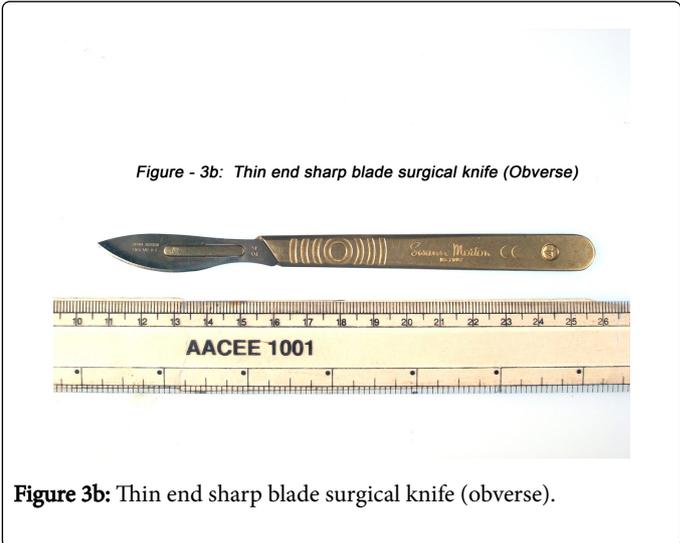
The Figure 2a shows the relatively thin blade knife with serrated single edge blade whose handle is broken near the choil. The cutting edge is serrated up to the full length of the blade and is clearly visible in the Figures 2a and Figure 2b. The Figure 3a shows a very thin end sharp blade knife commonly used for surgical application with the provision to remove the blade as seen in Figures 3a and 3b.

Figure 3a: Thin end sharp blade surgical knife (reverse).

Figure 3b: Thin end sharp blade surgical knife (obverse).

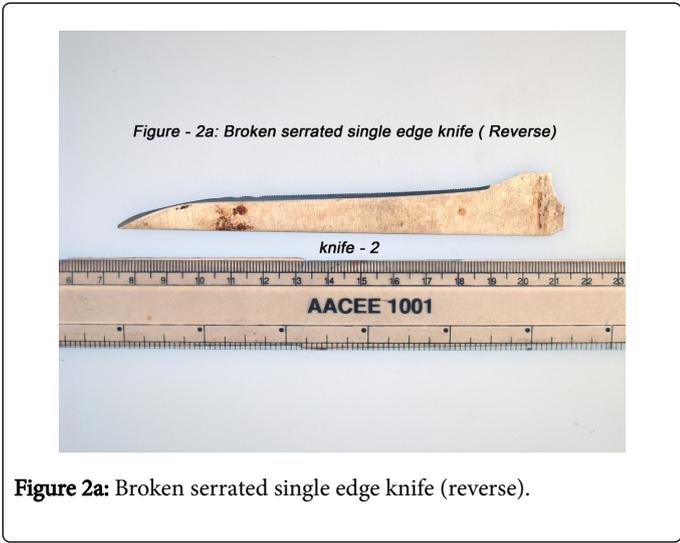
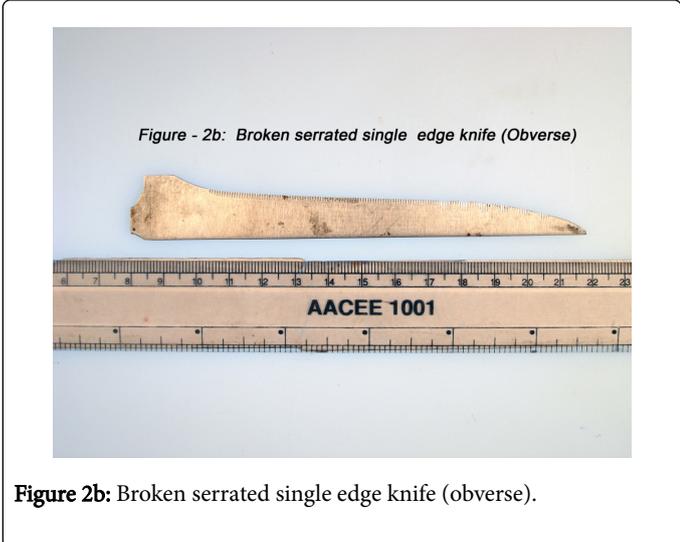
Figure 2a: Broken serrated single edge knife (reverse).

Figure 2b: Broken serrated single edge knife (obverse).

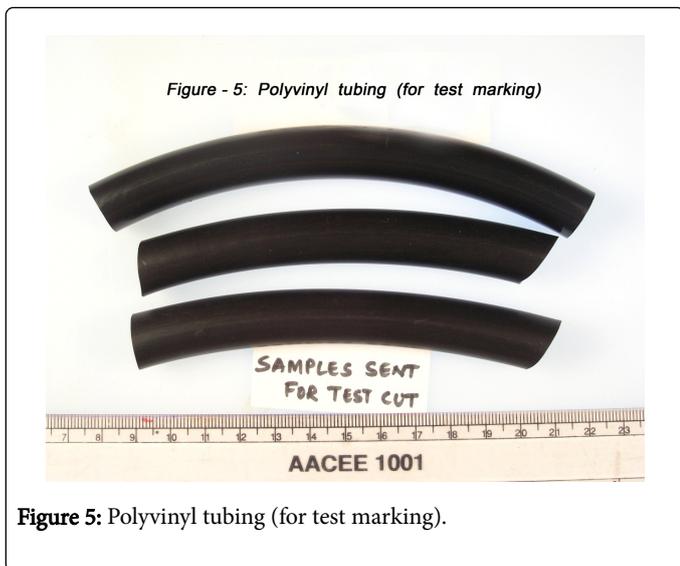
The Figure 5 shows the black colour, 1.7 mm thickness and 12 mm diameter cylindrical polyvinyl tubing cut and sent by the Investigating Officer (I.O) for the purpose of laboratory test cut marks.

Figure 5: Polyvinyl tubing (for test marking).

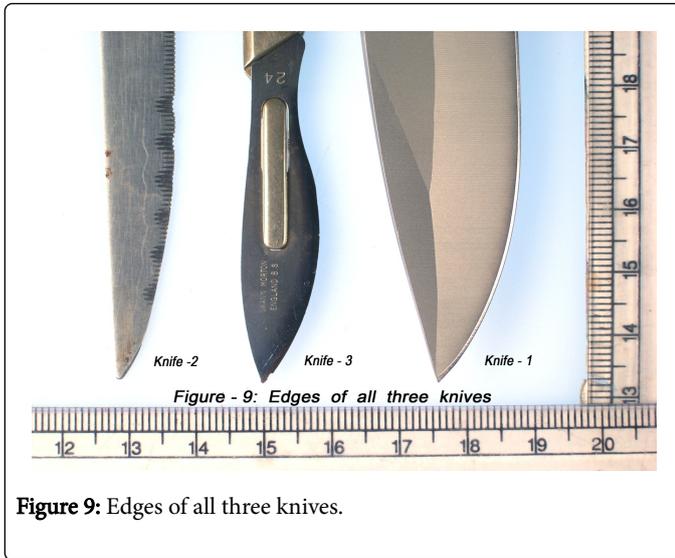
Figure 9: Edges of all three knives.

The comparison made between the puncture marks made by the above said three knives, whose close-up blade edge view is given in Figure 9, on the P.V. tubing showed the difference in puncture made by each knife. The comparison made showed that the knife in the Figure 1 had caused the puncture mark on the tubing shown in the Figure 4 and its comparison shown in the Figure 6.
