Experimental Investigation of Retrofitting Techniques for Steel Bridge Girders Subject to Fatigue Failure

Mirza O*, Milner L and Mashiri F

School of Computing, Engineering and Mathematics, Western Sydney University, Locked Bag 1797, Penrith South DC, NSW 1797, Australia

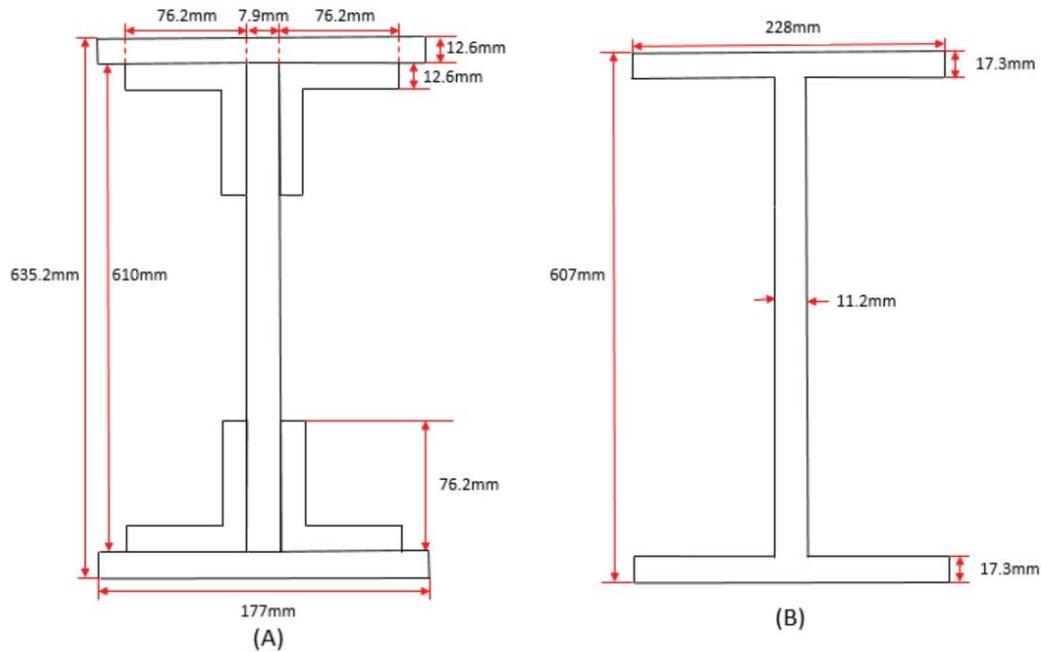
Figure 1: (A) Cross sectional dimensions at mid span of RMS 120-year-old girder, (B) Cross sectional dimension of EJV new equivalent girder.

There are two test specimens; the 120-year-old girder and the 610UB113 new equivalent girder. The test specimens are the same length being 6477 mm and have vertical stiffeners in the same locations. Figures 1A and 1B show the cross-sectional dimensions of the two girders.

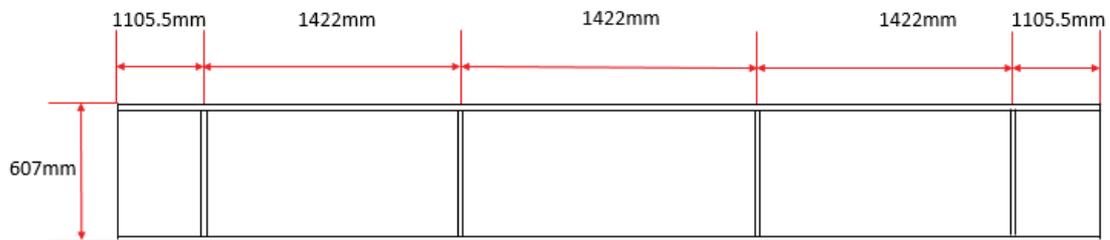
Figure 2: New equivalent girder.

The new hot-rolled girder varies from the RMS 120-year-old girder as it has a uniform cross section as shown in Figure 2, whereas the 120-year-old girder is a tapered I beam which can be seen in Figure 3. The hot-rolled girder was selected due to its cross-sectional dimensions and moment capacity being relatively similar to the 120-year old girder.

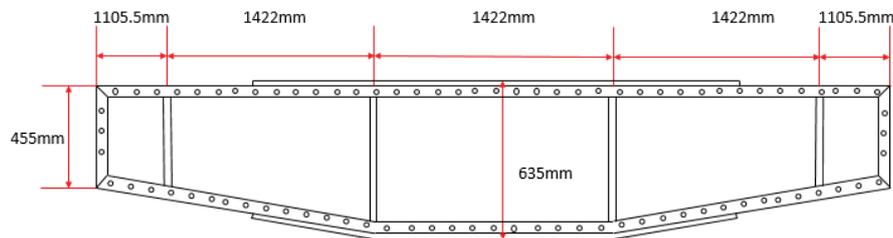
Figure 3: RMS 120-year-old girder.

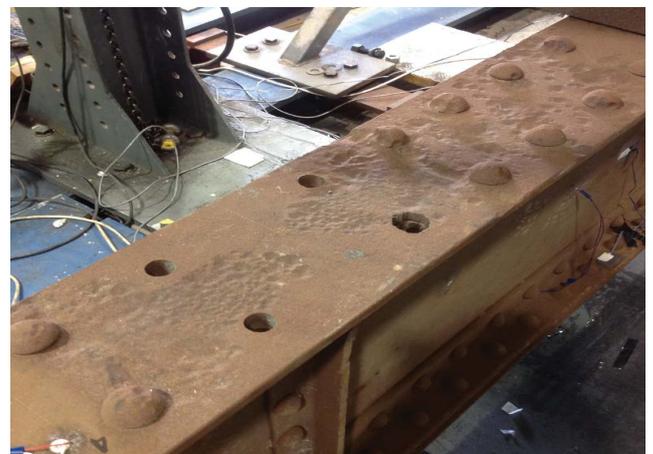
Figure 4: Defects for 120-year-old girder.

present. One defect experienced by the 120-year-old girder is corrosion, as the entire beam is covered in surface rust with some locations experiencing the corrosion more aggressively as the girder has started to pit. Another notable defect for the 120-year-old girder is that it had rivets missing in some locations. The defects for the 120-year-old girder are shown in Figure 4. The new hot-rolled 610UB113 girder has 7.9 mm vertical stiffeners fillet welded in place by EJV engineering to the flange and web. As expected the new equivalent has no defects present.

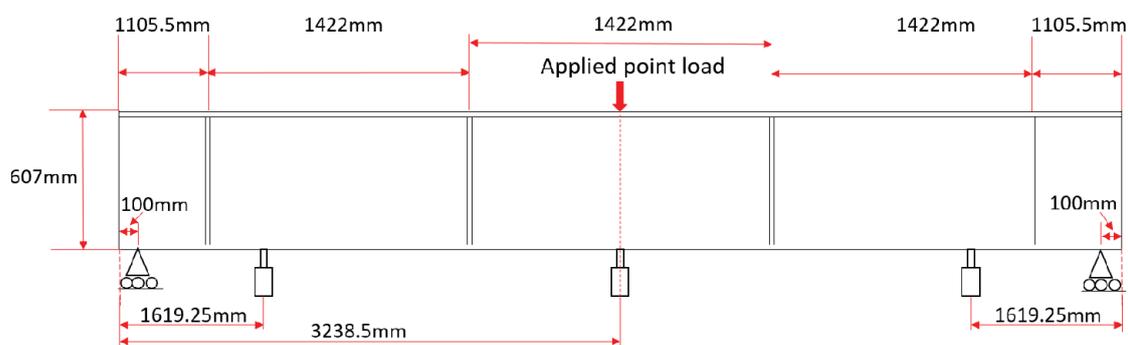
Figure 5: Experimental setup for girders.

The experimental setup can be seen in Figure 5. LVDTs were placed at a distance of 1619.25 mm from either end to ensure the girders were deflecting symmetrically and at mid span at a distance of 3238.5 mm from either end to measure the overall deflection. The 1000 kN hydraulic press applied the point load at mid-span. Roller supports were used 100 mm from the end of the girder to ensure the girders did not fall off the supports during testing.

The experimental test was carried out within the testing laboratory at Western Sydney University, Kingswood campus. The girders were simply supported at each end as shown in Figure 5. The calculated theoretical ultimate applied point load for the EJF new equivalent girder is 568.9 kN and for the RMS 120-year-old girder 540.1 kN.

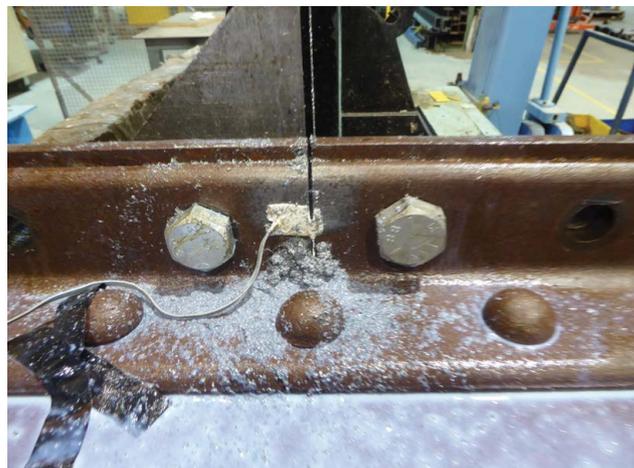
Figure 6: Artificially induced fatigue crack for 120-year-old girder.

made within the bottom flange at mid span as that is to be the location with the expected maximum tensile stress, according to Schroot [10]. The artificial fatigue crack was created by cutting the bottom flange at mid span with an industrial bandsaw which is seen in Figure 6.

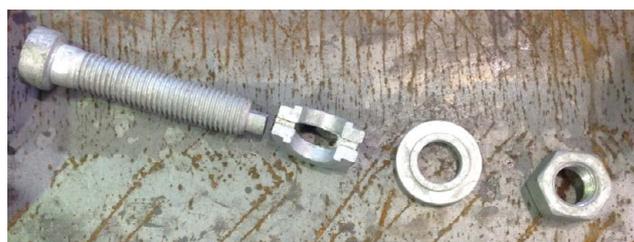
Figure 7: Ajax Oneside fastener.

The retrofitting technique for the girders is a way to combat fatigue that occurs at mid span within the bottom flange. The retrofit was required to be practical as it must be designed so it can be performed within a real-life situation to minimise disruption to bridge services. The retrofit performed was to combat an artificial fatigue crack at mid span within the two girders. The plate to be attached to the girders is 20 mm thick, 1410 mm in length and the width of the girder's flange which is 228 mm for the new girder and 177 mm for the old girder. 350 grade steel plates were found to be the optimum grade as 250 grade was not adequate in design. The plate is attached to the girders using 20 mm diameter Ajax Oneside fasteners which are high strength 8.8/S structural bolts. The Ajax Oneside fasteners are a bolting system that enables the bolt to be tightened with only having access to one side of the bolt. Without the Ajax Oneside fasteners this retrofit would not be practical for some bridge girders. Figure 7 shows the arrangement of the Ajax Oneside fasteners in the order it is installed, which includes a bolt, collapsible washer, flat washer and a nut.

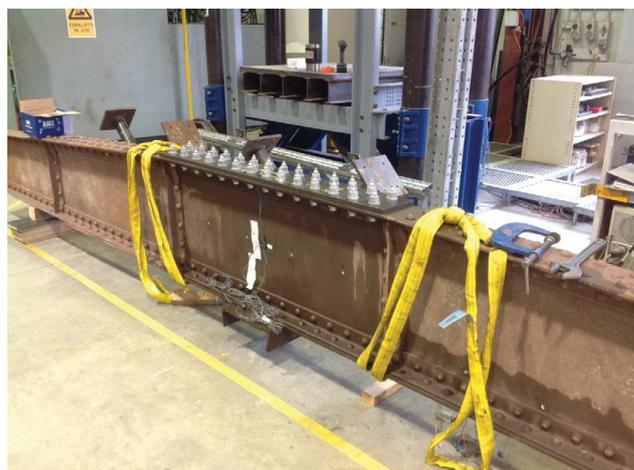
Figure 8: Completed retrofit for RMS 120-year-old girder.

Once all the drilling and rivet removal was complete the Ajax Oneside fasteners completed the retrofit by attaching the plate to the girders. Figure 8 shows the completed retrofit for the RMS 120-year-old girder. Figure 9 shows the completed retrofit for the EJF New equivalent girder.

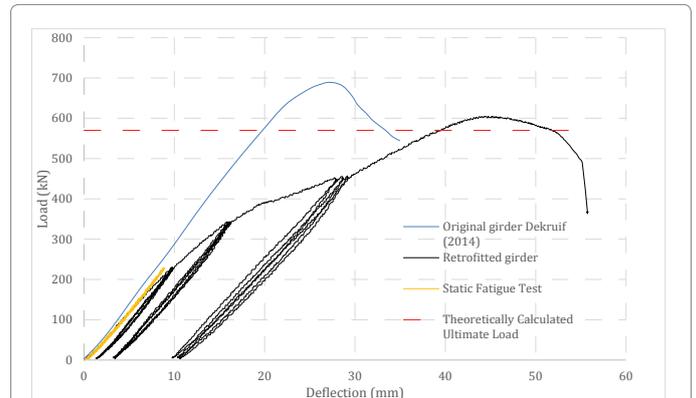
Figure 10: Load versus deflection curve for new equivalent girder experimental results.

New equivalent girder: The new equivalent girder had two experiments performed: before the girder had an artificially induced fatigue crack, and after the girder had an artificially induced fatigue crack that was retrofitted. Figure 10 shows a load versus deflection curve for the static fatigue test for the girder, and static strength test until failure for the retrofitted new equivalent girder. The load versus deflection curve was plotted due to the data obtained from the linear variable displacement transducers (LVDT), along with the known loading rate of 0.1 mm/s for the 1000 kN hydraulic press. Also displayed in Figure 10 is the experimental result from Dekruif [11], which is a static strength test until failure of an identical 610UB113 which is the same length and has vertical stiffeners in the same location; however, no retrofit was performed on the beam.

Figure 10 illustrates that the stiffness of the girder changed after the retrofit was installed on the girder. The girder initially had a stiffness of 26.14 kN/mm. Once the girder had the artificial fatigue crack induced and the retrofitting plate installed, the stiffness decreased to 23.16 kN/mm. The 11.4% decrease in stiffness is due to the artificially induced fatigue crack and the technique of the retrofit. Initially, the girder was a hot rolled uniform cross section with no discontinuities within the bottom flange. Once the artificial fatigue crack was induced in the bottom flange, it compromised the cross section of the girder reducing the stiffness. The connection of the retrofitting plate also affected the stiffness of the girder. The retrofitting plate was connected to the bottom flange using 20 mm diameter Ajax Oneside fasteners which were inserted to fill 22 mm holes within the flange and plate. The 22 mm holes were drilled so that the bolt had 2 mm of clearance. This caused the connection between the girder and the plate to slip as the Ajax Oneside fasteners would not engage with the plate and girder until the girder had deflected and engaged the fasteners with the outside of the holes for both the girder and retrofitting plate. Figure 11 shows the artificially induced fatigue crack propagating into the web of the new equivalent girder. This shows that the clearance of the bolt holes caused a slippage between the girder and retrofitting plate. This ultimately increased the deflection and reduced the stiffness of the girder. The slippage that occurred between the retrofitting plate and the girder is evident as the artificially induced fatigue crack was a 2 mm cut within the bottom flange. Once the testing was complete, the artificially induced fatigue crack had expanded to a 9 mm gap as seen in Figure 11. The result from the static strength test until failure for the retrofitted

new equivalent girder displayed in Figure 10 shows that retrofitting is effective for rehabilitating beams with fatigue failure within the bottom flange. It is seen in Figure 10 that the retrofitted new equivalent girder reached an ultimate applied point load of 604.86 kN. For a 610UB113 with a length of 6477 mm, the theoretically calculated ultimate applied mid span point load was calculated as 568.9 kN. This corresponds to a 6.32% increase in the ultimate applied point load the girder can sustain before failure. This is not a significant improvement although it clearly validates that the retrofit can restore the girder to its original design loading capacity determined according to the Australian standards published by Standards Limited (2012) entitled Steel Structures [11]. Results for the original girder showed that the girder before the retrofit could sustain an ultimate applied load of 681.4 kN. Dekruif [11] showed the girder could sustain 76.54 kN more than the retrofitted girder which corresponds to 12.65% decrease. However, as the results favour the original girder used [11], it can be seen in Figure 10 that the stiffness of the original girder used was greater than the girder used in this experimental study [11]. Original girder displays a higher stiffness and can resist a greater ultimate point load than the retrofitted girder. However, Figure 10 shows that the ductility of the retrofitted girder is greater than the original girder [11]. The greater ductility of the retrofitted girder is displayed, as the retrofitted girder yields and fails earlier than the original girder. Nevertheless, it is not as sudden and drastic as it sustains its ultimate point load for a longer duration.

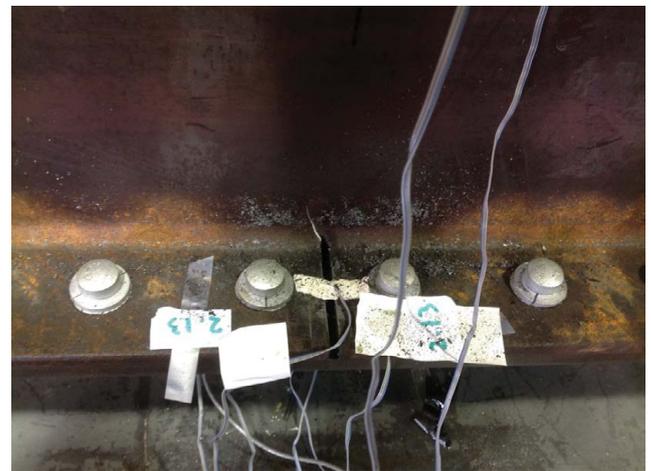
Figure 11: Artificially induced fatigue crack propagating into the web for new equivalent girder.

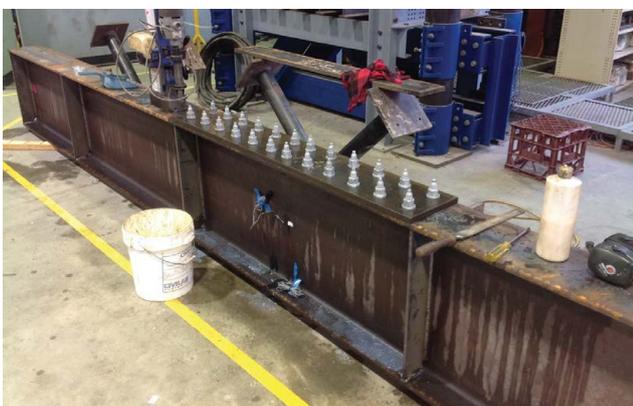
Figure 9: Completed retrofit for EJF new equivalent girder.

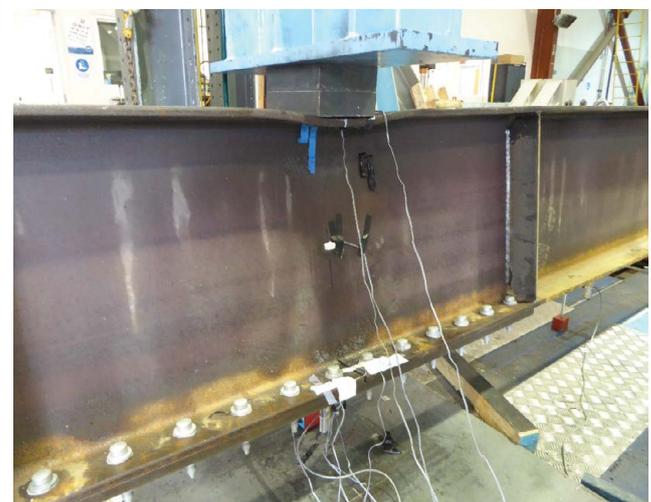
Figure 12: Local buckling within flange.

The new equivalent girder showed several failure modes, such as experiencing distortional and local buckling. The top flange of the girder experienced local buckling due to a large compressive force applied to a small area across the top girder by the 1000 kN hydraulic press, which is shown in Figure 12. Distortional buckling was evident within the flange and the web due to the lateral displacement caused through the application of the 1000 kN hydraulic press. Figure 13 shows the distortional buckling within the flange and web. Due to the mode of failures, the designed retrofit for the new equivalent girder is validated as a justifiable technique for rehabilitating girders that have sustained fatigue failure within the bottom flange. As evident in Figure 12, the plated retrofit did not sustain any form of failure and helped laterally restrain the girder. The retrofit was simple and cost effective whilst also repairing the girder to its design loading capacity proving it is the equivalent to a new girder that has not been in service. The retrofit

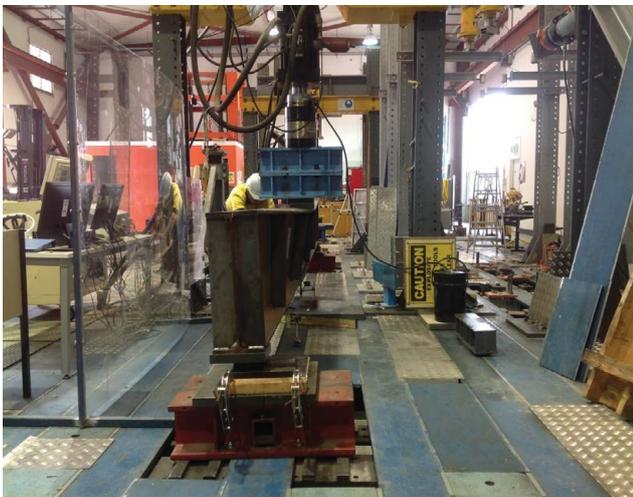
Figure 13: Distortional buckling in web.

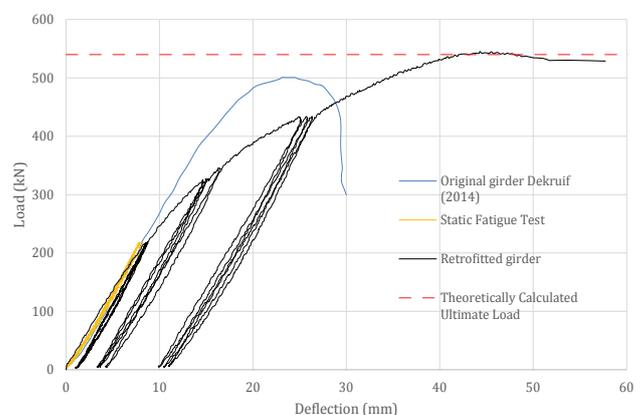
Figure 14: Load versus deflection curve for RMS 120-year-old girder experimental results.

RMS 120-year-old girder: The RMS 120-year-old girder had two experiments performed: before the girder had an artificially induced fatigue crack, and after the girder had an artificially induced fatigue crack that was retrofitted. Figure 14 shows a load versus deflection curve for the experimental results of the static fatigue test for the girder and static strength test until failure for the retrofitted girder. The load versus deflection curve was plotted due to the data obtained from the linear variable displacement transducers (LVDT), along with the 1000 kN hydraulic press known loading rate of 0.1 mm/s. Also, displayed in Figure 14 is the experimental result from Dekruif's [11] experimental study which is a static strength test until failure of an identical 120-year-old girder that has experienced the exact same loading conditions and environment. The identical girder is the same length and has vertical stiffeners in the same location; however, no retrofit was performed on the beam.

From Figure 14 the stiffness can be calculated, showing that the girder used to conduct this experimental study and the original girder used in Dekruif's [11] study had the same stiffness of 27.82 kN/mm. However, once the girder had the artificial fatigue crack induced and the plated retrofit installed, the stiffness decreased to 25.29 kN/mm. The 9.1% decrease in stiffness due to the artificially induced fatigue crack and the connection of the plate to the bottom flange of the girder for the retrofit similar to the new equivalent girder. Figure 15 shows the artificially induced fatigue crack before the girder was tested. Figure 16 shows the artificially induced fatigue crack extending into the web and rivet hole after testing. This shows that the clearance of the bolt holes caused a slippage between the girder and retrofitting plate, ultimately increasing the deflection of the girder, which in turn reduced the stiffness of the girder. The slippage that occurred between the retrofitting plate and the girder is evident as the artificially induced fatigue crack was a 2 mm cut within the bottom flange. Once the testing was complete, the artificially induced fatigue crack had expanded to a 9 mm gap as seen in Figure 16.

The static strength test until failure results in Figure 14 for the retrofitted girder furthermore reinforces that retrofitting is an effective technique for strengthening and rehabilitating girders affected by fatigue cracks within the bottom flange. Figure 14 shows the RMS

retrofitted 120-year-old girder reached an ultimate applied point load of 544.84 kN. The maximum applied point load for the RMS 120-year-old girder was calculated as 540.1 kN. The 0.88% increase in the ultimate applied point load is negligible, however, it is noteworthy as the 120-year-old girder had experienced many years of loading over its service life and had accumulated damage that would negatively affect the ultimate applied point load the girder could sustain. Nonetheless, the retrofit performed upon the 120-year-old girder had rehabilitated the girder to its original design loading capacities, according to the Australian standards published by Standards Limited (2012) entitled *Steel structures*, which further validates the retrofitting technique. The ultimate applied point load was 8.73% higher than Dekruif's [11] experimental study results for the original 120-year-old girder which had an ultimate applied point load of 501.1 kN. This further validates the retrofit and shows the need for retrofitting as Dekruif's [11] original 120-year-old girder did not reach its design load capacity. Another notable observation from the results in Figure 14 of the retrofitted 120-year-old girder is the ductility. The ductility of the girder was significantly increased with the retrofit. The retrofitted girder maintains the ultimate applied load for a longer duration before failing, whilst the original girder reaches its ultimate load and drastically loses its strength and fails. This shows that the retrofitted girder has an improved ductility.

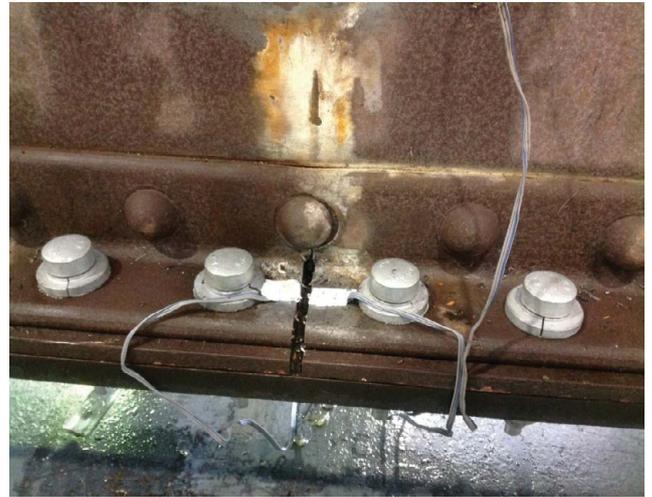
Figure 16: Artificially induced fatigue crack propagating into web of RMS 120-year-old-girder.

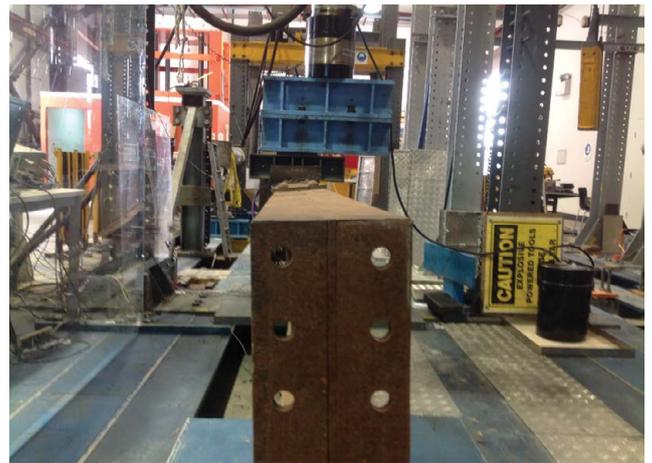
Figure 17: Distortional buckling within flange.

The failure mode of the retrofitted 120-year-old girder was due to distortional buckling within the flange and web of the girder similar to that of the new girder. Figure 17 shows the distortional buckling within the flange, whilst Figure 18 shows the distortional buckling within the web. The plated retrofit did not sustain any form of failure and helped laterally restrain the girder which is evident in Figures 17 and 18.

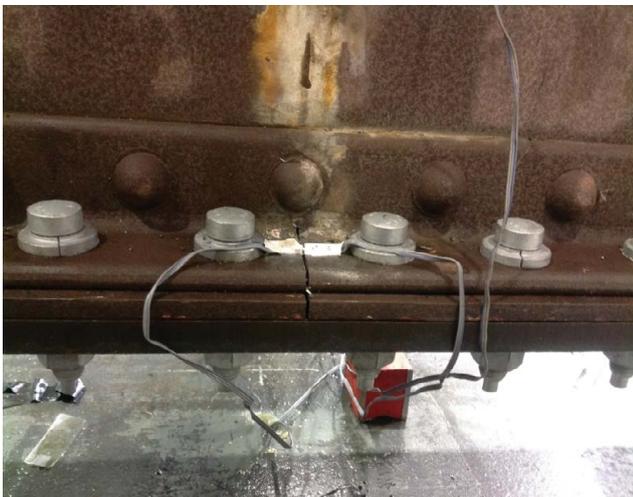
Figure 15: Artificially induced fatigue crack for RMS 120-year-old girder.

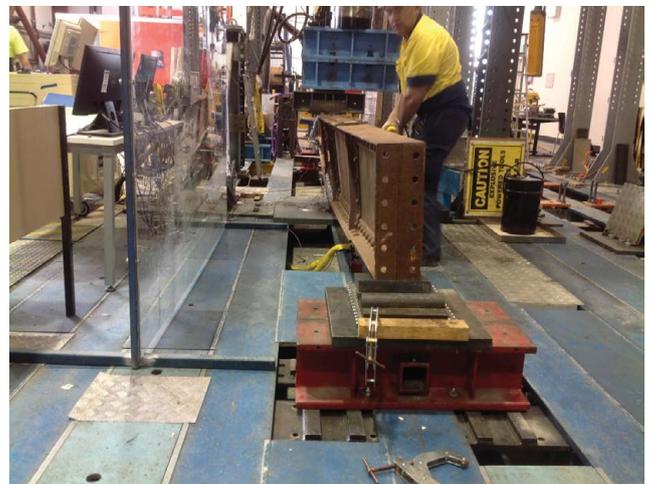
Figure 18: Distortional buckling within web.
