Repair Method of Damaged Steel Framed Structures and Ultimate Seismic State of Repaired Steel Frames

Takumi Ito* and Kenjiro Mori

Department of Architecture, Tokyo University of Science, Japan

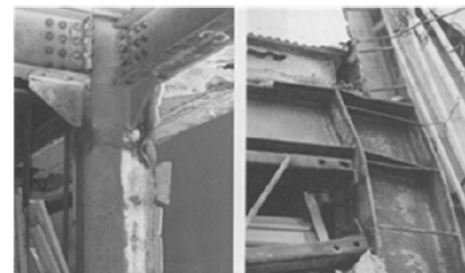
(a) Example of damaged steel frames (the Great Hanshin-Awaji Earthquake, Japan, 1995)

(b) Failure mode of steel frame

Figure 1: Failure mode of steel frames during earthquake.

When the great earthquake motions occur, a various kind of failure mode is generated on the steel framed structures as shown in Figure 1. After the plastic hinge or local buckling is formed on the members, it is desirable to repair this damaged portion. And the example of restoration method on Restoration Manual is summarized as shown in Figure 2.

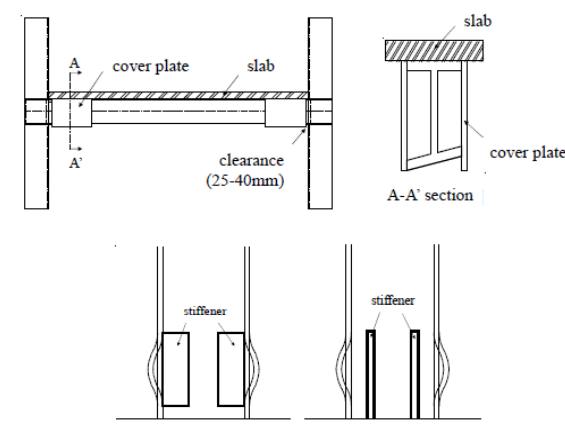
(a) H-shaped section steel members

Figure 2: Examples of restoration method of damaged steel members.

Restoration method and repairing process on damaged H-shaped steel members: From the Restoration Manual, some repair methods for damaged H-shaped steel members are indicated as shown in Figure 2a. Herein, the diagram of actual repair method is illustrated in Figure 3. This method is as follows; the damaged portion is repaired by welding cover plates to the flanges with local buckling, and a clearance of 25 mm is opened between the end plate and the edge of the cover plates. The thickness of the cover plates is equal to that of the flange plate of the H-shaped steel members.

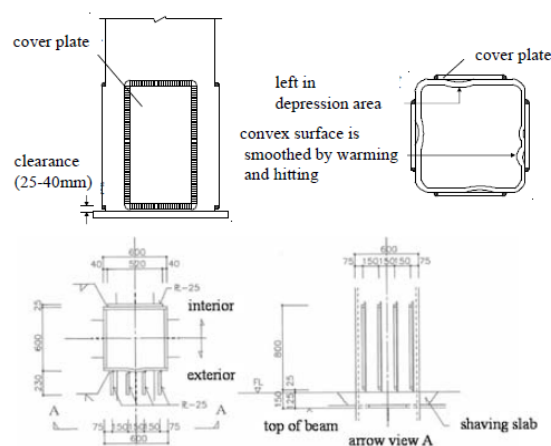
(b) Box-type steel members

Restoration method and repairing process on damaged Box-shaped steel members: From the Restoration Manual, some repair methods for damaged box-type steel members are indicated as shown in Figure 2b. This method is as follows; the surface of damaged portion is corrugated, and this convex surface is smoothed by warming and hitting. The cover plates are attached by welding, and a clearance of 25 mm is opened between the end plate and the edge of the cover plates. The thickness of the cover plates is equal to the box type steel member.

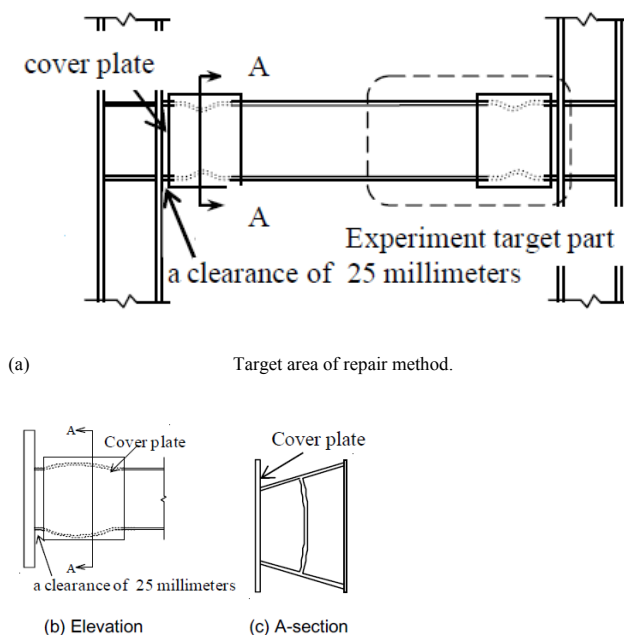
Figure 3: Diagram of restoration method of damaged H-shaped steel member.

study to investigate the applicability and reparability of the restoration method for damaged H-shaped steel member as shown in Figure 3. From the test results, the ultimate states of test specimens were observed as shown in Figure 4. And the test results of moment-angle relation were obtained as shown in Figure 5, which compares the original state and repaired member. From the test results, the ultimate state behavior was observed as follows; on the repaired steel member, the plastic hinge were formed to the side of cover plates, and the repaired portion with cover plate behaved as rocking of rigid body. And also, the strength and ductility of repaired member were improved by

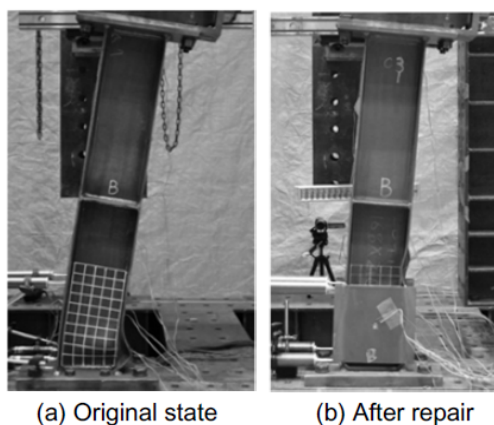
Figure 4: Ultimate state of test specimen.

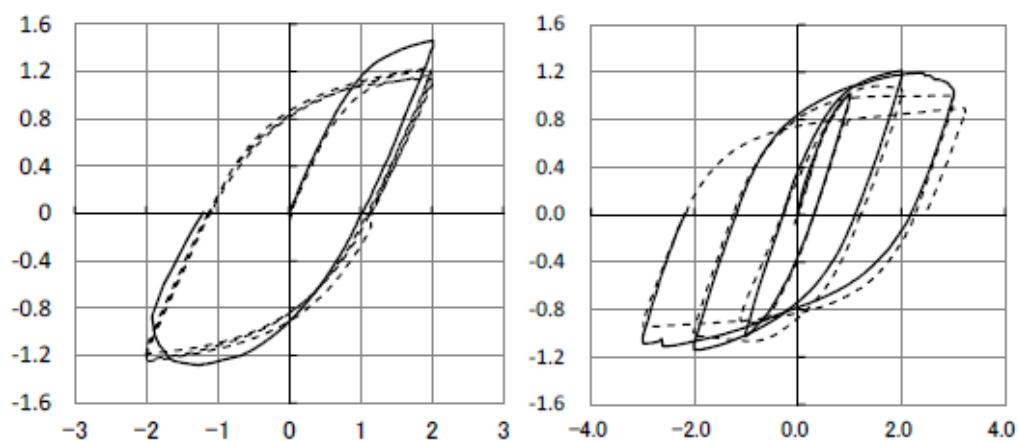
Figure 5: Comparison of test results.

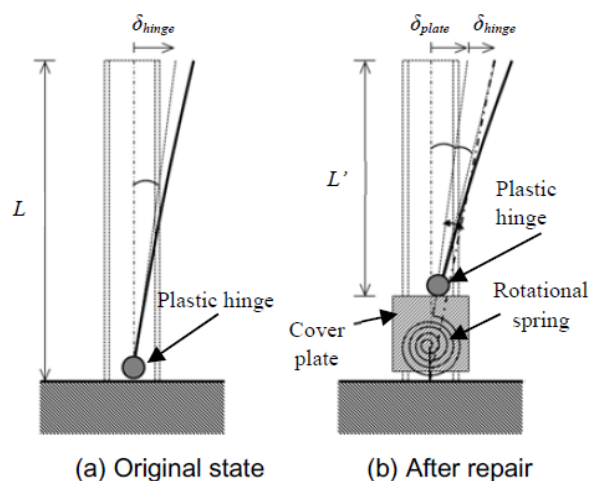
Figure 6: Assumption of analytical model.

Comparison with original state and damaged member without repair. From these considerations, the analytical models of H-shaped steel member of original and repaired state were established as shown in Figure 6. And also, the hysteresis models during inelastic cyclic loading were applied with Skeleton Shift Model as shown in Figure 7. And the comparison of test results and analytical results are presented in Figure 8, and it can be said that the proposed analytical model can chase the test results well.

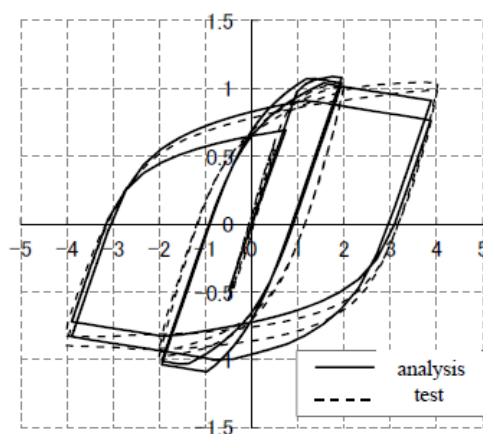
Figure 8: Comparison of test and analytical results.

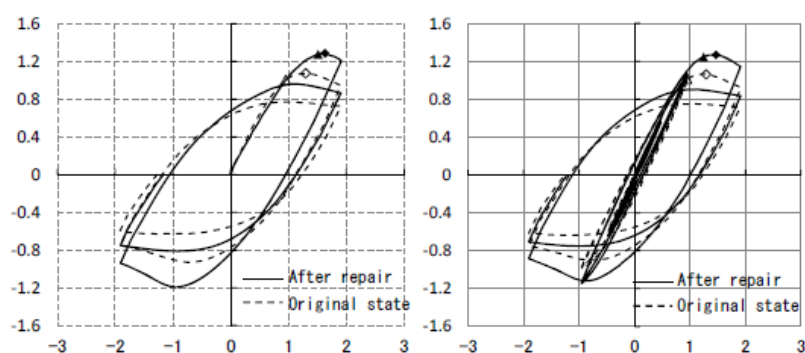
Figure 10: Comparison of test results.

in Figure 4. From the test results, the ultimate states of test specimens were observed as shown in Figures 8 and 9. And the test results of moment-angle relation were obtained as shown in Figure 10, which compares the original state and repaired member. From the test results, the ultimate state behavior were observed as follows; on the repaired steel member, the plastic hinge were formed to the side of cover plates, and the repaired portion with cover plate behaved as rocking of rigid body. And also, the strength and ductility of repaired member were improved by comparison with original state and damaged member without repair. From these considerations, the analytical model of box type steel member of original and repaired state was established as shown in Figure 11. And also, the hysteresis model during inelastic cyclic loading was applied with Skeleton Shift Model as shown in Figure 8 too. And the comparison of test results and analytical results are presented in Figure 12, and it can be said that the proposed analytical model can chase the test results well.

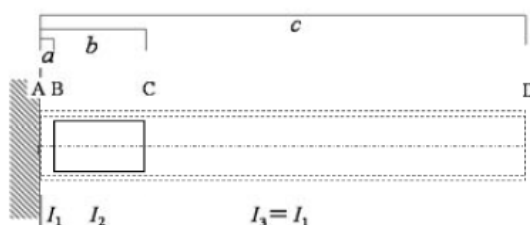
Figure 11: Assumption of analytical model.

H-shaped steel girder and Box type steel column. Generally, the failure mode of ultimate seismic state after large seismic input are formed as shown in Figure 13, in which the plastic hinges are generated on the end of most girder and few column end. The restoration method above mentioned (see 5.1) is adopted on this plastic hinge, the frame after repair is illustrated as shown in Figure 13a, and also the analytical model of the frame can be given as Figure 13b. Furthermore, the restoring force characteristics model of this repaired member can be referred with model as shown in Figures 7, 8 and 11.

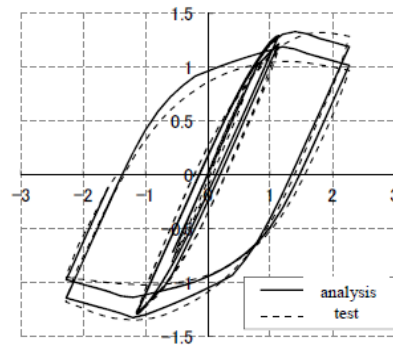
Figure 12: Comparison of test and analytical results.

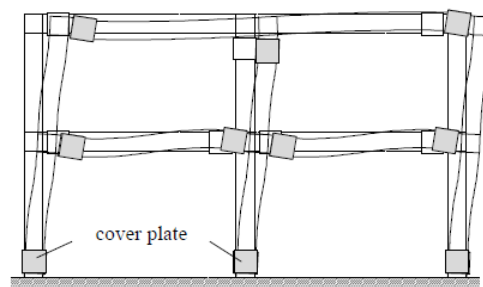
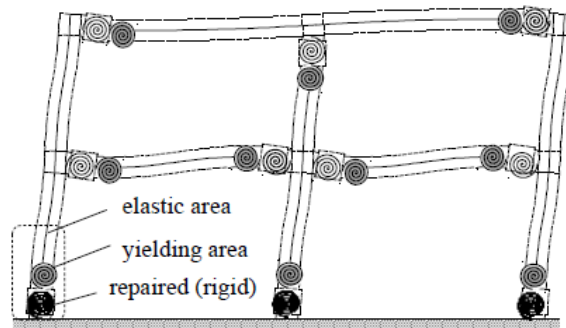
(a) Steel frame after repair.

(b) Analytical model of repaired frame

Figure 13: General diagram of steel frame after repair.

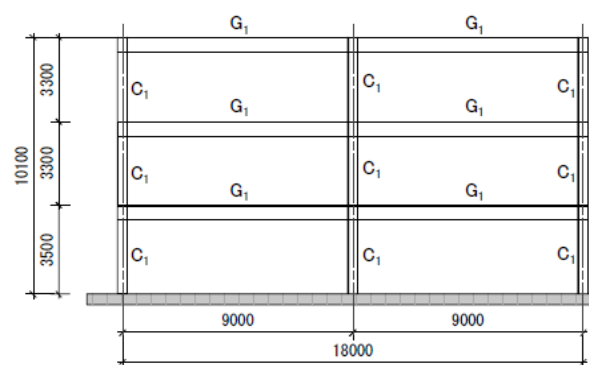
Figure 14: Analytical model of 3-story 2-bay steel frame.

Herein, by use of proposed analytical model above mentioned, the ultimate seismic behavior and seismic resistant performance of repaired steel frame are discussed. A 3-story 2-bay steel moment-resisting frame shown in Figure 14 is studied hereafter. The member properties are as follows; moment of inertia, beam = $9.28 \times 10^8 \text{ mm}^4$, column = $7.56 \times 10^8 \text{ mm}^4$, plastic moment capacity, beam = 1,182 kN m, column = 682 kN m, and floor weights are 0.29M (2nd, 3rd), 0.42
