ATP Measurement in the Last Rinse Water of Automated Washer-Disinfectors: The Added Value of Every Load Monitoring

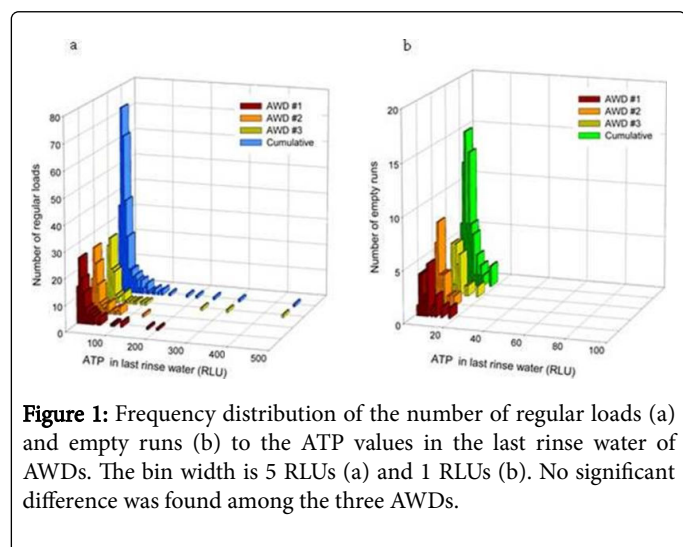
ATP values from regular loads ranged between 2 and 452 RLUs, with a median value [I quartile; III quartile] of 12[7;22] RLUs. The frequency distribution histograms of the whole regular load dataset and of each single AWD are shown in Figure 1a. The non-normal distribution of data is obvious and was confirmed by Shapiro-wilk test showing non-normality for both ATP ($p < 0.001$) and logATP values ($p < 0.001$). Half of the ATP values was between 7 and 22 RLUs, nevertheless 9 (3.1%), 4 (1.3%), 2 (0.7%), and 1 (0.3%) out of the 287 measurements performed on regular loads were above 100, 200, 300, and 400 RLUs, respectively.

No significant difference among the three AWDs was found for ATP of regular loads (Figure 1a) and empty runs (Figure 1b). In a summary, Figure 1 and Table 1 demonstrated that the ATP values of the three AWDs were comparable.

Inspection of the Table 1 and Figure 1 indicates that the three AWDs generated comparable results in terms of ATP value of empty runs and regular loads. This made it possible to accumulate the result of the three AWD and to analyse if the kind of load and the loading method influenced the ATP readings. Figure 3b indicates that surgical instruments were associated to the highest ATP levels and the anaesthesia devices to the lowest. Generally, the biological load on an instrument used for surgery is higher than the contamination on the anaesthesia equipment. The cannulated instruments generated values in between the surgical and anaesthesia loads. The inner surface of these devices cannot be easily assessed by visual inspection or tested. Consequently more information of inner surfaces has to be acquired.

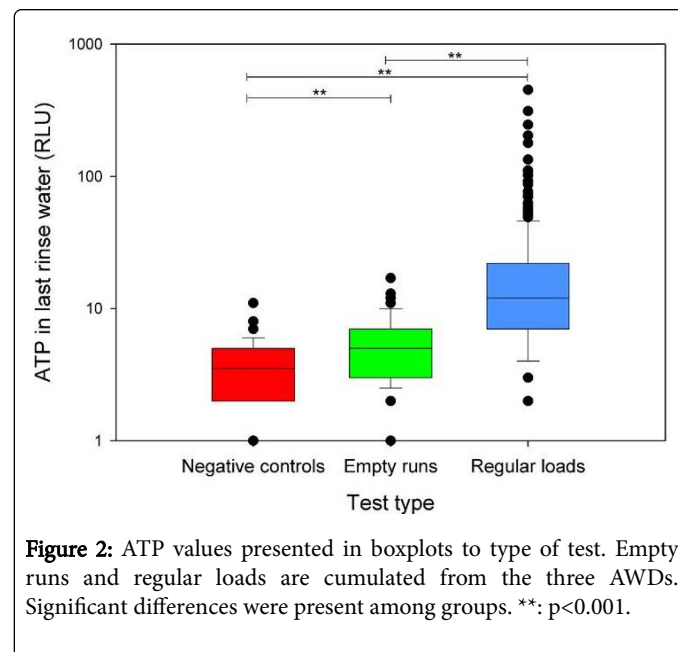
Considering that no significant difference was obtained among the three AWDs, collected data were accumulated and then compared according to test type. ATP values from negative controls and empty runs showed a median value [I quartile; III quartile] of 4[2;5] RLUs and 5[3;7] RLUs, respectively. When compared to regular loads, ATP values from negative tests and empty runs differed significantly ($p < 0.001$) (Figure 2).

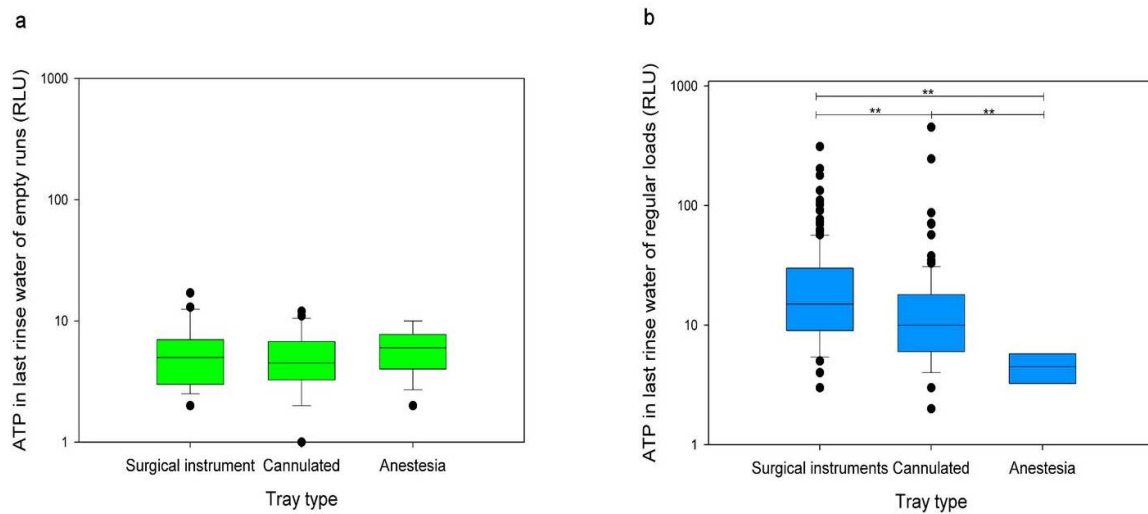
Figure 3: ATP results from empty loads (green) and regular loads (blue) grouped according to the tray type used in the AWD cycle. Significant differences among groups were found only when load was processed. **: p<0.001.

The use of different loading trays (Figure 3a) or different AWD programs (Figure 4a) during empty runs did not determine different ATP results (Table 1). However, grouping ATP values from regular loads according to the loading tray (Figure 3b) or to the AWD program (Figure 4b) resulted in significant differences.

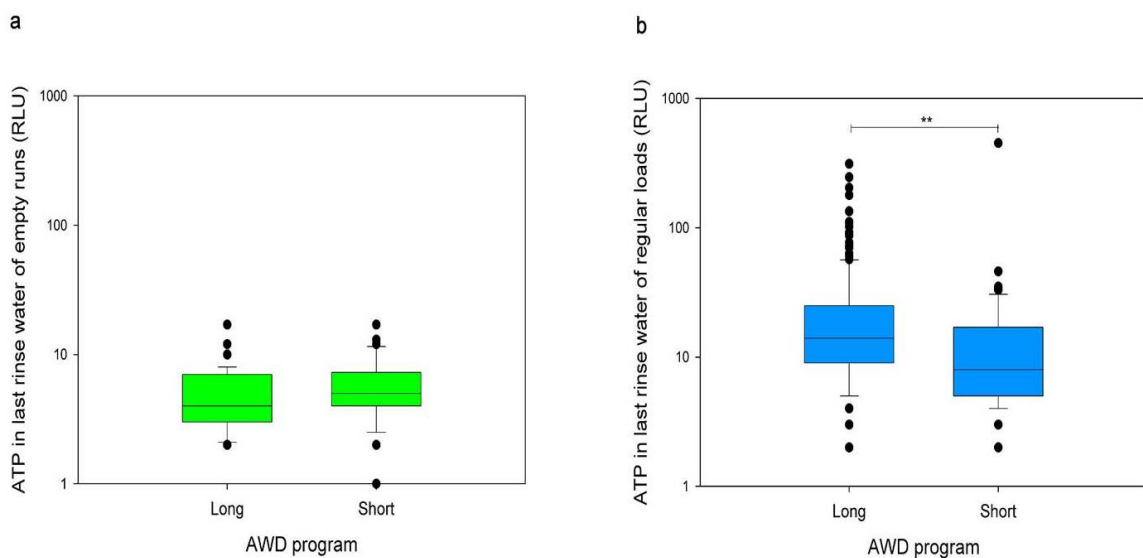
Figure 4: ATP results from empty loads (green) and regular loads (blue) grouped according to the AWD program used in the AWD cycle. Significant differences among groups were found only when load was processed. **: p<0.001.

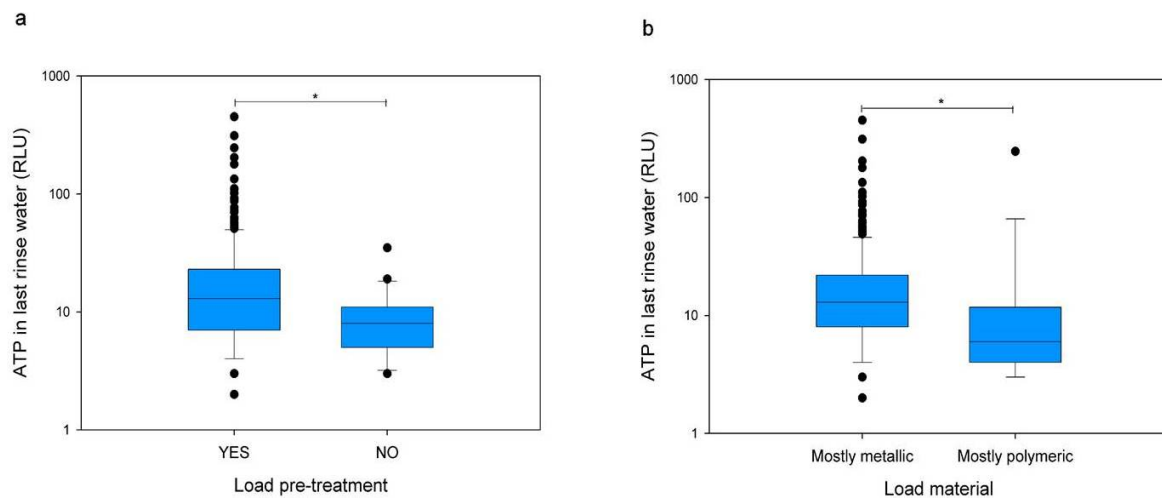
Figure 5: ATP results from regular loads grouped according to load pre-treatment (a), or load material (b). Significant differences were present among groups. **: $p < 0.001$.

In Figure 5, the results of load pre-treatment or not, and the kind of material processed are presented. The significant differences between groups demonstrate a trend that the higher the initial contamination (i.e., instruments needing for pre-treatment) the higher the ATP results (Figure 5a). The results in Figure 5b indicate that the metallic devices

generated significantly higher ATP values than polymeric devices (Figure 5b). By considering the amount of load processed by the AWD, a trend can be recognized that the more load the higher the ATP results (Figure 6).

A closer inspection of the accumulated results in Figure 5a indicates that instruments with a pre-treatment before processing in an AWD have higher ATP value than not pre-treated instruments. This might be caused by the fact that these instruments contain more bioburden than the normal contaminated instruments. Therefore these instruments are pre-treated before being processed in an AWD. A similar tendency is recognized between the long process (for dirty instrument) and the short process cycle (Figure 4b). The amount of ATP appears also to be influenced by the amount of load: the more load, the higher the ATP value (Figure 6). This could have potential application for defining the optimal load amount into the AWD, having a quantitative indicator to avoid overloading of the machine. Material of instruments seems to influence the ATP value as well. Loads containing more of polymeric than metallic (stainless steel) instruments show lower ATP readings (Figure 5b). Micromorphology and chemistry at the device surface may play a role on this. To find a correlation on this topic, a study is necessary in which the surface is investigated more in detail. Indeed, a limitation of the study is the absence of randomization in assigning the loads to the various subgroups. According to the observational design of the study, the choice of applying or not a pre-treatment to the load and the selection of the AWD washing protocol was related to the device to be processed (protocols were designed according to indications of the device manufacturers and were already established before data collection) and to the experience of the CSSD operators in evaluating the difficulty in cleaning and disinfecting the specific load.

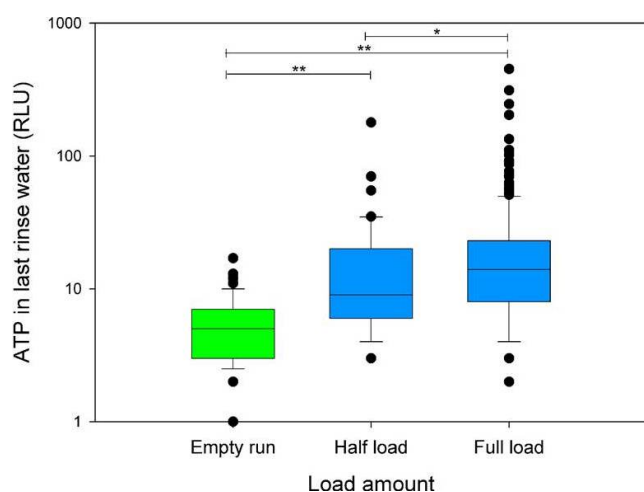
Figure 6: ATP results from regular loads (blue) and empty runs (green) grouped according to load amount. Significant differences were present among groups. **: $p < 0.001$, *: $p < 0.05$.
