Case Report after Introducing a New Abutment Surface for Bone Anchored Hearing Implants: Hydroxiapatite Abutment Surfaces and Skin Reaction

Department of Otorhinolaryngology, Karolinska University Hospital, Stockholm, Sweden

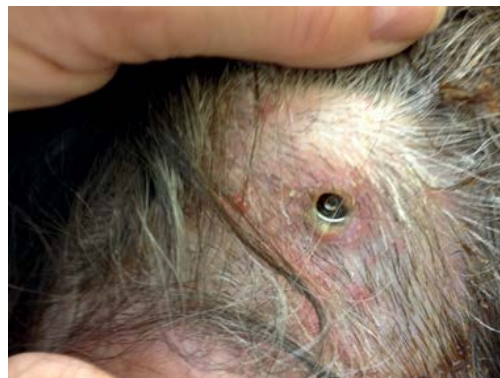
Patient A, with a pituitary adenoma and a mixed hearing loss (MHL), had already at time for the post-operative appointment an infection with a skin overgrowth and pus (Figure 1). The 10 mm abutment was directly changed to a 12 mm, after opening the skin with a small incision in an out-patient procedure. The patient was given antibiotics post-operation. The skin around this coated abutment was continuously infected and painful even though intensive skin care and antibiotics systemically and locally were given and stayed in place for 3 months, before it had to be removed. She had to use her processor on a headband during the treatment. Samples showed growth of *Staphylococcus aureus*. Another alternative with a transcutaneous system was introduced.

Figure 1: One week after implantation with a hydroxiapatite abutment the skin showed partly overgrowth. The skin was opened as a revision surgery and the 10 mm abutment was switched to a 12 mm.

Already after 7 days the abutment was overgrown in patient A and after 1 month in patient D. Their abutments were changed to longer ones. No explanation could be identified. No solution to the following repeated skin infections, starting at different time period after surgery, was found among all patients using the hydroxiapatite abutments. Bacterial samples were taken in 6 of the implanted persons, and in 3 of them *Staphylococcus aureus* were growing while the rest showed no growth. These bacteria are commonly reported in skin infections surrounding implants [17]. A lot of explanations for the increase in peri-implant infections surrounding the hydroxiapatite abutment surface came forward during discussions, among them different care or contamination during the surgical procedure which both could be removed as arguments. The gender with 7 females can be discussed as well as a skin related underlying disease (Wegener's disease) which was present in one woman. However, this patient was among the 2 who was still using the same abutment after 1 year.

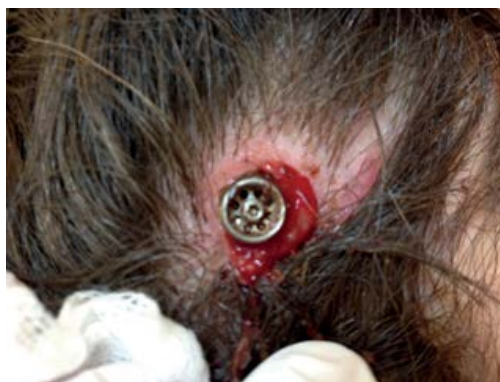
Patient C, who suffers from Turner syndrome and had a conductive hearing loss, had after 3 month a severe and aching peri-implant infection. She had a lot of pain and could not touch the area nor cleans it and could not sleep on the implanted side (Figure 2). She had a massive amount of hair and the hair was constantly gluing to the infected skin area with pus. After both revision surgery, removing of hair around the area and conservative treatment, the clinical signs of infection grew worse and the abutment had to be removed after 5 months. Patient C had another system introduced, but after 1 year she wanted to have also this implant removed, because she did not feel any hearing gain by the processor in her study situation.

Figure 2: Severe peri-implant infection 3 month after implantation showing a Holgers' scale 4.
