Alloying of Steel and Graphite by Hydrogen in Nuclear Reactor

Evgenii Krasikov*

National Research Centre Kurchatov Institute 1, Kurchatov Sq, Moscow 123182, Russia

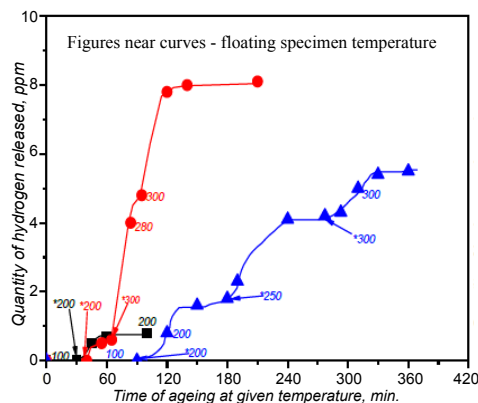
Figure 1: IPH degasation kinetics for irradiated steel ($4,5 \times 1020\text{cm}^2$ at 140°C).

Degasation kinetics is plotted in Figures 1 and 2.

As one can see from Figure1 that RIH discharge starts when heating temperature exceeds the irradiation temperature. It means that RIH is accumulated in radiation defects (traps).

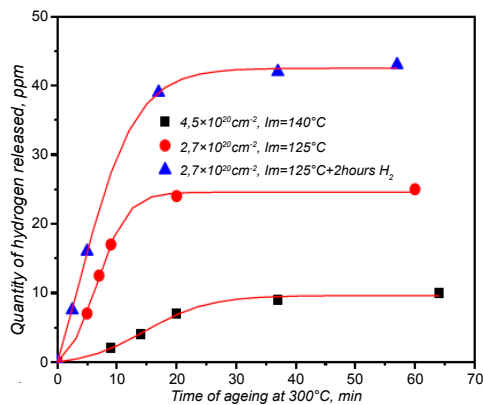
Figure 2: Hydrogen degasation kinetics for irradiated and irradiated+hydrogenated steel.

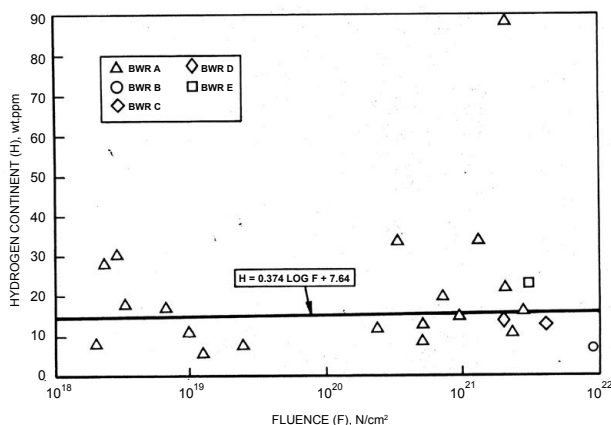
Figure 3. IPH content in 304 SS versus FNF ($E>1\text{ MeV}$).

concentrations in stainless steels irradiated in BWR type reactors (Figure 3) and high generations of hydrogen and helium in nickel [5,6].
