# An Implantable Pressure Sensor for Long-term Wireless Monitoring of Cardiac Function- First Study in Man

Henrik Casimir Ahn<sup>1\*</sup>, Baz Delshad<sup>1</sup> and Jacek Baranowski<sup>2</sup>

<sup>1</sup>Department of Cardiothoracic Surgery, Institution of Medical and Health Sciences, Linköping University, Linköping, Sweden

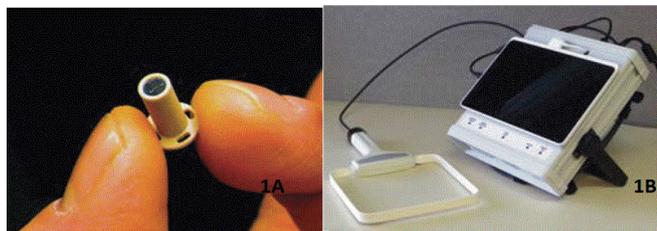
**Figure 1:** a) An 18 mm implant. The sensor is at the distal end, and the proximal part has a flange with 4 holes for fixation sutures. b) shows an antenna and a tablet pc on a read-out unit. With the permission of ISS Inc.

The wireless implantable hemodynamic monitor system Titan™ (ISS Inc., MI, USA) comprises two parts; an implantable, telemetric sensor (no implanted power source/battery is required) and an extracorporeal companion readout electronics and user interface (Figure 1). There is

no physical connection between the implant and the rest of the system (extracorporeal components). Using radio frequency (RF) magnetic telemetry, the receiver transmits power to the sensing implant and communicates with it. The RF interface requires very little power. The wireless communication transmits detailed cardiac pressure waveforms and implant information such as implant power enabling advanced dynamic power transmission.

The miniature implant has two main components; polyether ketone housing and a cylindrical pressure-sensing probe placed inside. The probe contains a miniature micro-electromechanical pressure sensor along with custom electronics and a telemetry antenna.

An important feature of the implant is that the pressure sensing element is located at the distal flat side of the cylindrical implant. This small flat side is the only part of the implant that must be placed within the vessel whose pressure is to be monitored. There are 4 implant lengths between 18 and 30 mm and the implant is secured in place with sutures through 4 small holes in a flange at the proximal end of the housing.

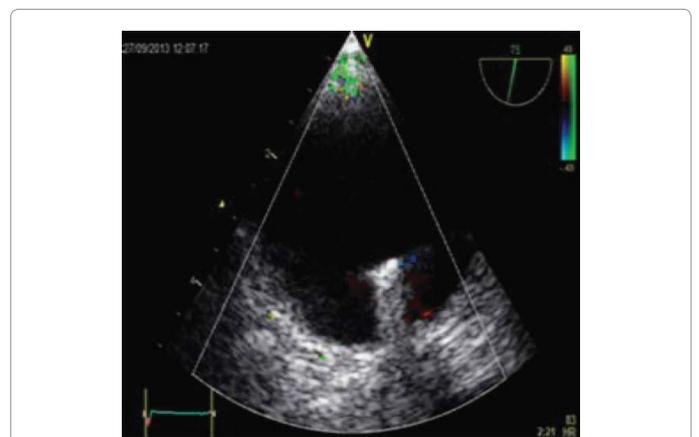
**Figure 2:** Echocardiographic image of a sensor implanted in the left atrium.

An adequate position free from the wall of the pulmonary vein or atrium was confirmed with ultrasound (Figure 2). A standard LA fluid-filled reference catheter was inserted and simultaneous baseline sensor and reference catheter measurements were made to confirm agreement, as with the LV sensor. After closure of the surgical incision repeated recordings were performed to confirm reproducibility of the pressure recordings. The length of time the reference LA catheter was left in place depended on the patient's hemodynamic condition.

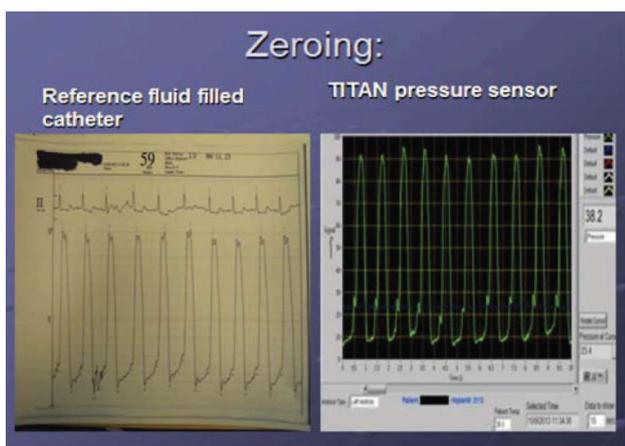
**Figure 3:** Intraoperative recording after implant of the pressure sensor in the LV after TAVR. The curves from the reference catheter (left panel) and pressure sensor (right panel) have the same waveform and pressure values.

All sensors were successfully implanted within 15 min regardless of LA or LV location. Figure 3 shows concomitant recordings from fluid filled catheter as reference and sensor pressure at the end of TAVR in our first patient. They have very similar waveform and pressure values. There was no need for calibration of the sensor in this patient or in any of the cases with LA or LV implants.

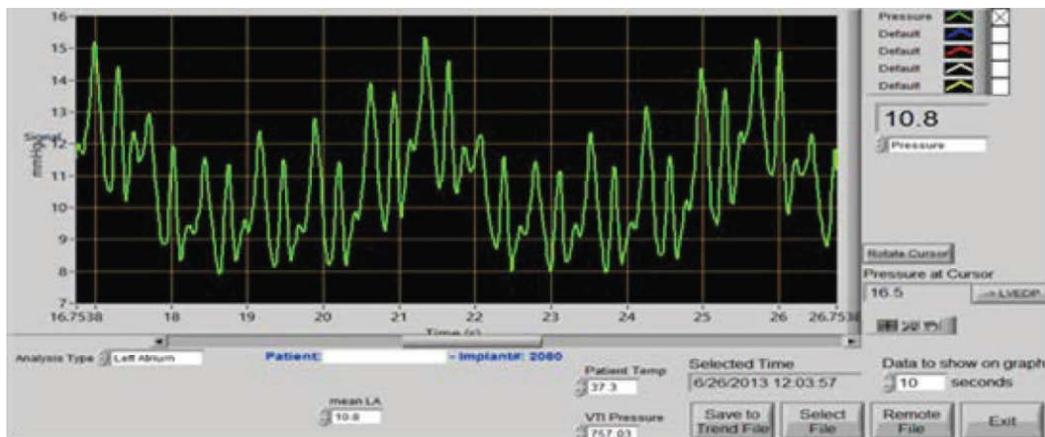
**Figure 4:** Pressure curve from a LA implant. The baseline variation correlates with the patient's breathing. Mean value is calculated by the software. ISS inc. Lab View-software.

Figure 4 shows an original LA pressure recording from the sensor after open chest cardiac surgery with baseline variation synchronous with the patient's respiration.

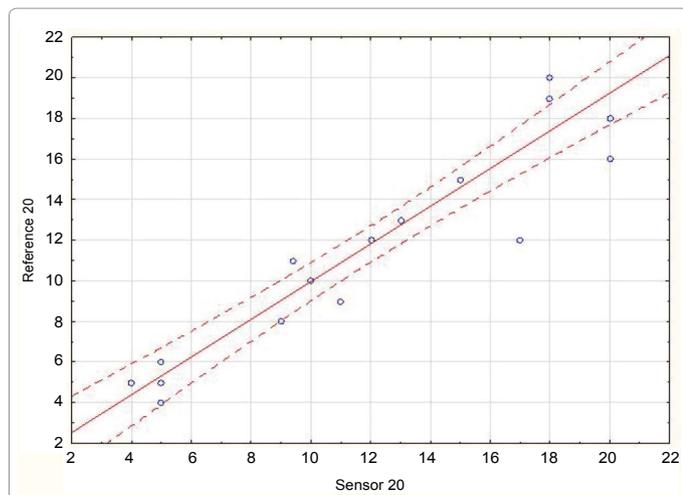
**Figure 5:** Correlation between initial intraoperative sensor pressure and reference values from a fluid-filled catheter. There was a good correlation ( $r=0.96$ ,  $p<0.001$ ). The dotted lines indicate 95% confidence interval.

The sensor recordings from the implant in the LA in 16 patients were compared with the LA pressure measurements with a routinely used fluid-filled catheter. Initial intraoperative sensor pressure and reference values from the fluid-filled catheter showed a significant linear correlation without the need for calibration of the sensor output (Figure 5).
