ATP Measurement in the Last Rinse Water of Automated Washer-Disinfectors: The Added Value of Every Load Monitoring

Francesco Tessarolo^{1,2*}, Lorna Valentinotti³, Giuliano Mariotti⁴, Andrea Ziglio⁴, Marta Rigoni², Giandomenico Nollo^{1,2} and Josephus PCM van Doornmalen Gomez Hoyos⁵

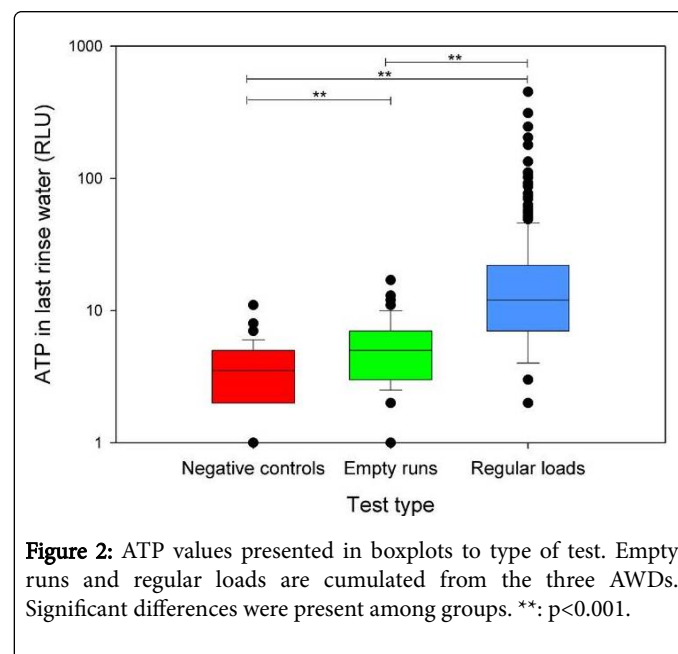
Considering that no significant difference was obtained among the three AWDs, collected data were accumulated and then compared according to test type. ATP values from negative controls and empty runs showed a median value [I quartile; III quartile] of 4[2;5] RLUs and 5[3;7] RLUs, respectively. When compared to regular loads, ATP values from negative tests and empty runs differed significantly ($p < 0.001$) (Figure 2).

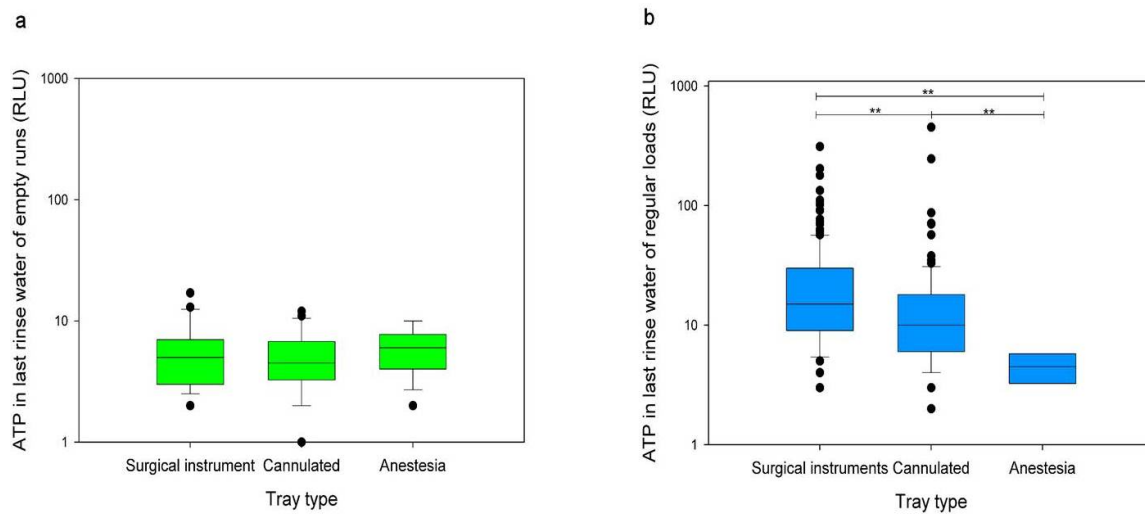
Figure 3: ATP results from empty loads (green) and regular loads (blue) grouped according to the tray type used in the AWD cycle. Significant differences among groups were found only when load was processed. **: p<0.001.

The use of different loading trays (Figure 3a) or different AWD programs (Figure 4a) during empty runs did not determine different ATP results (Table 1). However, grouping ATP values from regular loads according to the loading tray (Figure 3b) or to the AWD program (Figure 4b) resulted in significant differences.

Inspection of the Table 1 and Figure 1 indicates that the three AWDs generated comparable results in terms of ATP value of empty runs and regular loads. This made it possible to accumulate the result of the three AWD and to analyse if the kind of load and the loading method influenced the ATP readings. Figure 3b indicates that surgical instruments were associated to the highest ATP levels and the anaesthesia devices to the lowest. Generally, the biological load on an instrument used for surgery is higher than the contamination on the anaesthesia equipment. The cannulated instruments generated values in between the surgical and anaesthesia loads. The inner surface of these devices cannot be easily assessed by visual inspection or tested. Consequently more information of inner surfaces has to be acquired.

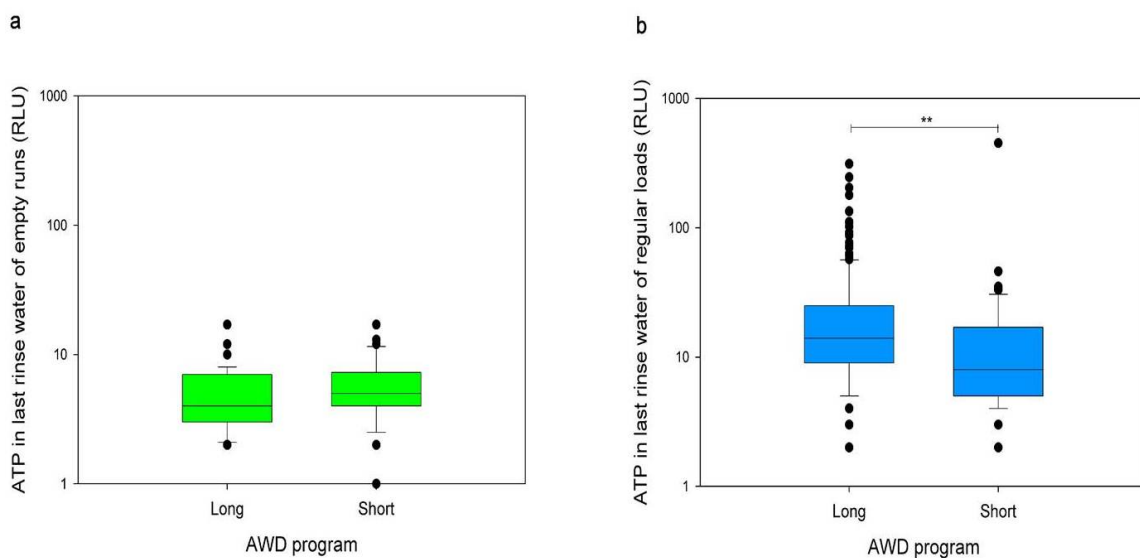
Figure 4: ATP results from empty loads (green) and regular loads (blue) grouped according to the AWD program used in the AWD cycle. Significant differences among groups were found only when load was processed. **: p<0.001.
