Heterotopic Ossification of the Humerus

Case Presentation

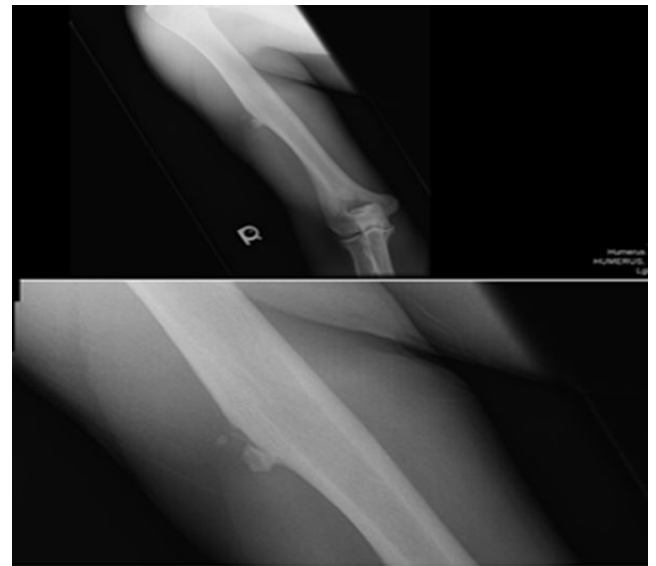
Figure 1: Anterior-to-posterior radiograph of the humerus demonstrating heterotopic ossification at the deltoid tuberosity.

The humerus series demonstrated a significant amount of HO located over the deltoid tuberosity as demonstrated in Figure 1. The patient was then referred to an orthopedic surgeon for follow on care and consultation with instructions to resume activity to tolerance.
