Self-induced Pacemaker Mutilation Three Months Post Implant

Raffaele Corbisiero*, David Muller RN, Matthew Levy DO and Rebecca Armbuster DO

Department of Cardiology, Electrophysiology Division, Deborah Heart and Lung Center, USA

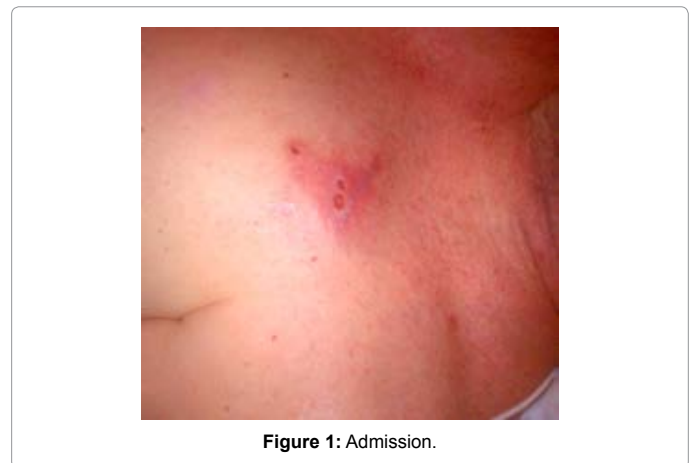
At that time, the patient was transferred to our facility for further treatment and management of his pacemaker. Upon our evaluation, the patient was noted to have a series of lesions on the left anterior chest wall, mid-clavicular region overlying his pacemaker pocket. Three traumatic bruises were noted (Figure 1). Two discrete sites of superficial trauma were located just beneath the original, well-healed incision, with the lateral site being somewhat larger. There was also one additional site of trauma inferior to the above which appeared less healed. The remainder of the skin in the region was intact, with mild erythema in a triangular shape noted with the original device incision serving as the apex. No open skin was noted at this time, nor was there exposure of any device components.

Figure 1: Admission.

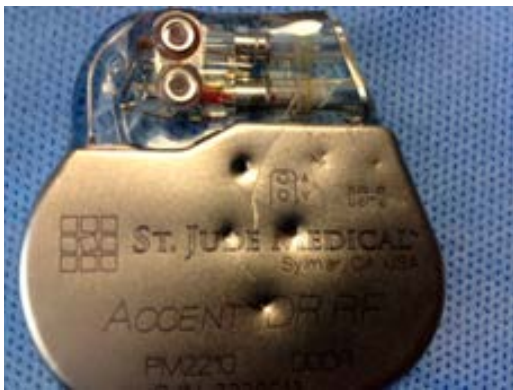
After local anesthetic infiltration, an incision was made over the previous scar. No purulent discharge was noted in the pocket and additional wound cultures were obtained. The device was retrieved and upon visual inspection, a total of 6 indentations of a well-circumscribed nature were noted on the anterior aspect of the can (Figure 2). Two of the six indentations penetrated the titanium case and one caused a concave protrusion on the deep posterior aspect of the can, almost

penetrating both the front and back of the titanium casing. The pulse generator was then disconnected from the can.

Figure 2: Front view of can post explant. Arrows indicate penetration of titanium Pulse generator case.

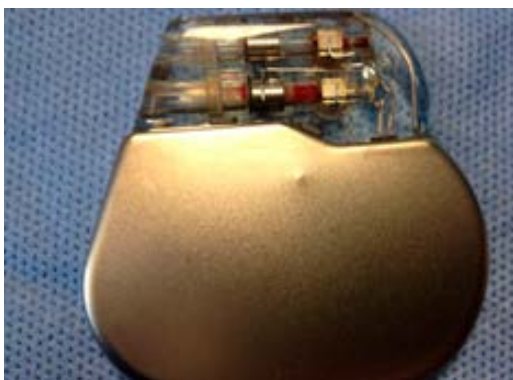
Upon inspection of the leads, no apparent damage was visually detected. Checking lead integrity through the pacing system analyzer revealed an electrically compromised right ventricular lead. The atrial lead was intact and provided adequate pacing, sensing, and impedance. Subsequently the right ventricular lead was extracted and a new 1888T lead (St Jude Medical Sylmar, CA) was placed into the right ventricular outflow tract. To discourage future attempts to damage the device, the new pulse generator was placed in a deep sub-pectoral pocket and the incision was closed (Figure 3).

Figure 3: Rear view of can post explant Arrow indicates protrusion from impact through pulse generator.

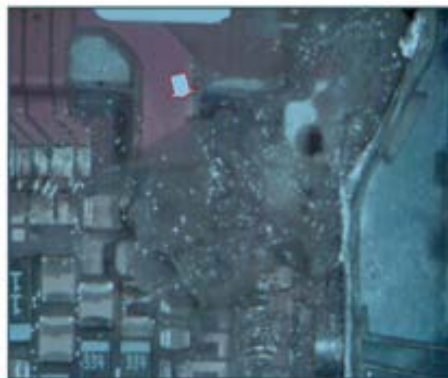
The manufacturer's analysis reported puncture holes noted on the device casing. The superior penetration was noted on top of the battery (Figure 4). Excessive body fluids were noted inside of the device casing and on the circuitry (Figure 5). Electrical tests were performed and indicated that the pacemaker had no output and no telemetry was possible with a 500 ohm load at 42°C. Additional attempts to measure output using an oscilloscope also demonstrated no output. It was felt these failures were due to excessive body fluids that caused shorting to the device circuitry. The extracted lead suffered a breach of the insulation.

Figure 5: Opened can with body fluids inside of titanium case and noted on the hybrid.
