Self-induced Pacemaker Mutilation Three Months Post Implant

Keywords: Attempted suicide; Ideation diagnosis; Pacemaker

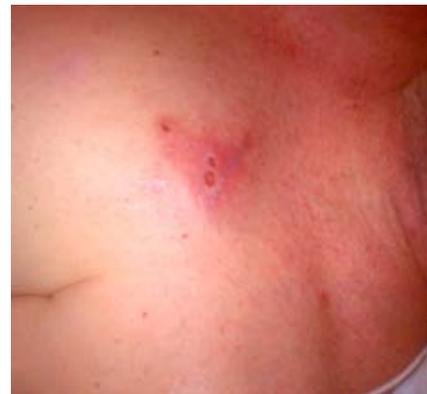
At that time, the patient was transferred to our facility for further treatment and management of his pacemaker. Upon our evaluation, the patient was noted to have a series of lesions on the left anterior chest wall, mid-clavicular region overlying his pacemaker pocket. Three traumatic bruises were noted (Figure 1). Two discrete sites of superficial trauma were located just beneath the original, well-healed incision, with the lateral site being somewhat larger. There was also one additional site of trauma inferior to the above which appeared less healed. The remainder of the skin in the region was intact, with mild erythema in a triangular shape noted with the original device incision serving as the apex. No open skin was noted at this time, nor was there exposure of any device components.

Figure 1: Admission.

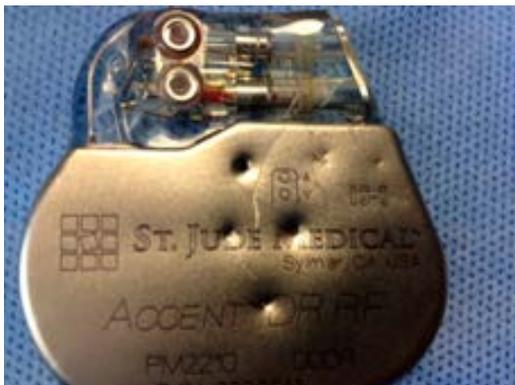
After local anesthetic infiltration, an incision was made over the previous scar. No purulent discharge was noted in the pocket and additional wound cultures were obtained. The device was retrieved and upon visual inspection, a total of 6 indentations of a well-circumscribed nature were noted on the anterior aspect of the can (Figure 2). Two of the six indentations penetrated the titanium case and one caused a concave protrusion on the deep posterior aspect of the can, almost

Figure 2: Front view of can post explant. Arrows indicate penetration of titanium Pulse generator case.

Multiple attempts at device interrogation proved unsuccessful, thus the decision was made to replace the device. Due to the patient's tenuous, agitated, and at times aggressive psychiatric state with residual suicidal ideation, it was decided that the procedure should be performed under general anesthesia to better protect the patient's airway. Broad Spectrum Intravenous antibiotics were administered as blood cultures from the transferring facility were still pending. We obtained a CBC which demonstrated normal WBC, coagulation and repeat blood cultures. Due to the patient's unstable mental status and agitation compounded with his unstable hemodynamic condition, it was decided a temporary pacemaker would not be tolerated. After discussions with the patient's power of attorney, it was decided to replace the generator and or leads as needed.

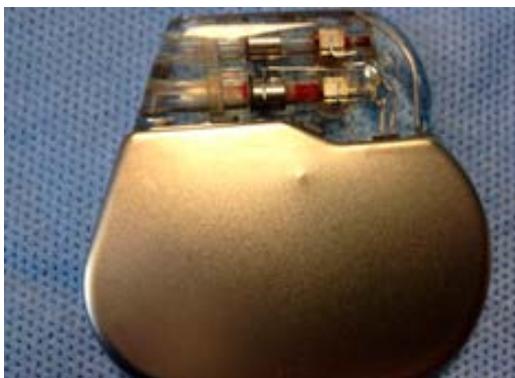
penetrating both the front and back of the titanium casing. The pulse generator was then disconnected from the can.

Figure 3: Rear view of can post explant Arrow indicates protrusion from impact through pulse generator.

Upon inspection of the leads, no apparent damage was visually detected. Checking lead integrity through the pacing system analyzer revealed an electrically compromised right ventricular lead. The atrial lead was intact and provided adequate pacing, sensing, and impedance. Subsequently the right ventricular lead was extracted and a new 1888T lead (St Jude Medical Sylmar, CA) was placed into the right ventricular outflow tract. To discourage future attempts to damage the device, the new pulse generator was placed in a deep sub-pectoral pocket and the incision was closed (Figure 3).

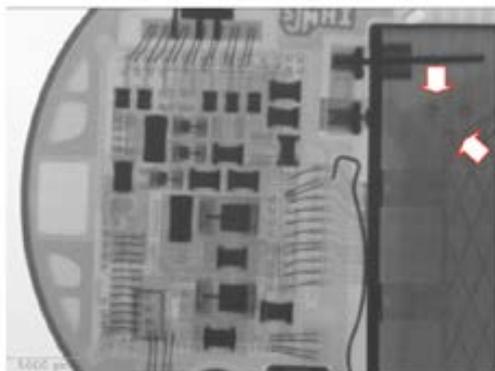
The manufacturer's analysis reported puncture holes noted on the device casing. The superior penetration was noted on top of the battery (Figure 4). Excessive body fluids were noted inside of the device casing and on the circuitry (Figure 5). Electrical tests were performed and indicated that the pacemaker had no output and no telemetry was possible with a 500 ohm load at 42°C. Additional attempts to measure output using an oscilloscope also demonstrated no output. It was felt these failures were due to excessive body fluids that caused shorting to the device circuitry. The extracted lead suffered a breach of the insulation.

Figure 4: X-Ray of can post implant. Arrows indicate punctures on top of Battery.

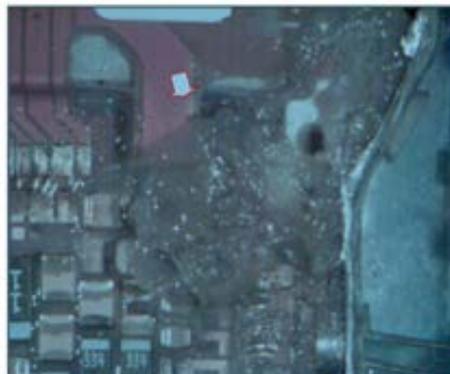
Figure 5: Opened can with body fluids inside of titanium case and noted on the hybrid.
