Self-Recovering Section of RPV Steel Radiation Embrittlement Kinetics as Indication of Material Smart Behavior

Abstract

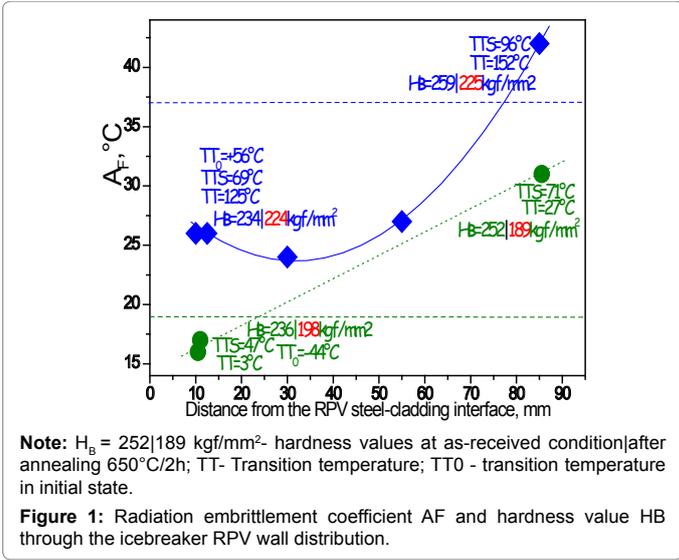
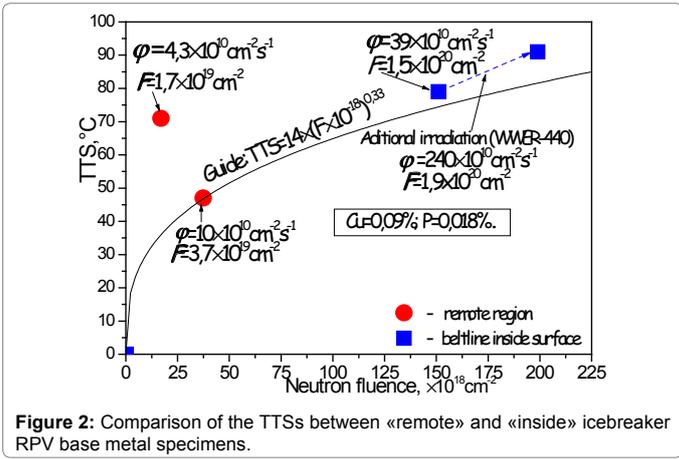
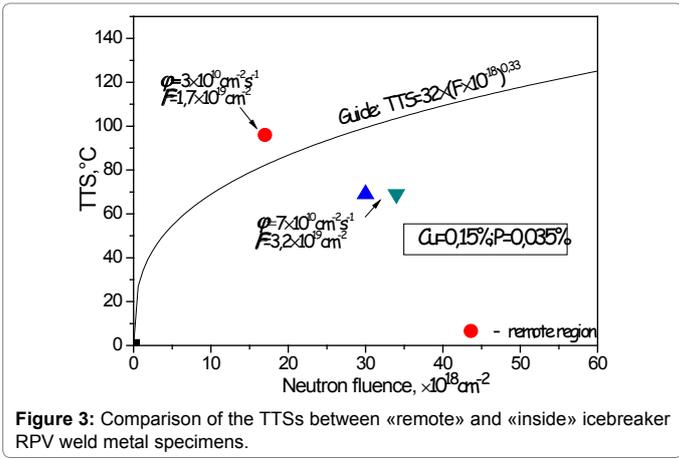
The unexpected results of the icebreaker RPV weld and base metal studying are given in Figure 1, where one can recognize that the actual (measured) radiation embrittlement coefficients of the trepan materials for the periphery (remote) zone of the vessel are significantly higher than for the inner part. One can see also that hardness measurement and Charpy impact testing results agree.

First impression from foregoing decommissioned PWR pressure vessel material properties study- enhanced degradation rate at low neutron fluxes. Examples for icebreaker base metal and weld metal are demonstrated in Figures 2 and 3. Registered facts denote that known as «flux effect» factor was in action. Unexpected circumstance however is reduced embrittlement zone appearance that follows after of previous part of enhanced embrittlement. It is seen by means of TTS on neutron flux and fluence dependencies observation.

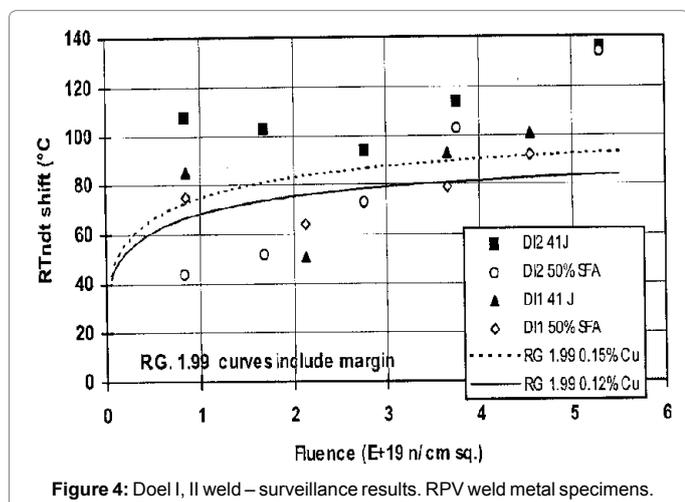
Figure 4: Doel I, II weld – surveillance results. RPV weld metal specimens.

For the sake of correctness, it is necessary to underline that the first mention concerning distinction between test reactors and low-lead-factor (surveillance) data had appeared as early as 1980 (Figure 4) [3].

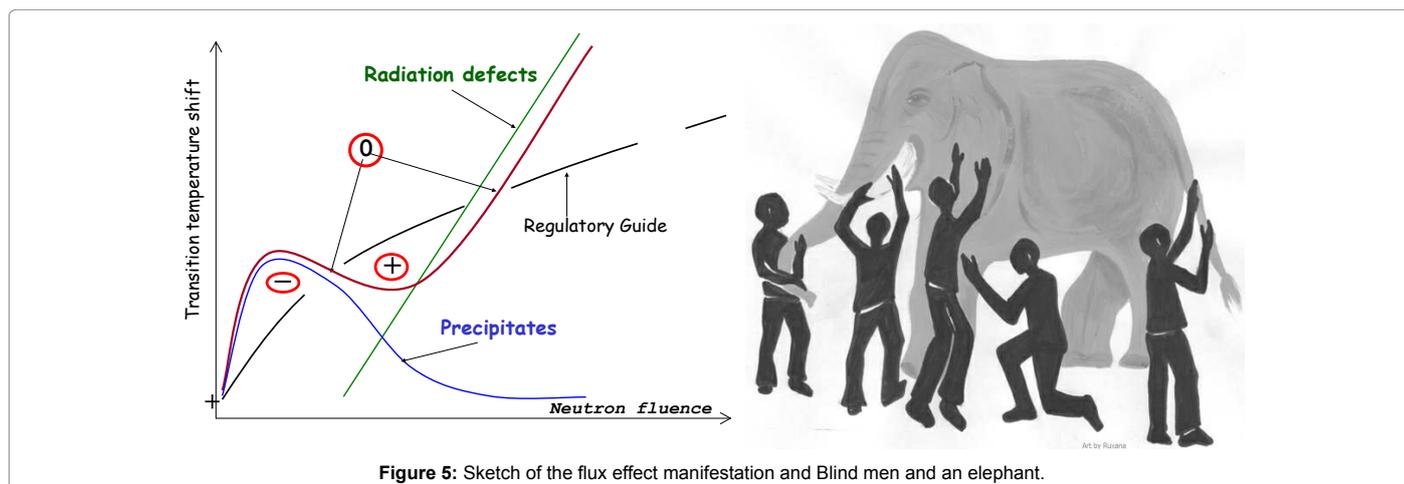
Figure 5: Sketch of the flux effect manifestation and Blind men and an elephant.

Summing the previously mentioned on the subject discussed one might conclude, that depending of the fluence level reached manifestation of the «flux effect» in reference to Guide pattern may be quite different, namely: negative, positive and «two zeros» as represented in Figure 5. Situation looks like famous parable «blind men and an elephant», where a group of blind men (or men in the dark)

In accordance with sketch of Figure 5 flux effects manifestation depends on fluence level. At low fluencies radiation degradation has to exceed normative value, then approaches to normative meaning and finally became sub normative. As a result of dose rate effect manifestation peripheral RPV's zones in some range of fluencies have to be damaged to a large extent than situated closely to core.

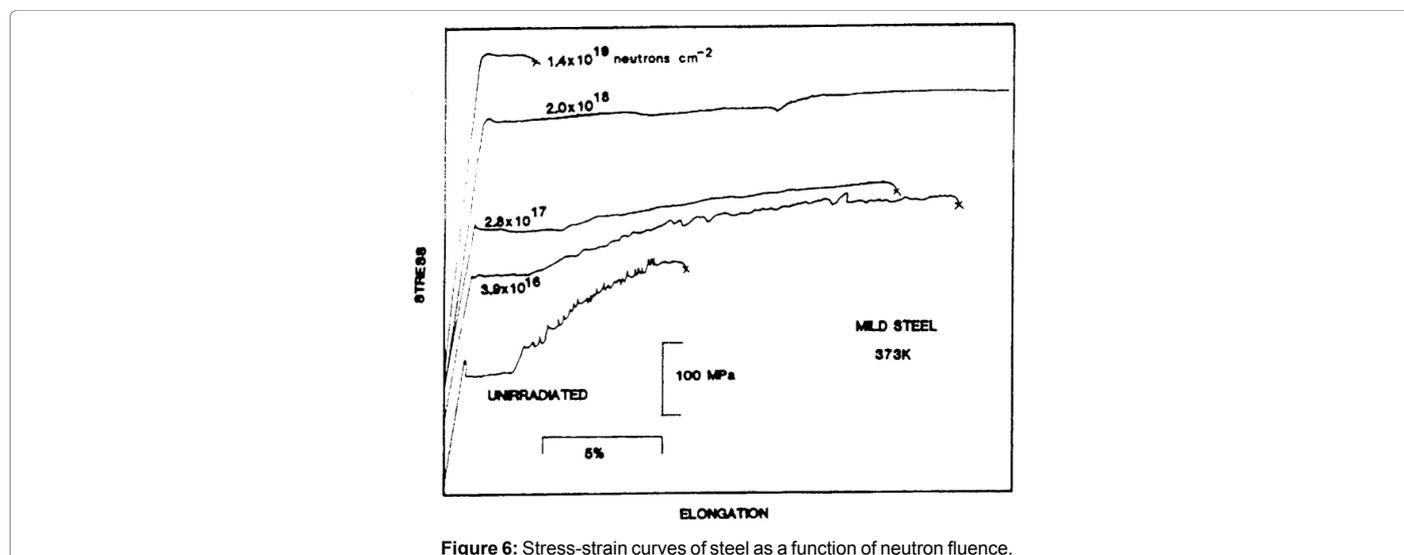
Figure 6: Stress-strain curves of steel as a function of neutron fluence.

Regulatory Guide dependence (formula) has appeared as a result of forced irradiation in test reactors. One can recognize however those specific properties of metal and actual reactor environment may deform this ideal trajectory to the extent that curve monotony character damage. The very wonderful fact is the enhanced degradation *after effect* of the temporary weakening of the embrittlement appearance. Possible comprehensible explanation is as follows: the radiation-induced copper-rich precipitates nature (dimensions and concentration) alteration. Evidently, we have fixed phenomenon similar to observed in [4] where neutron irradiation in some range of doses improves the mechanical properties of the unirradiated mild steel (Figure 6).

It is seen that irradiation of unirradiated (initial condition) steel up to dose of $\sim 2,0 \times 10^{18} \text{ cm}^{-2}$ along with strengthening lead to more than 2-fold ductility increase.
