Original Paper

THE IMPROVEMENT OF BUILDINGS AND INFRASTRUCTURE CONDITION TO ANTICIPATE DEGRADATION PROCESS OF FISH-SMOKING CENTRE IN BANDARHARJO, SEMARANG

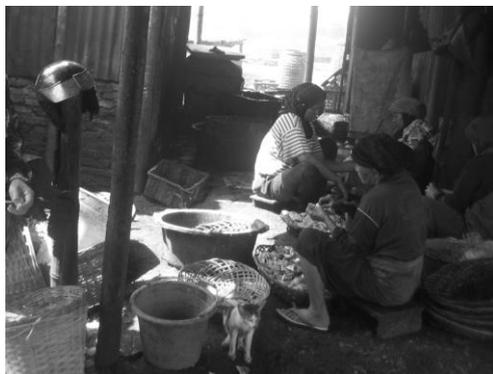
Fig. 5. Row fish processing area with two side walls.

The lighting in the workplace relies entirely on the natural light from the sun. The light in the fish smoking room is rather dim since the only opening for the light is the entrance. Here, too many openings on the wall will disrupt the coconut shell smoke used in the fish smoking process (**Fig. 5 and Fig.6**). Based on the measurement results conducted in the sunny weather at 12 a.m. by using "Lux and Fc Light Meter type Krisbow KW06-288", the lighting condition in the smoking room with four sidewalls is 120 Lux. Meanwhile, the lighting condition of row material process with two sidewalls is 789 Lux. The brightest lighting condition measured from 8 a.m. to 4 p.m. can be seen on the graph in **Fig.7**. When it rains, the light fades away and it is time to use other

According to Indonesian national standard 03-6197-2000 for Energy Conservation for lighting system. The illumination for the rough industrial activities range between 100-200 Lux. Therefore data in **Fig.7** for the smoking room with four sidewalls is below the requirement of properly illumination. But based on the interview with the worker, they don't have any problem with the lighting, because they are already accustomed to the given environment. The illumination in the row material processing area with two sidewalls from 8 am to 6 pm is always suitable with the requirement of properly illumination.

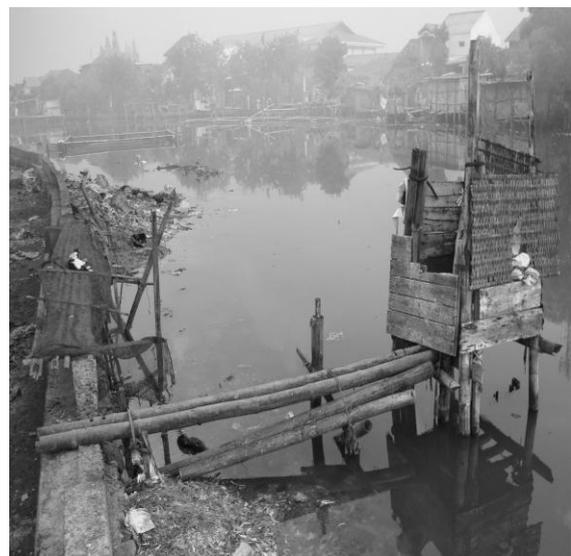
The toilet is built on the riverbank that the waste directly flows into the river stream (**Fig.12**). Users need to bring their own water taken from the nearby well to wash their hands. There are three toilets in the fish-smoking centre. The toilets are not properly built that they may endanger the users. Besides, the toilets also spoil the aesthetic of the environment. There are no permanent toilets built on the ground and the toilets built by local government have long been out of order.

Fig. 12. Shallow well. (left); Toilet is on the riverbank (right).

- Proper toilets need to be built to prevent people from using the toilets at the riverbank.
- It is important to plant more trees in the fish-smoking area. The trees can reduce the emission resulting from fish smoking activities. Trees also provide shady spaces for parking area, rest area, and spots for vendors selling food and drink.
